The Professional Journal of the
Earthquake Engineering Research Institute

Surface Fault Rupture

Extensive surface rupture accompanied the August 17, 1999, Kocaeli earthquake. Surface rupture consisted primarily of right-lateral strike-slip displacement of up to 5.5 meters, averaging 3 to 4 meters, with localized vertical displacements of up to 2.4 meters. The fault rupture produced classic examples of strike-slip offset, including well-formed mole tracks, left-stepping *en echelon* fault traces at a variety of scales, uplift of pressure ridges, and subsidence of extensional pull-apart basins. Four distinct segments of the North Anatolian fault (NAF) ruptured during the earthquake, providing the opportunity to investigate the dynamic process of fault rupture and the physical and behavioral features of a fault that may control the propagation of fault rupture. Surface fault rupture traversed both rural and urban areas, generating excellent examples of the effects of surface fault rupture on engineered structures and, locally, the influence of some engineered structures on the surface expression of fault rupture.

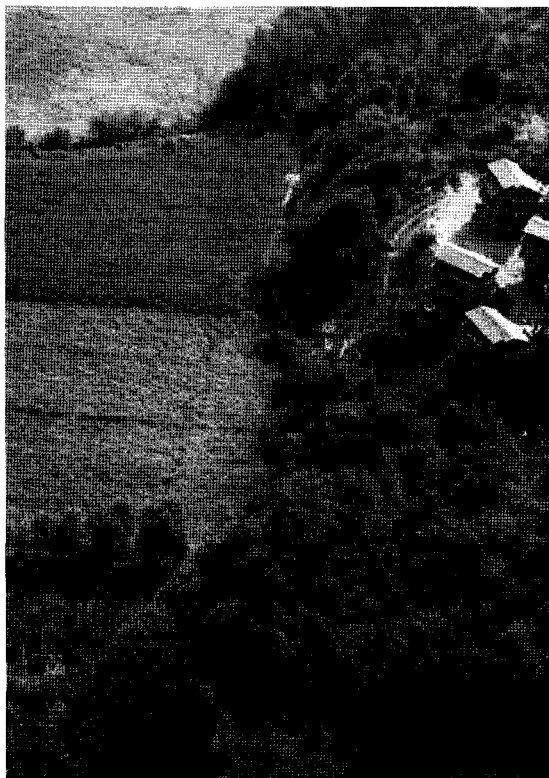
Figure 2.1. *Left* Fault rupture extends along eroded scarp between Holocene valley alluvium and elevated Pleistocene alluvium.

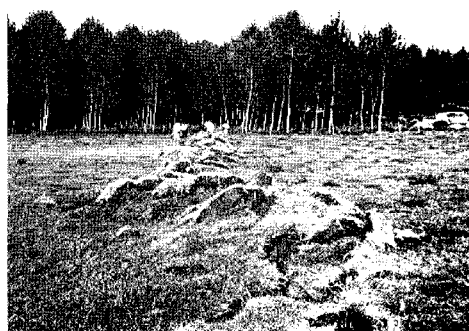
Figure 2.2. *Above* Moletrack along Sapanca segment produced by 3.1 meters of right lateral-offset.

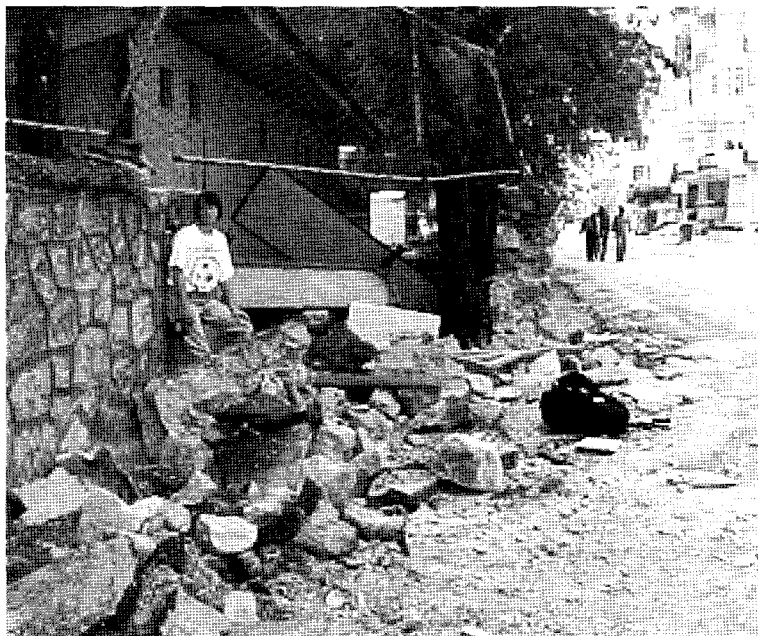
Figure 2.3. Right-lateral fault offset of stone wall along western margin of Gölcük Naval Base. Total fault offset at time of photo (September 2) was 4.2 meters. Subsequent measurement of the offset on October 2 showed cumulative offset of up to 5.5 meters.

Several cases of afterslip were reported following the August 17 earthquake. The best example of afterslip occurred at the Gölcük Naval Base, where fault rupture offset a stone wall. On September 2, total offset of the wall was measured at 4.2 meters (figure 2.3). On October 2, total offset of the wall was measured at up to 5.5 meters. Multiple surveys at several other sites suggest that afterslip of a few tens of centimeters occurred on both the Sapanca and Gölcük fault segments. No observations were made along the Sakarya and Karadere fault segments to document the presence or absence of afterslip.

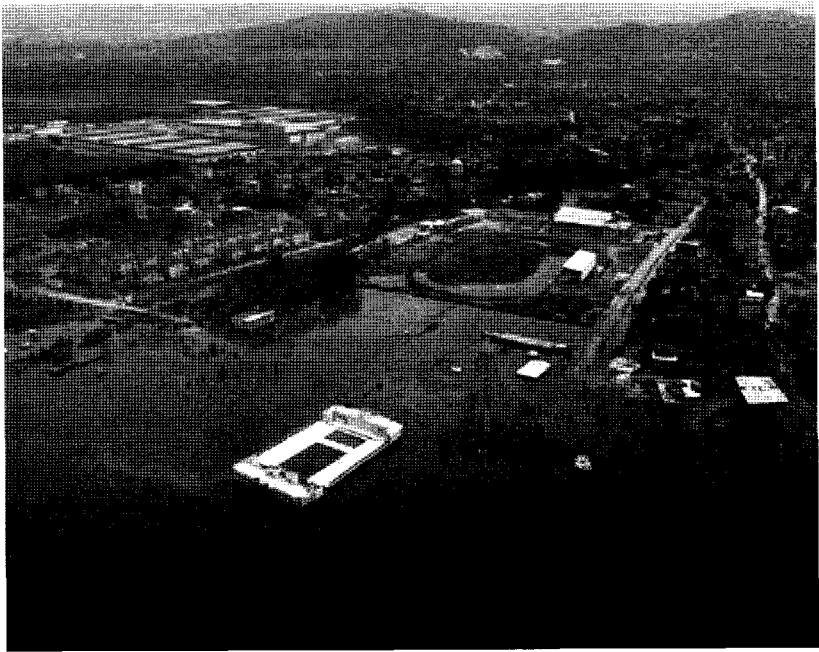
Figure 2.10. Widespread tectonic subsidence in eastern Gölcük City caused by normal faulting and subsidence of the Gölcük pull-apart basin.

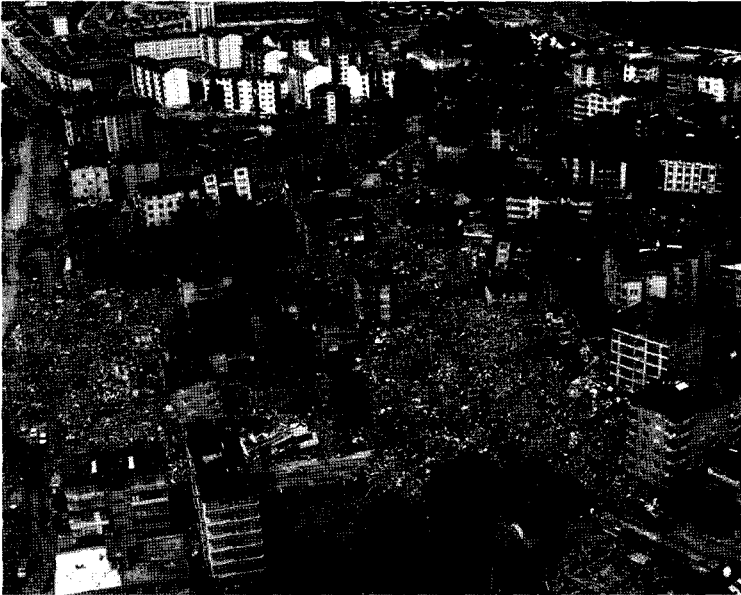
Figure 2.13. Aerial view of extensive damage in Gölcük with Izmit Bay in upper corner. Surface fault rupture extended through the city. Although most of the observed damage in this photo resulted from strong ground shaking, surface fault rupture contributed to damage when apartment buildings and houses lay astride the rupture.

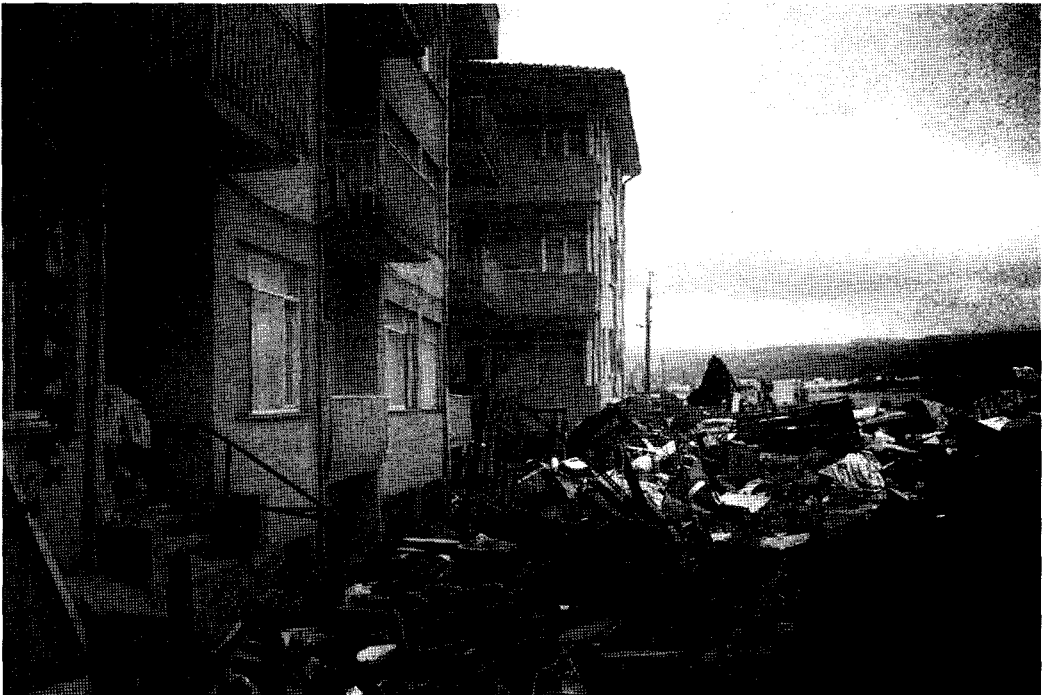
Figure 2.14. Four-story apartment house that collapsed from surface rupture on right side of photo, west of Gölcük Naval Base. Fault rupture passes left to right across the middle of the photo between two standing apartment buildings. These apartment buildings were originally aligned and are now offset about 4 meters relative to one another across the fault.

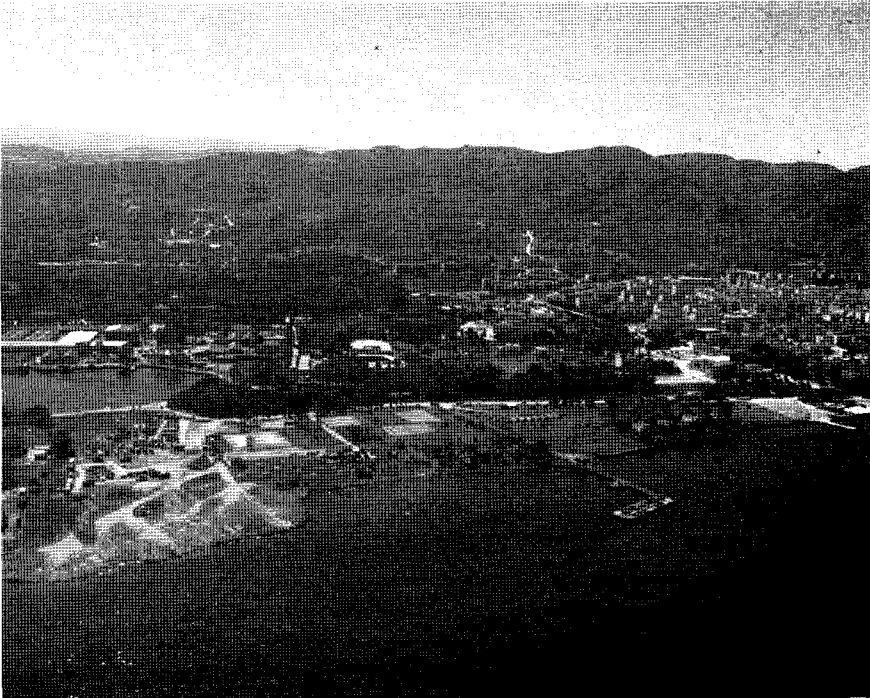
Surface fault rupture also damaged numerous buildings on the Gölcük Naval Base (figure 2.15). Fault rupture crossed the base near the southern margin of a linear pressure ridge and extended beneath a single-story building and a three-story building in the western part of the base (figures 2.16, 2.17). Both buildings were severely damaged by the rupture but did not collapse. Rupture also extended beneath a large officer quarters building on the base, causing complete collapse of the building and significant loss of life. A series of three buried bunkers are present

Figure 2.15. Aerial view of Gölcük Naval Base; view toward the south. Izmit Bay is in the foreground. The linear hill covered with trees in middle of photo is a pressure ridge along the Gölcük segment of the North Anatolian fault. Three to four meters of fault rupture occurred along the far side of the ridge, and extended through the naval base and docks.

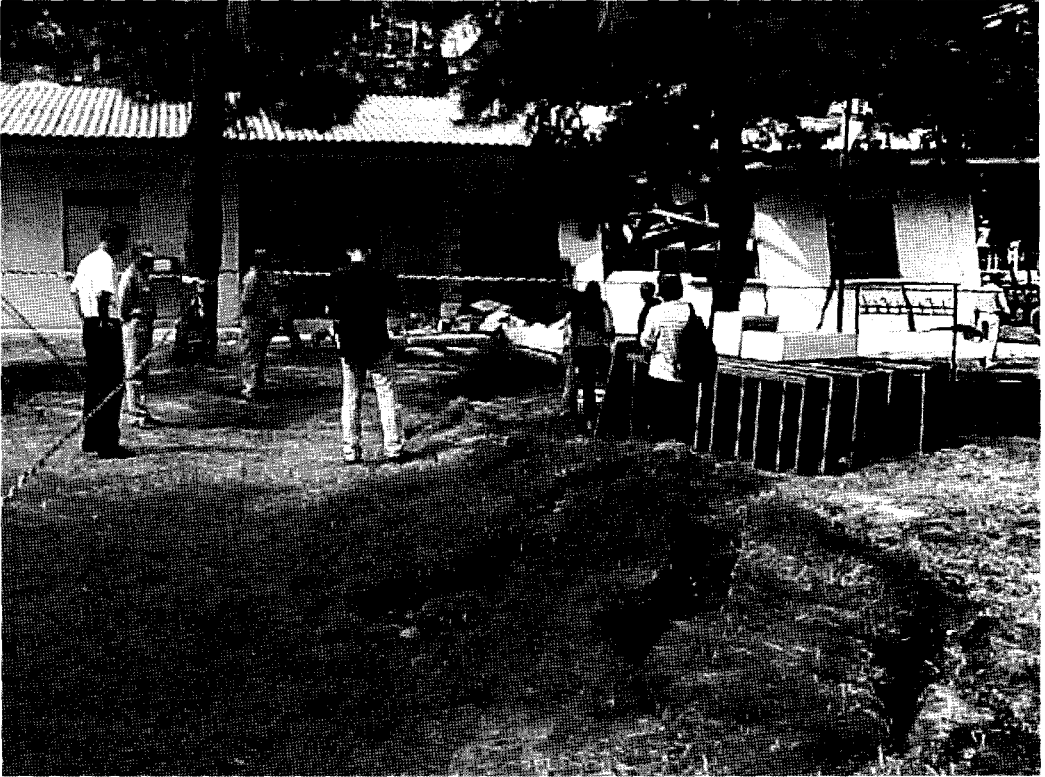
Figure 2.16. Fault rupture through single-story building, west part of Gölçük Naval Base.

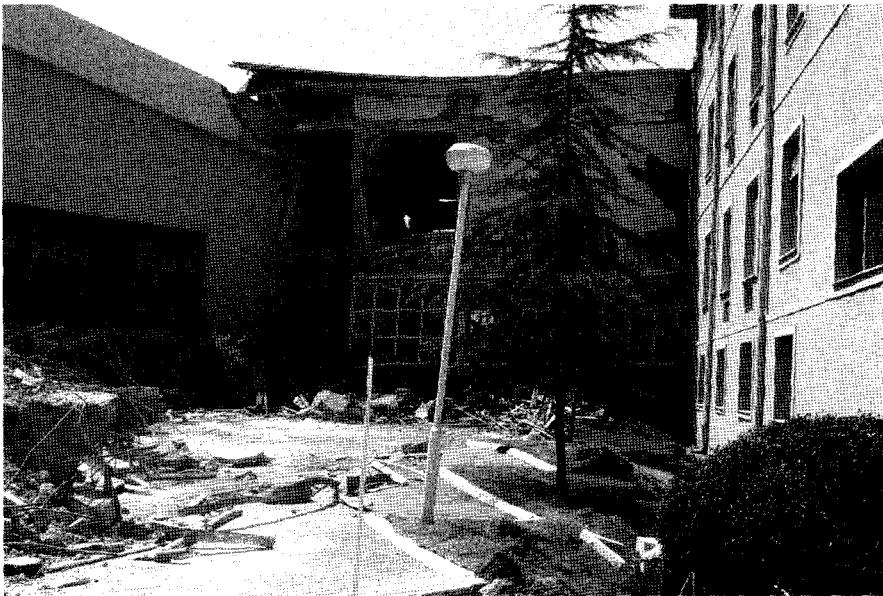
Figure 2.17. Fault rupture between and through a complex of three-story buildings, west part of Gölçük Naval Base.

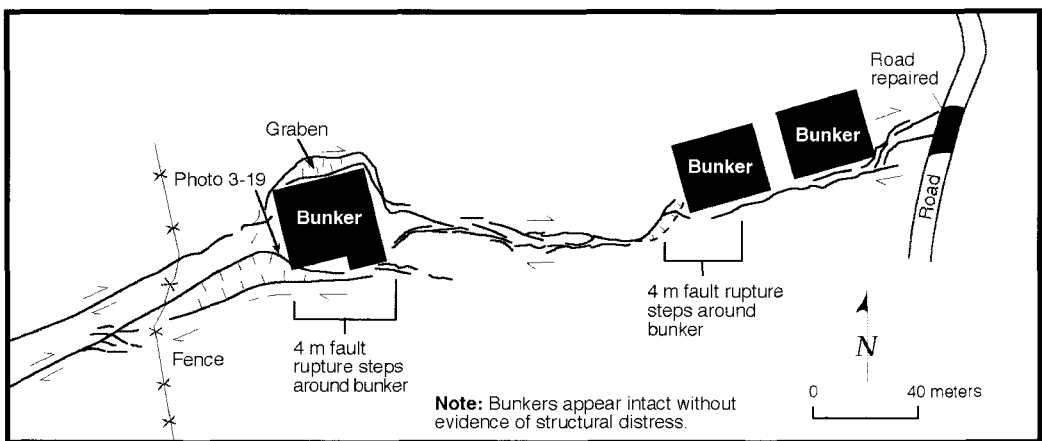
along the base of the linear pressure ridge. Fault rupture of 3 to 4 meters directly intersected the bunkers, which appear to be constructed of heavily reinforced concrete. The massive concrete bunkers caused the surface rupture to go around them (figure 2.18, 2.19). The bunkers did not appear to be damaged, although a small amount of counterclockwise rotation may have occurred.

Figure 2.18. Surface rupture on Gölçük fault segment at Gölçük Naval Base broke around massive concrete bunkers without structural damage to the bunkers (see also figure 2.19).

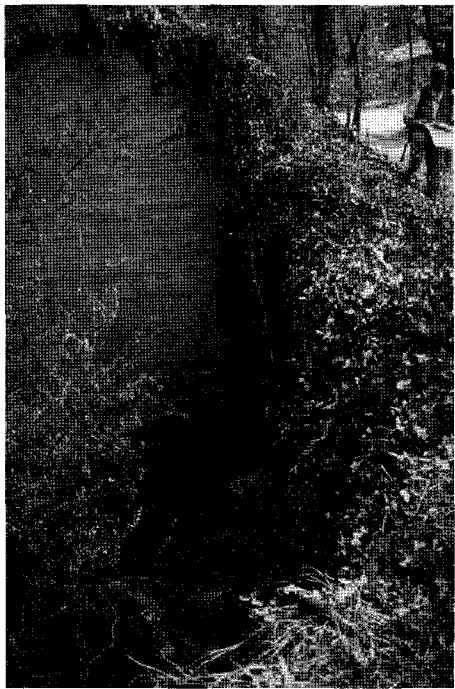
Figure 2.19. *Left* Fault rupture of 3 to 4 meters extending around undamaged bunker on south side of the pressure ridge (in figure 2.18), west part of Gölçük Naval Base. Rupture locally pulled the soil away from the bunker on one side, and compressed the soil on the other side.

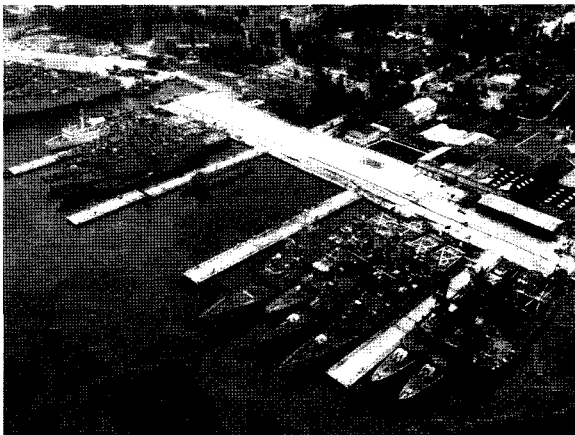
Farther to the east on the Gölcük Naval Base, fault rupture extended offshore and crossed a series of docks and port facilities (figure 2.20). Displacement typically was transferred through the rigid structural members to weaker connections, joints, or elements of the docks or was accommodated by global rotation, thereby spreading the damage over a wider area (figure 2.21).

Figure 2.20. *Above* Aerial view of the docks at Gölçük Naval Base. Surface faulting has displaced the docks, most clearly seen in the middle of the photo.

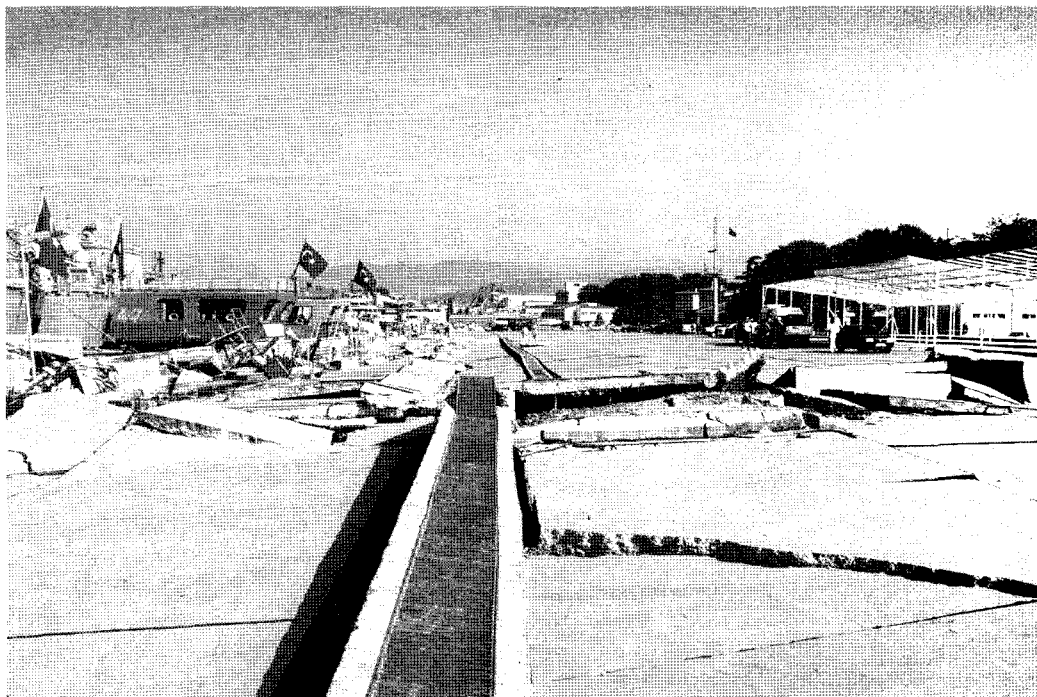
Figure 2.21. Fault offset of about 2 meters of a dock at the Gölcük Naval Base.

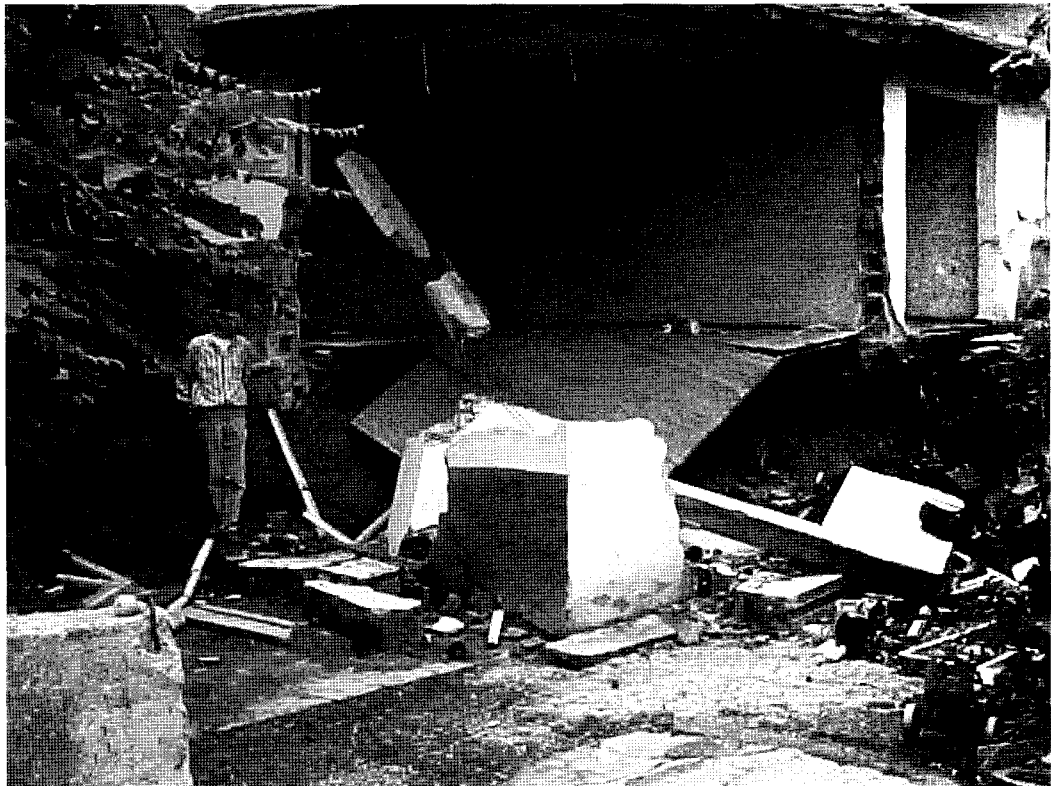
Figure 2.22. Concrete frame, clay-tile infill two-story apartment damaged by normal fault displacement of 1 to 2 meters in eastern Gölcük City.

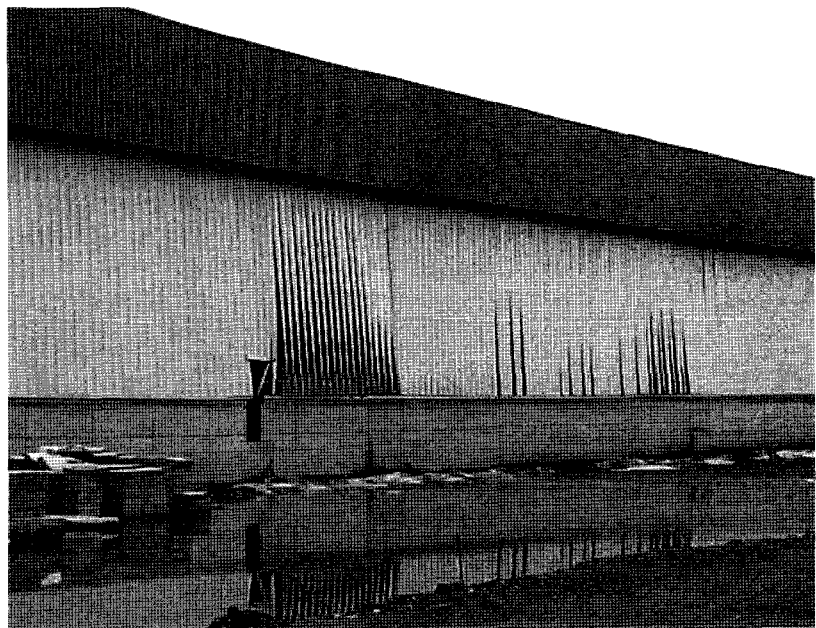
Figure 2.23. Wall of Ford-Otosan assembly plant building showing distress caused by secondary faulting beneath the building. Building consists of multi-column truss structure on a concrete slab. Secondary displacement of 30 to 40 cm significantly damaged the building.

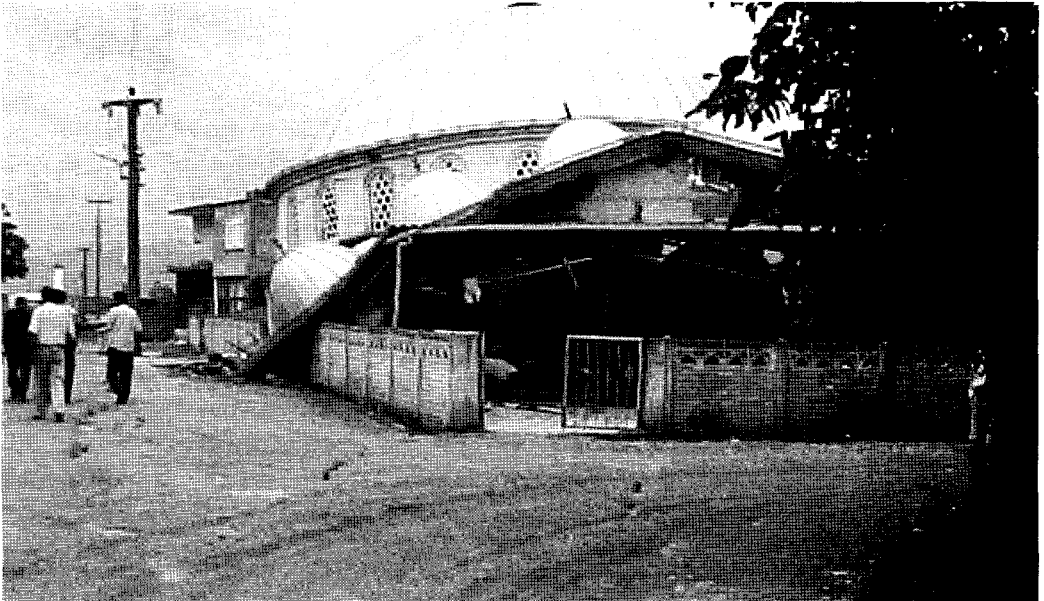
Directly west of the Ford-Otosan plant, normal fault rupture extended beneath a large mosque (figure 2.24). Vertical displacement of approximately 1 meter caused collapse of the western part of the mosque.

Figure 2.24. Vertical surface displacement of about 1 meter extended beneath and caused collapse of a mosque in a residential area directly east of the city of Gölcük.

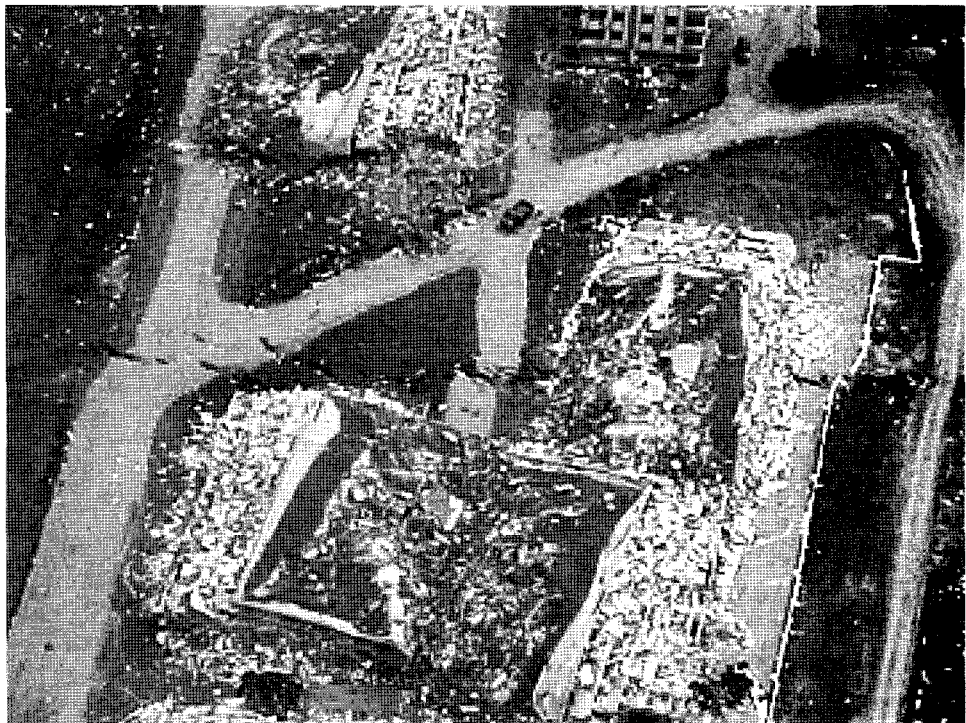
Figure 2.25. Aerial view of a recently completed, but unoccupied, complex of six-story apartment buildings directly west of the town of Kullar. Surface rupture along the Sapanca fault segment is visible as a series of open fissures in the middle of photo.

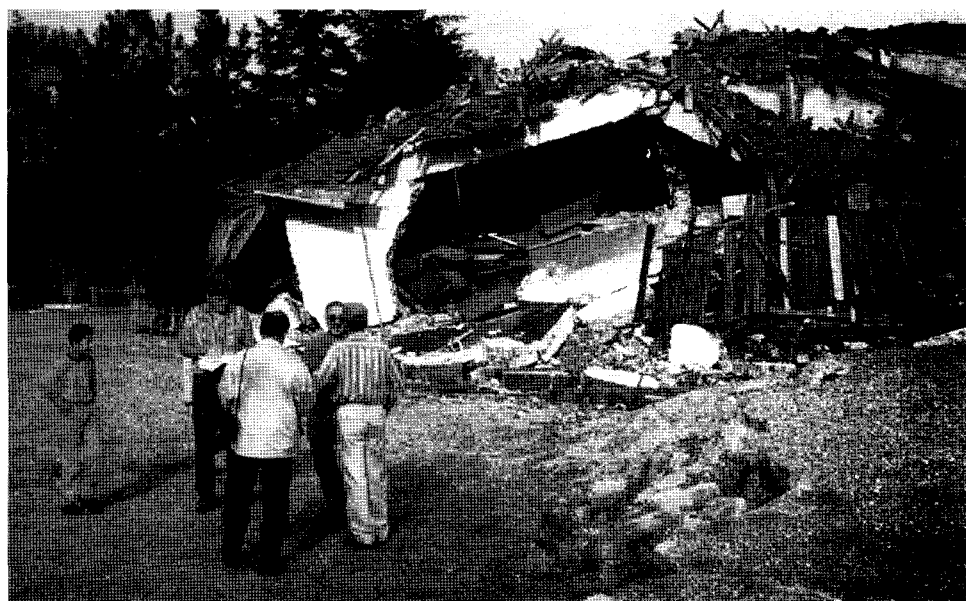
Figure 2.26. Fault rupture extended beneath the music building of a primary school in Kullar, about 4 km east of Izmit Bay. About 2 meters of lateral offset and 0.5 meter of vertical offset caused partial collapse of the school.

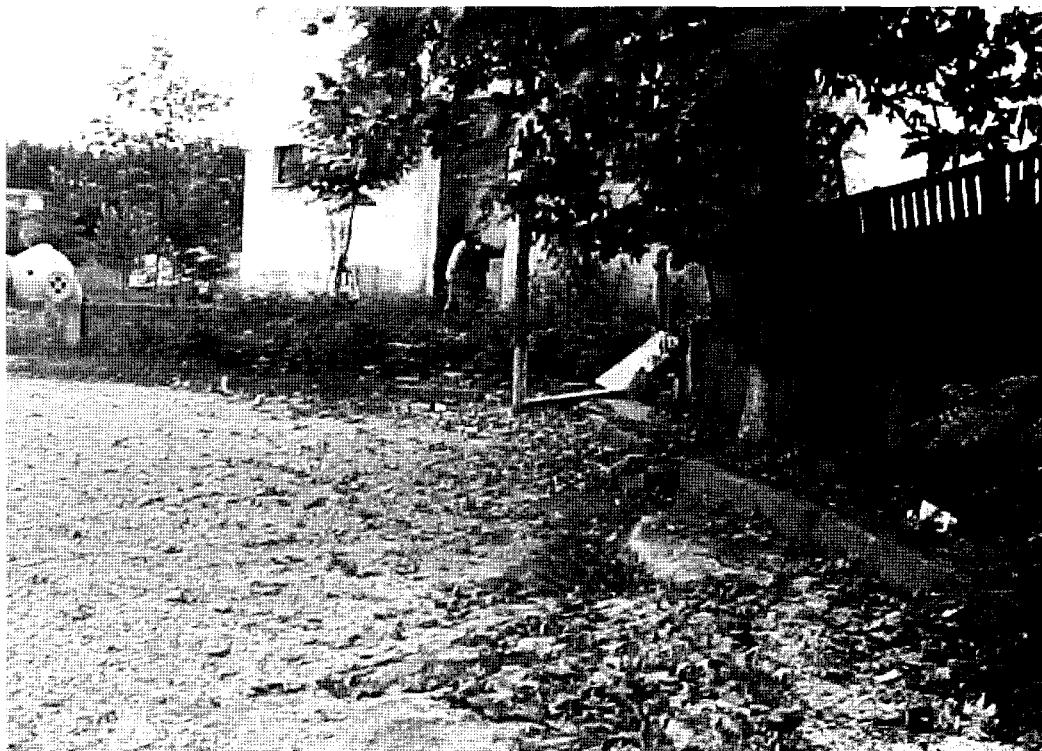
Figure 2.27. Fault rupture extended toward and went around a two-story concrete frame building near the damaged school in Kullar shown in figure 2.26. Approximately 1 meter of lateral offset extended to, but was arrested at, the building. Slip on the fault strand was transferred to an adjoining parallel fault strand.

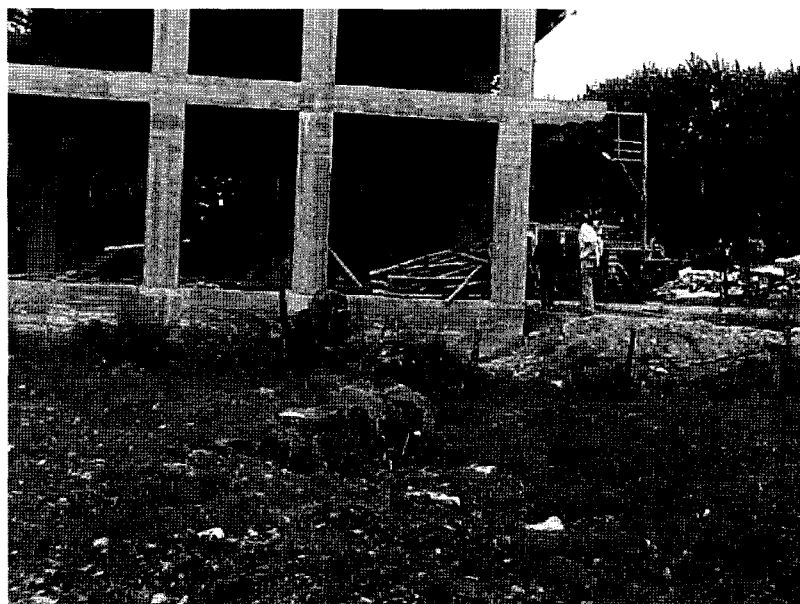
Figure 2.28. Four-story concrete frame building under construction in eastern Kullar City. Fault rupture extended beneath the building, but the building foundation decoupled from soil, and the structure was not damaged.

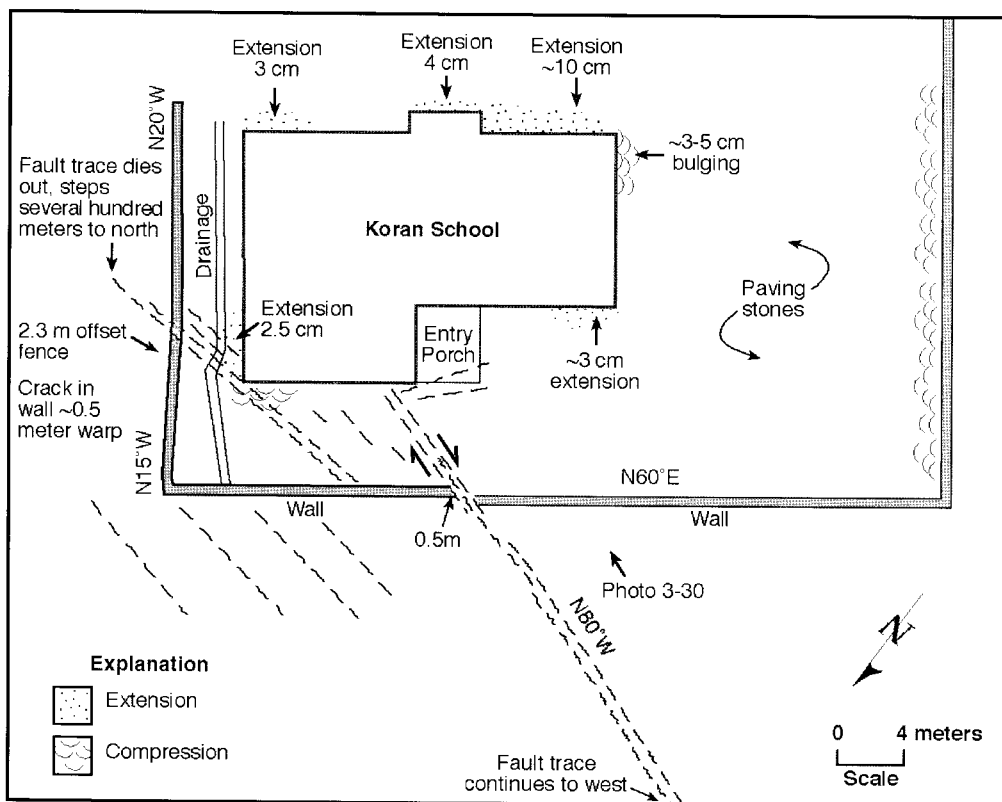
Figure 2.29. Map of surface faulting at a Koran school along the Sapanca fault segment. Distributed fault rupture of 1 to 2 meters impacted the northern corner of the building. Rupture appears to have been stopped by the building foundation and forms a left *en-echelon* step around the building. The building rotated slightly but was not damaged.

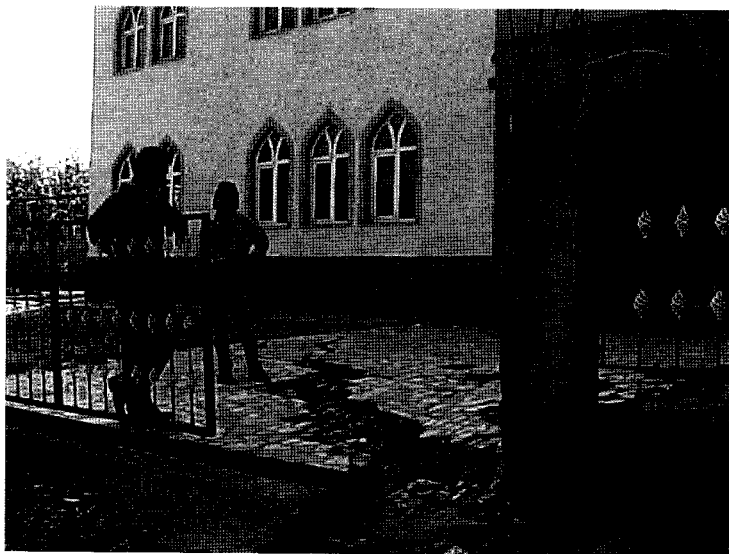
Figure 2.30. Fault rupture of about 1 meter extends toward the northern corner of the Koran school shown in figure 2.29.

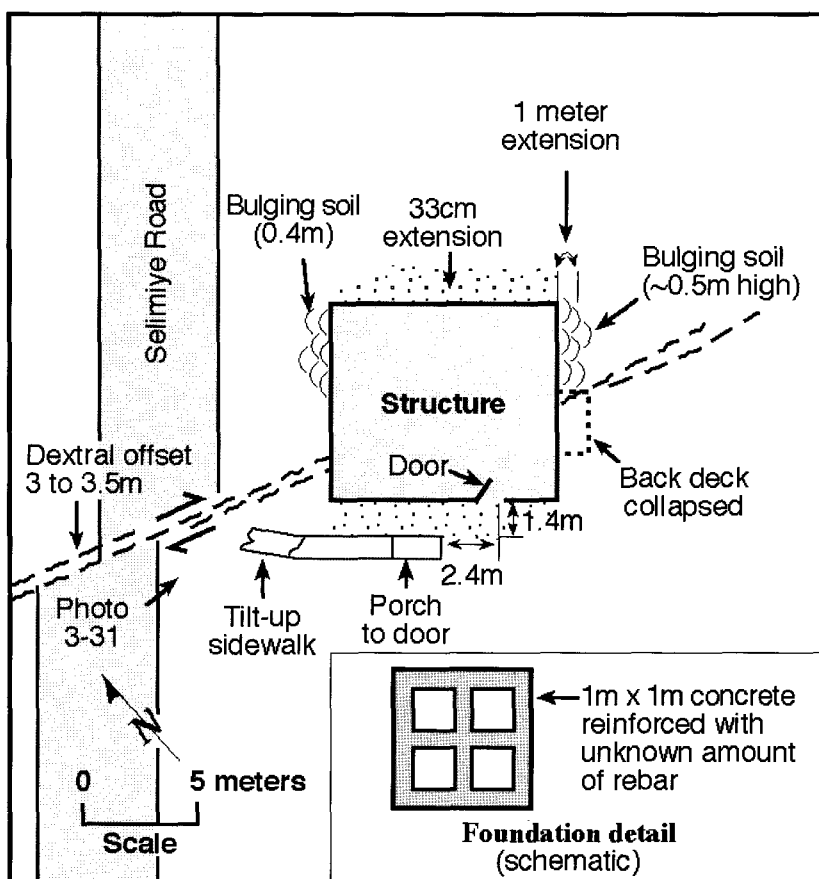
Figure 2.31. Sketch map of fault rupture beneath two-story house at #27 Selimiye Street, Arifiye, along the Sakarya fault segment.

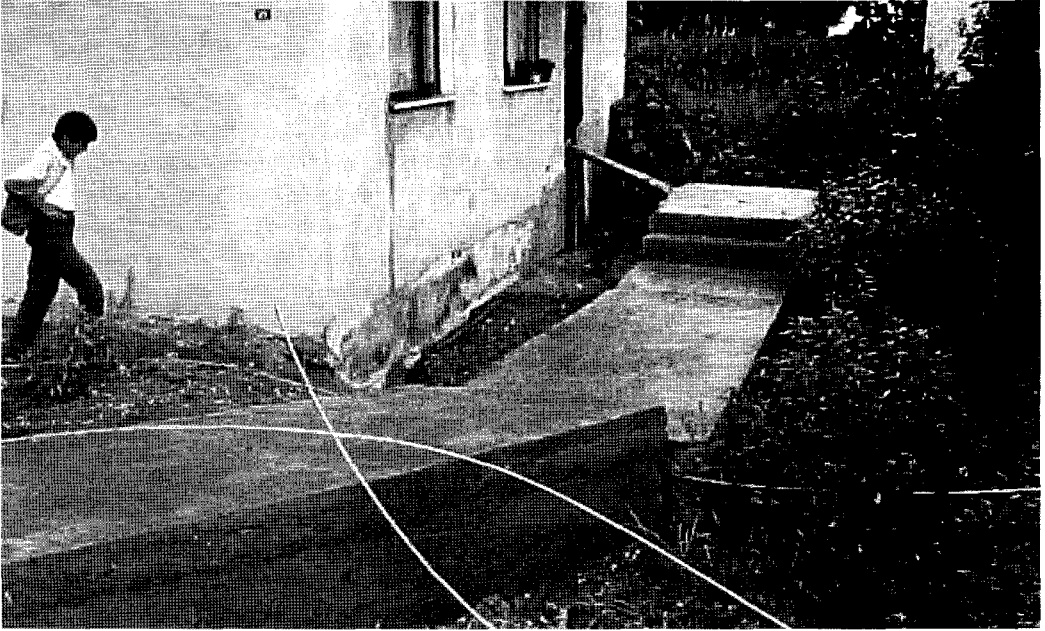
Figure 2.32. Surface faulting beneath the two-story house in figure 2.31 pulled the front porch and walkway away about 2 meters, yet the building is essentially undamaged.

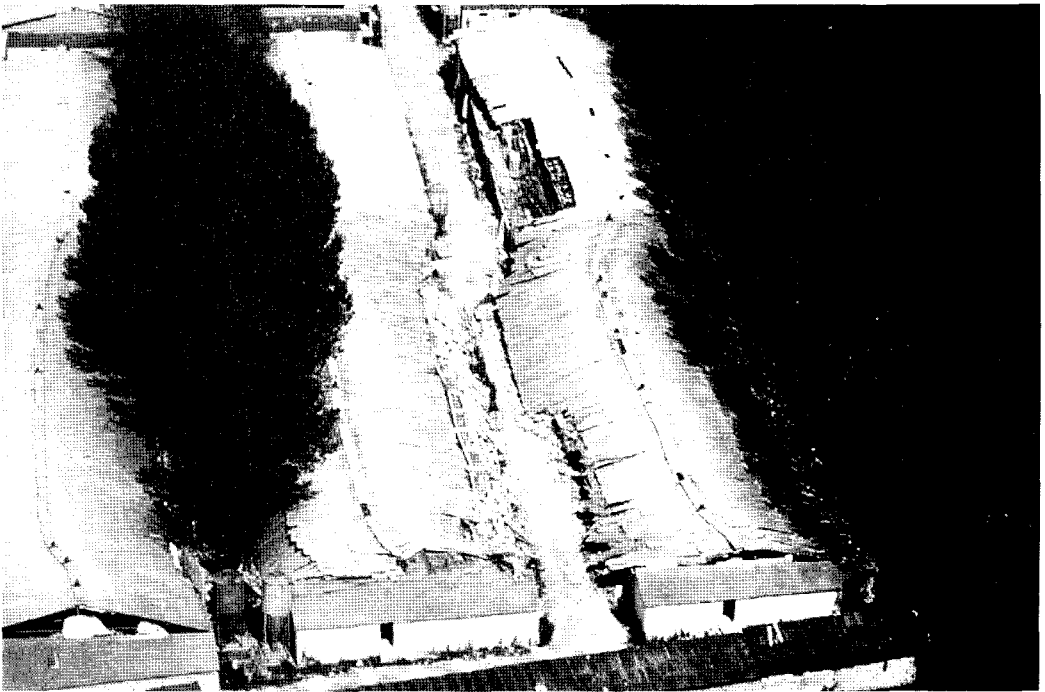
Figure 2.33. Directly east of Arifiye, surface rupture of about 5 meters on the Sakarya fault segment caused partial collapse of three agriculture warehouses.

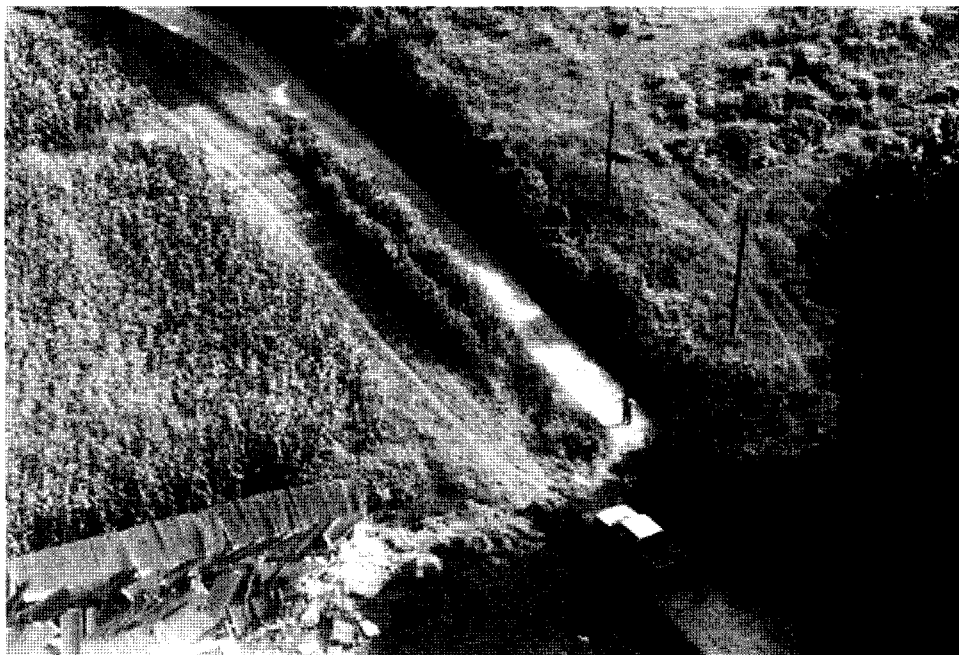
Figure 2.34. In the area of maximum offset along the Sakarya fault segment, a road is laterally offset 5.2 meters. Fault rupture extended the length of a tool storage shed and caused collapse of the shed.

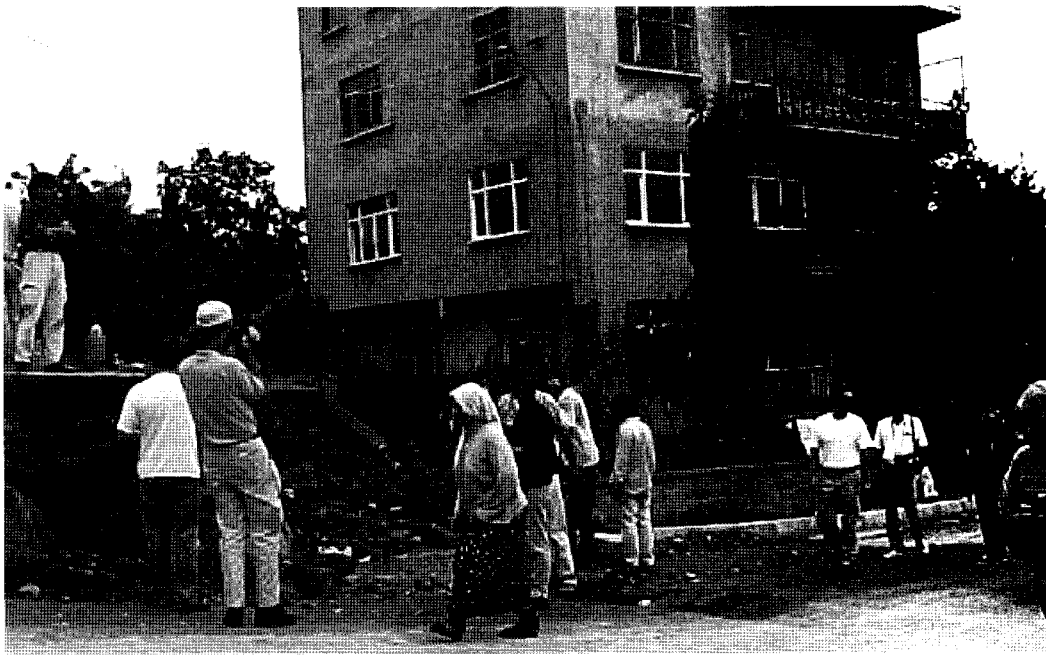
Figure 2.35. Normal fault displacement of 2.4 meters passed within 1 meter of a four-story concrete frame apartment building. The building is undamaged.

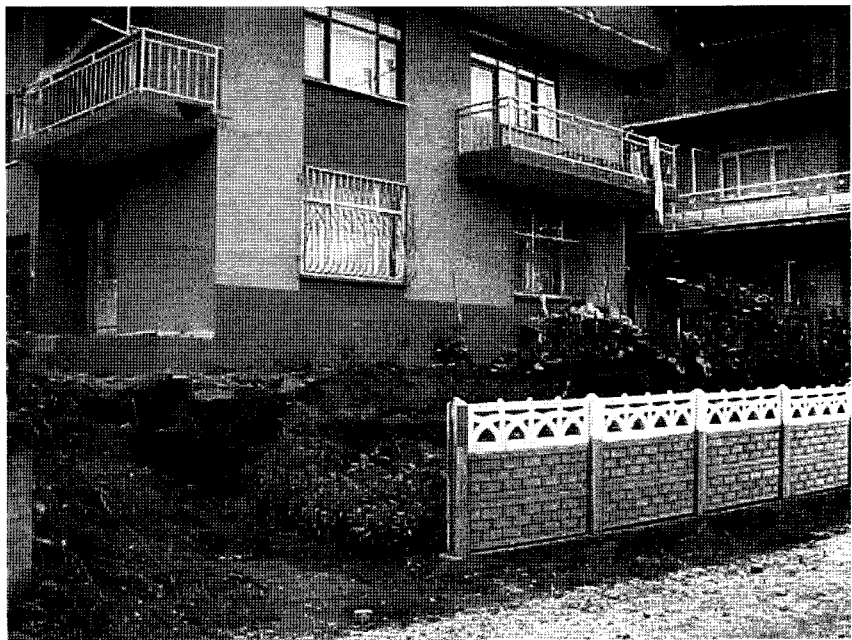
Figure 2.36. Two-story house in the city of Gölcük with 1.5-meter fault scarp. The house was not damaged.

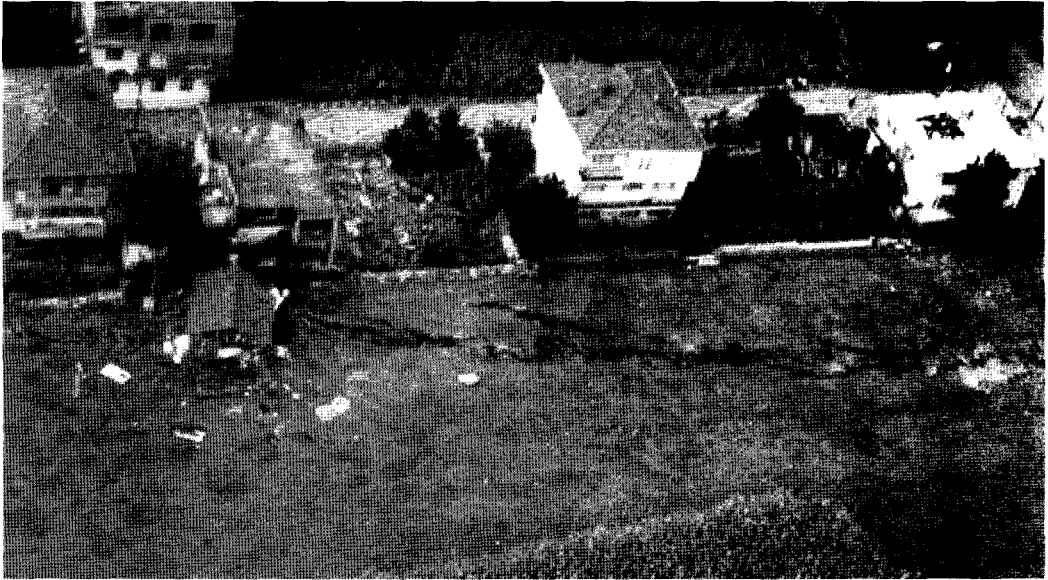
Figure 2.37. Fault offset of 3 meters on the Sapanca fault segment. Rupture caused collapse of the house in the left foreground, but houses adjacent to the rupture were not damaged by either the fault rupture or by strong ground shaking.

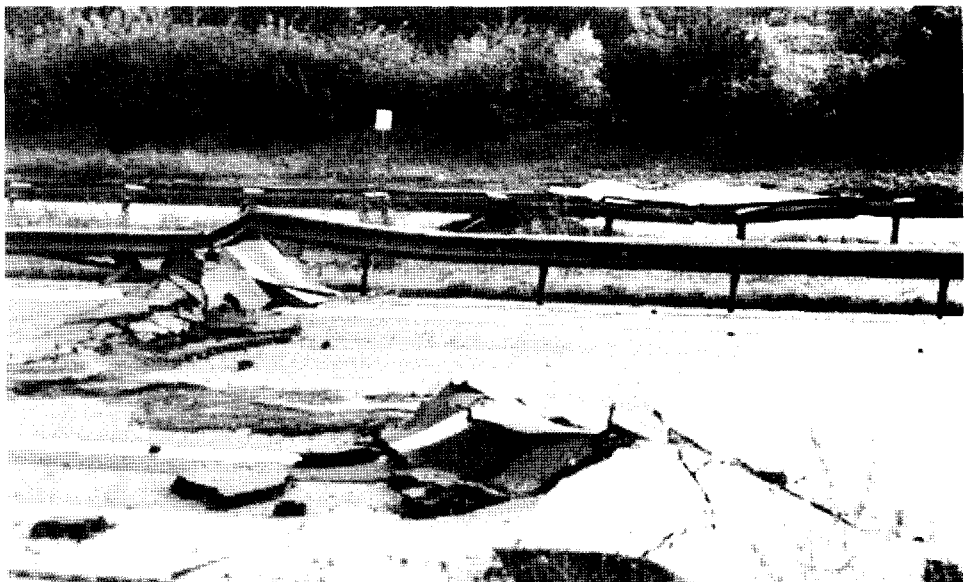
Figure 2.38. Fault offset of about 3 meters along the Sakarya fault segment near the town of Arifiye damaged roadways and the Trans-European Motorway.

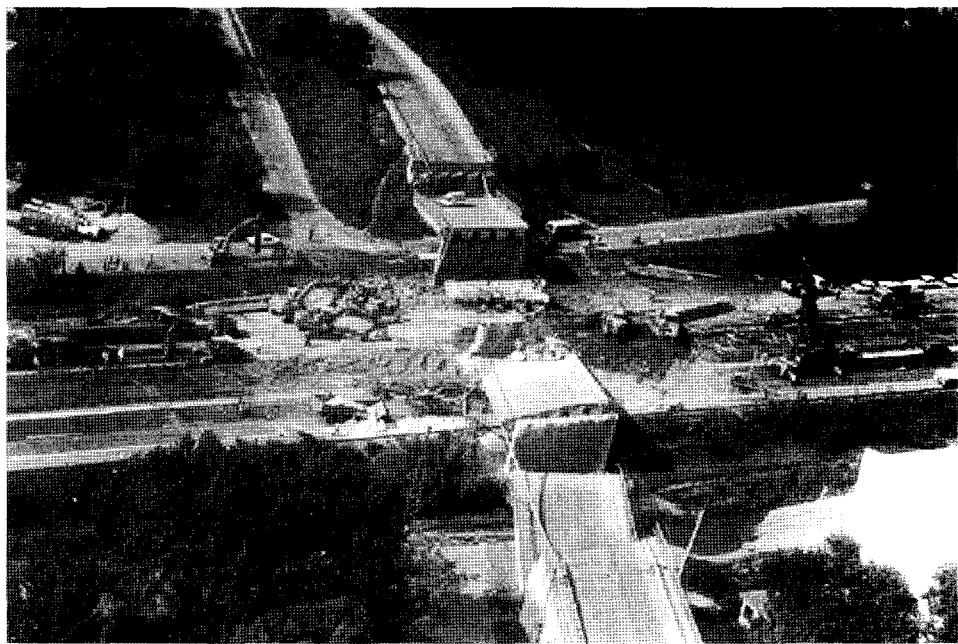
Figure 2.39. Collapse of overpass across the Trans-European Motorway (E80) near the town of Arifiye caused by 3 to 3.5 meters of right-lateral offset along the Sakarya fault segment. Collapse of the overpass caused closure of the highway for several days.

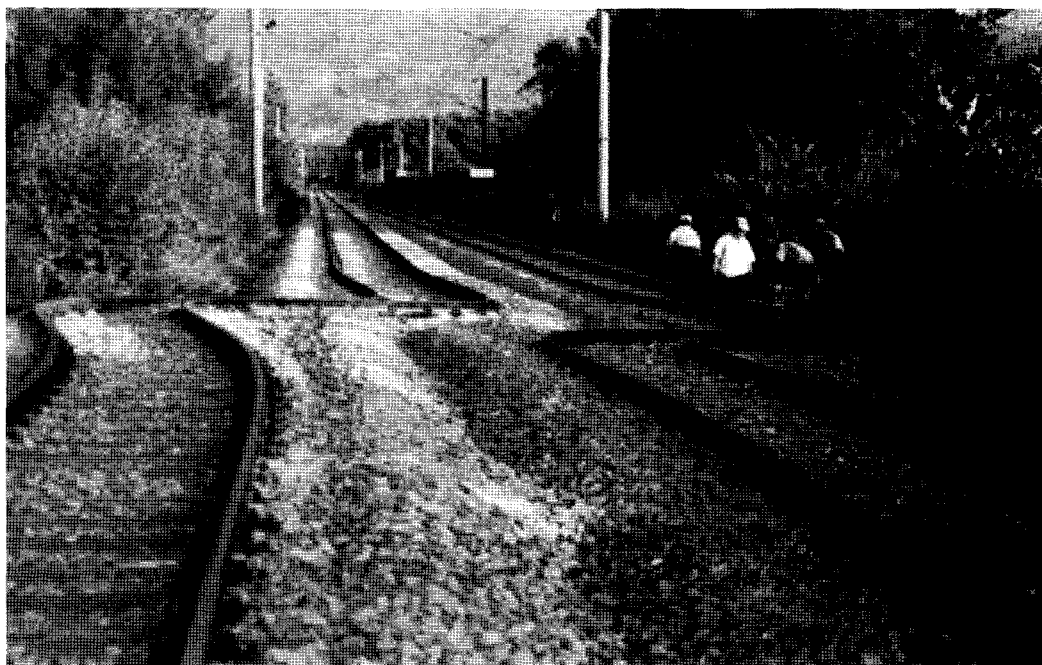
Surface fault rupture caused closure of both tracks of the railroad between Izmit Bay and the town of Arifiye (figure 2.40). The tracks were damaged at several locations by lateral offset, compressional buckling, and extensional opening of the tracks. Repair crews partially opened one line within two days after the earthquake; however, repairs extended for several weeks before railway traffic could be returned to normal. The chapter on transportation includes additional discussion of earthquake effects on railways.

Figure 2.40. Fault rupture produced 3 meters offset of the railroad between Izmit Bay and Lake Sapanca. Repairs to the railroad opened one line within two days of the earthquake, but extended for several weeks following the earthquake.

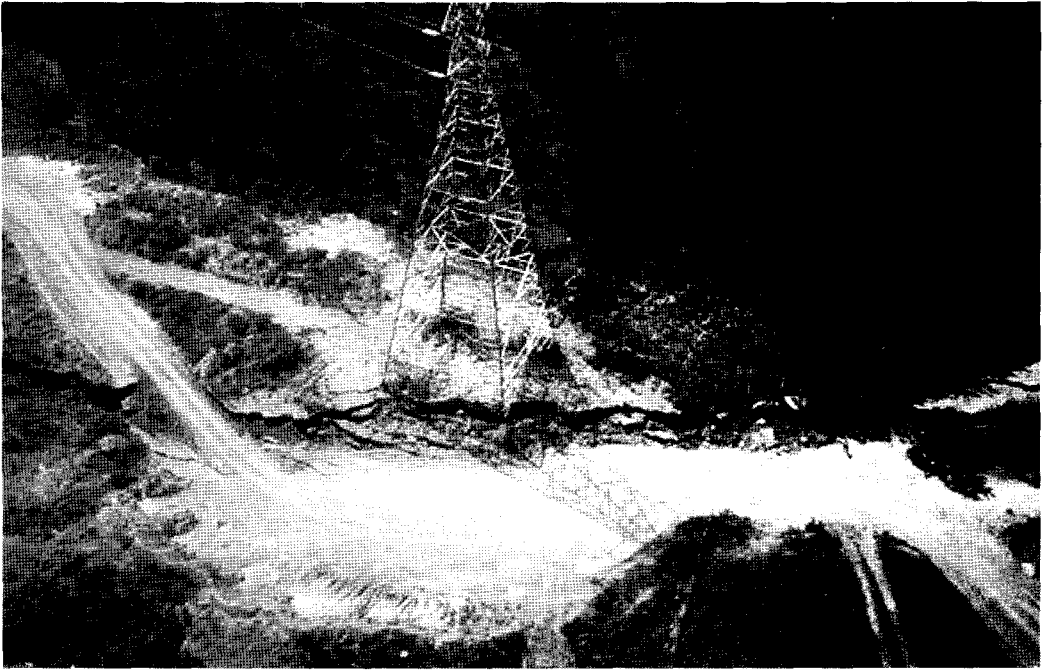
Figure 2.41. Aerial view of the normal fault along the Gölcük segment east of Gölcük, near the Ford-Otosan plant. Fault rupture crosses beneath one footing of the tower, which was pulled out of the soil, preventing damage to the tower lattice.
