## Failures of masonry and concrete buildings during the March 8, 2010 Kovancılar and Palu (Elazığ) Earthquakes in Turkey

Zekai Celep<sup>a</sup>, Ayfer Erken<sup>b</sup>, Beyza Taskin<sup>a</sup>, Alper Ilki<sup>c,\*</sup>

<sup>a</sup> Istanbul Technical University, Civil Engineering Faculty, Structural Engineering Department, 34469 Istanbul, Turkey

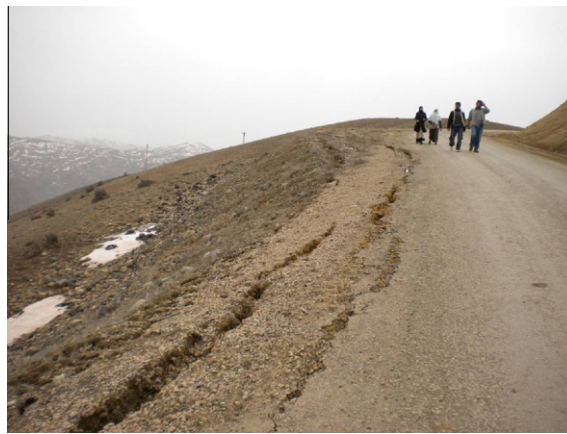
**Fig. 11.** Tension cracks on the side of the road in the region.

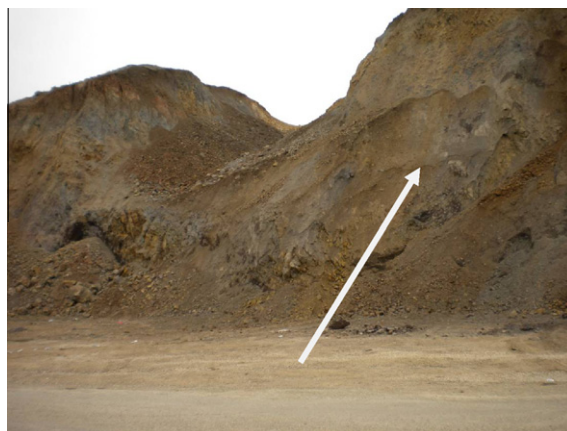
**Fig. 12a.** Failure surface.

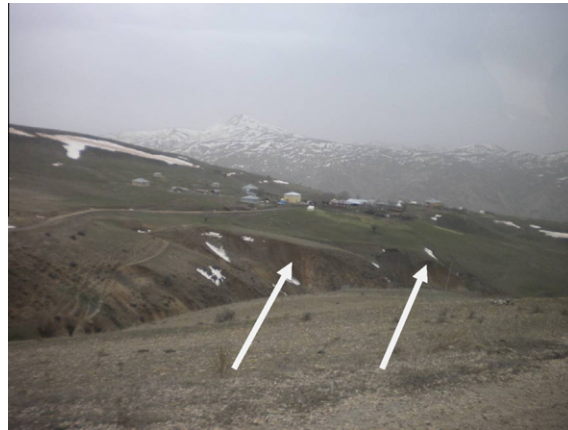
**Fig. 12b.** Slope failures around the stream in the region.

slopes of streams next to Yukarı Demirci Village as shown in Fig. 12b. The maximum displacements on the ground surface at foundation levels in the villages of Yukarı Demirci, Okçular and Kayalık were observed to be up to 20 cm, which is comparable to the calculated displacement values within a few centimeters.

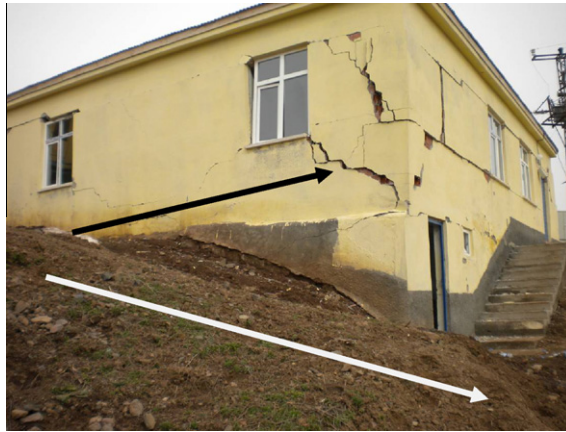
**Fig. 13a.** A rural building on slope at Yukarı Demirci Village.

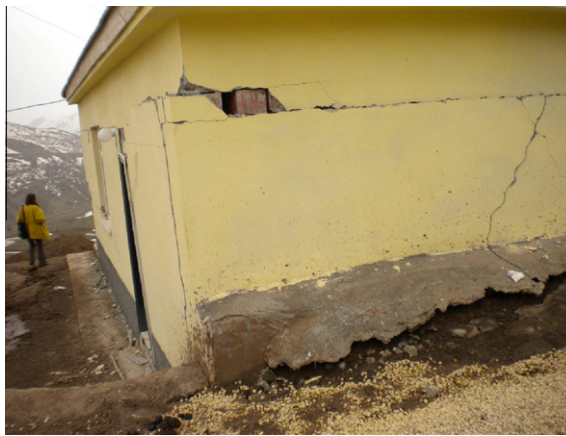
**Fig. 13b.** A view of the building from backyard.

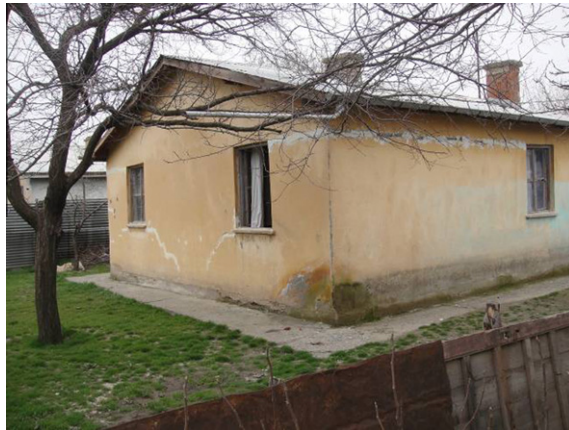
Fig. 18. Slightly damaged brick masonry buildings in Palu.

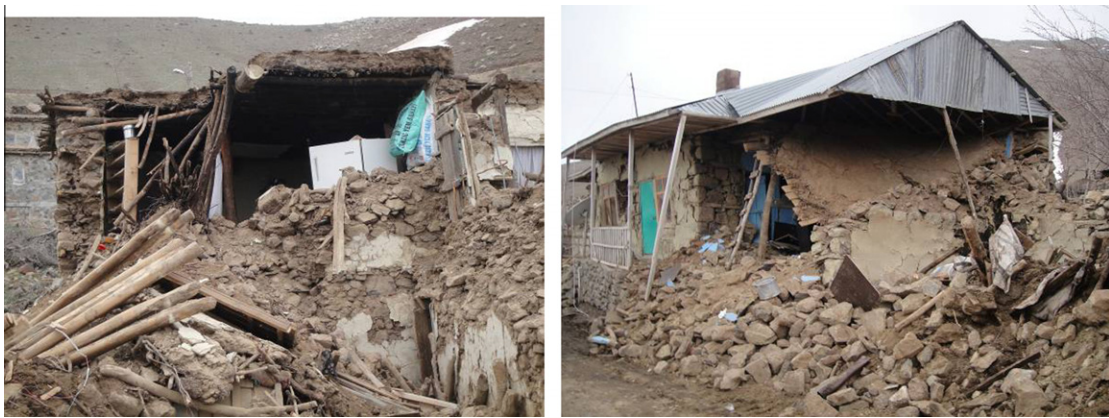
Fig. 19. Typical failures of stone masonry buildings (Göçmezler and Yukarı Demirci villages).

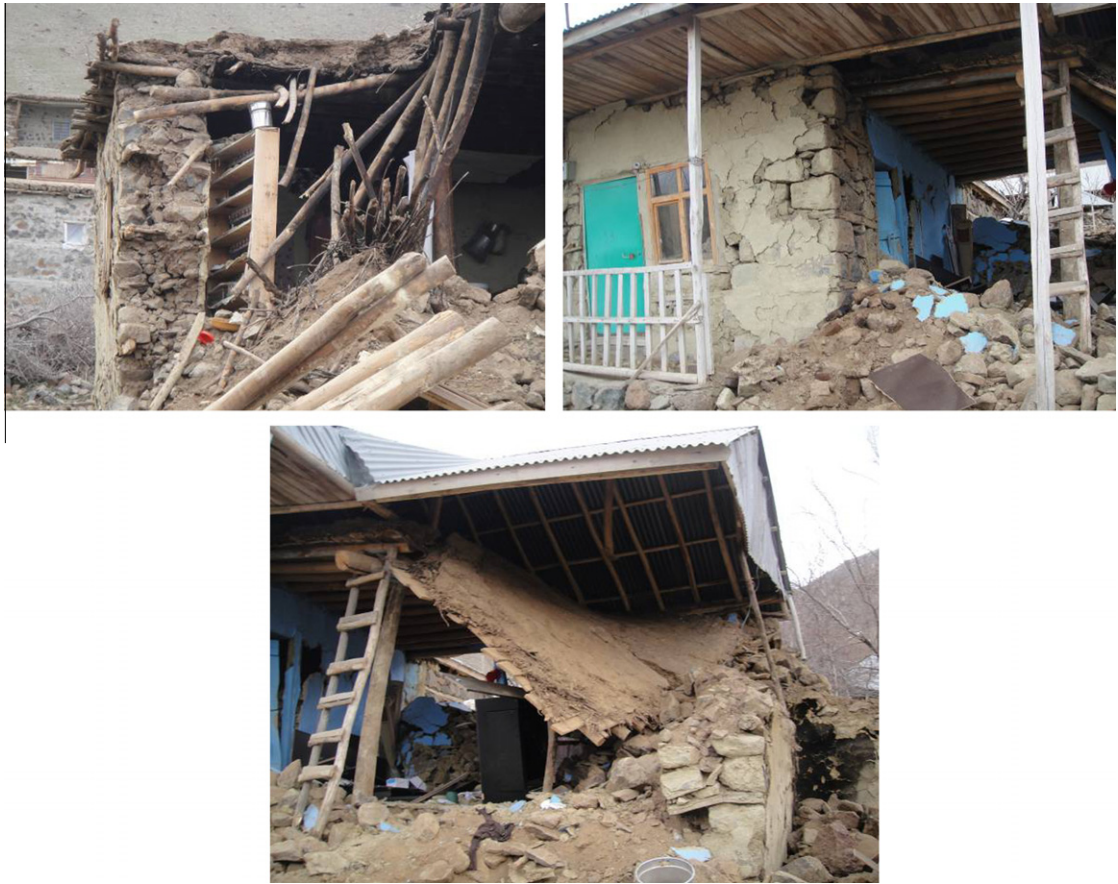
Most of the failures causing casualties occurred in the stone masonry buildings constructed with mud mortar binder and heavy clay roofs formed on the irregular wooden beams supported by two main walls of the buildings. Often roofs having very weak support connections or very small support lengths tend to separate from the walls very easily (Fig. 19). The thicknesses of multi-leaf stone walls are generally about 50 cm. These thick stone walls and clay roofs are preferred by the local people due to their heat insulation characteristics. They provide cool environment in summer and relatively warm environment in winter. In some buildings, animals such as cattle are kept as well. As seen in Fig. 19, the remarkably poor performance of this type of buildings can mainly be attributed to the irregular wall construction with stones of small dimensions insufficiently tied with larger dimension stones or wooden ties. Very poor quality of the mud mortar binder and its deterioration by time are also among main reasons of poor performance. The configurations of typical stone walls with relatively larger stones at the outer surface insufficiently tied to inner irregular wall parts can be seen in Fig. 20.

**Fig. 20.** Typical configurations of stone masonry walls (Göçmezler and Yukarı Demirci villages).

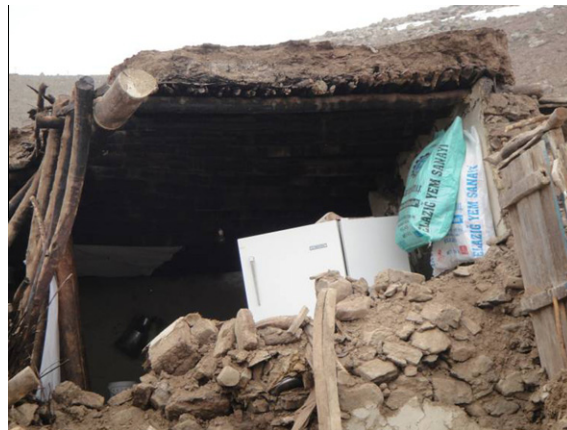
Another main reason of the poor performance of the typical masonry buildings in the region is the very heavy compacted clay roofs constructed for resisting the harsh climate conditions in terms of insulation against cold and sometimes rain (Fig. 21).

**Fig. 21.** Heavy compacted clay roofs (Göçmezler village).

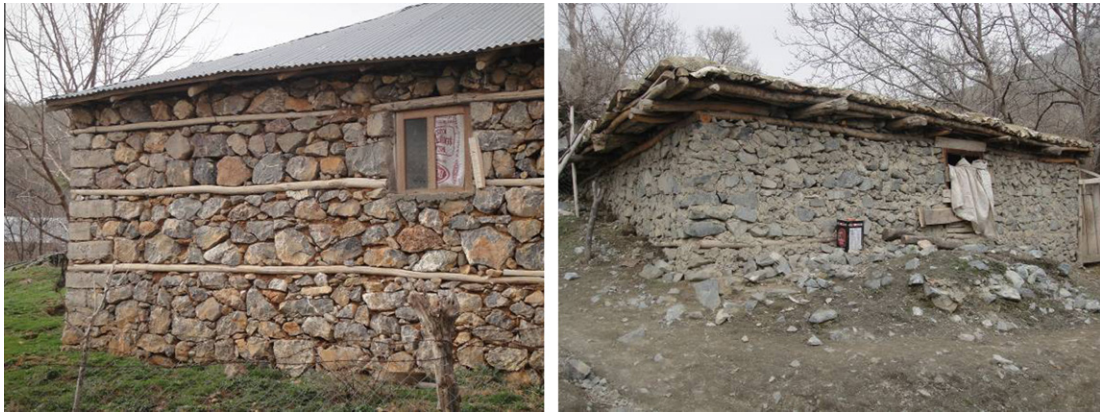
Fig. 22. Inadequate and adequate connections of walls at corners (Arındık and Köklüce villages).

The other main reasons of the failure of these stone masonry buildings are: (i) inadequate corner connections of the walls (Fig. 22); (ii) insufficiency of the wooden beams in one direction to provide the diaphragm action; (iii) insufficient wooden ties in walls in longitudinal and transverse direction to provide sufficient redundancy and continuity to the structural system; (iv) large window openings, which are normally not permitted in masonry constructions (Fig. 23) and (v) excessive wall lengths without any lateral support or restraints (Fig. 23).

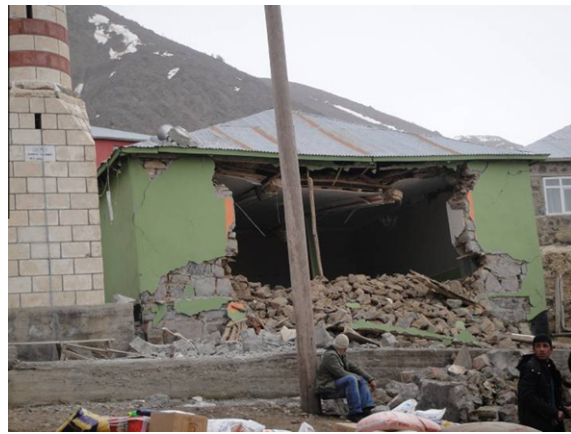
Fig. 23. Excessive wall lengths without any lateral support or restraints and large openings (Yukarı Demirci village).

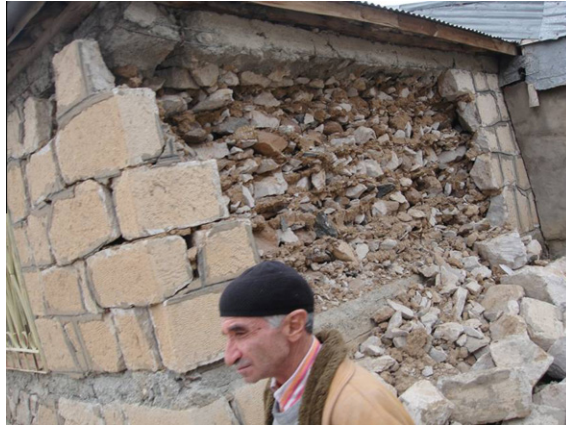
**Fig. 24.** Poor workmanship in wall construction, poor binder, insufficient connection in transverse direction (*Okçular village*).

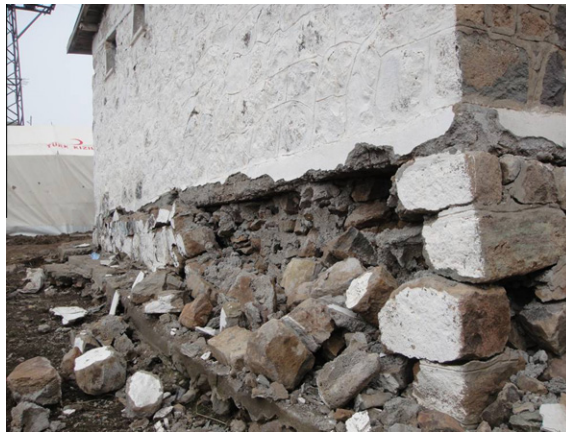
**Fig. 25.** Poor workmanship in the foundation (*Kayalık village*).

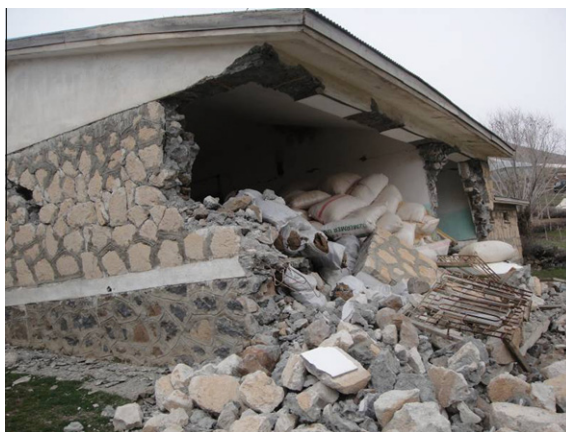
**Fig. 26.** Excessive wall lengths without any support or restraints and large openings (*Göçmezler village*).

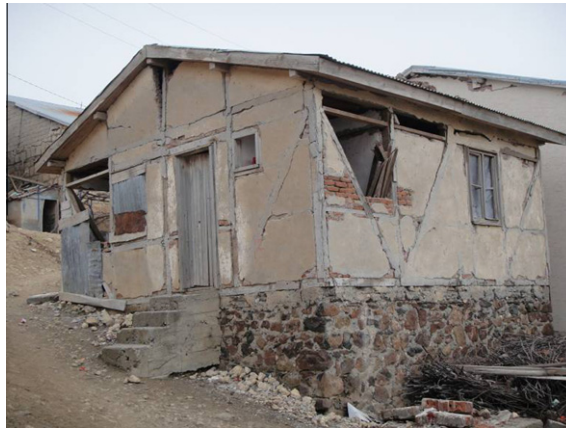
find. Although the common building materials in the region are stone and clay, a limited number of hımiş buildings can be found in the earthquake affected area. Fig. 27 shows a damaged hımiş building. As seen, its seismic performance has been better than many heavy stone masonry buildings. Generally hımiş buildings experienced some damage in different extents, but did not collapse totally due to the flexible behavior of the wooden skeleton. While foundations of hımiş buildings are

**Fig. 27.** Typical damage of hımiş buildings in earthquake affected region (Okçular village).

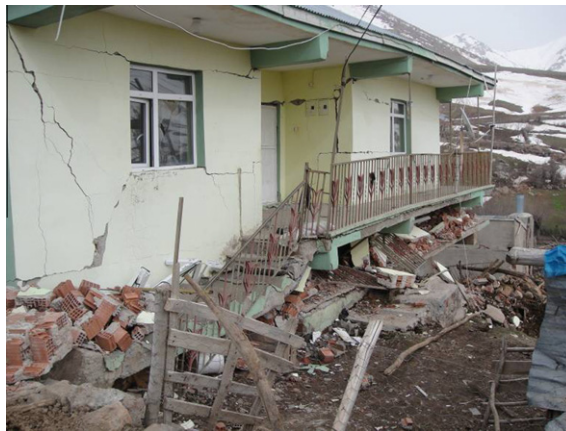
**Fig. 28.** Failure of a confined brick masonry building (Kayalık village).

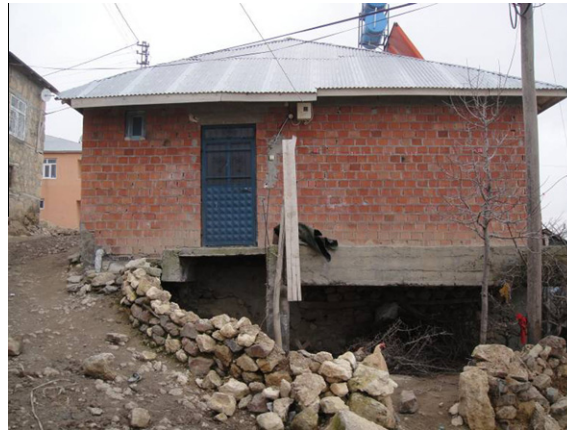
Fig. 29. Performance of an unconfined unreinforced brick masonry building (Okçular village).

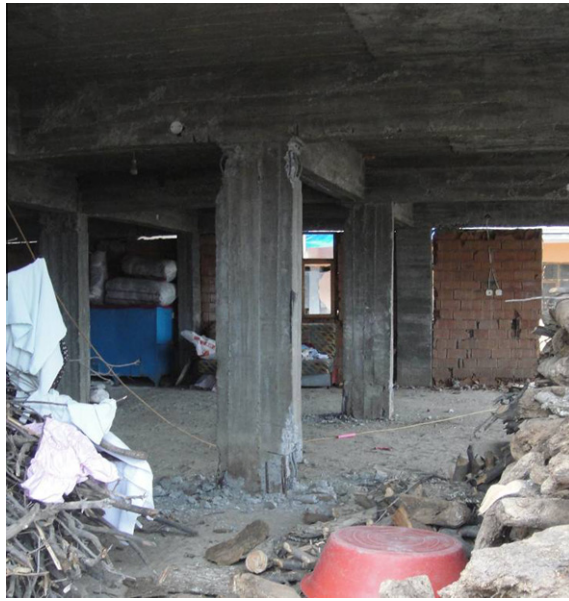
In the villages, there are only a few two-storey reinforced concrete frame buildings. While the buildings with reinforced concrete frame structural systems did not collapse totally, some of them experienced severe damage (Fig. 31). It should be noted that the reinforced concrete frame buildings are relatively new. Damages of the reinforced concrete frame buildings can mainly be attributed to low quality of concrete and improper detailing of reinforcing bars.

**Fig. 31.** A reinforced concrete frame building in Yukan Demirci.
