# October 23<sup>rd</sup>, 2011 Van Earthquake: Preliminary Reconnaissance Report: Structural and Geotechnical Aspects of the Damage

U. Yazgan, B. Taşkın, P. Özdemir Çağlayan, A. Erken, Z. Celep,  
E. Ergüven, A. Sezen, R. Oyguç, Ü. Mert Tuğsal  
*Istanbul Technical University, Turkey*

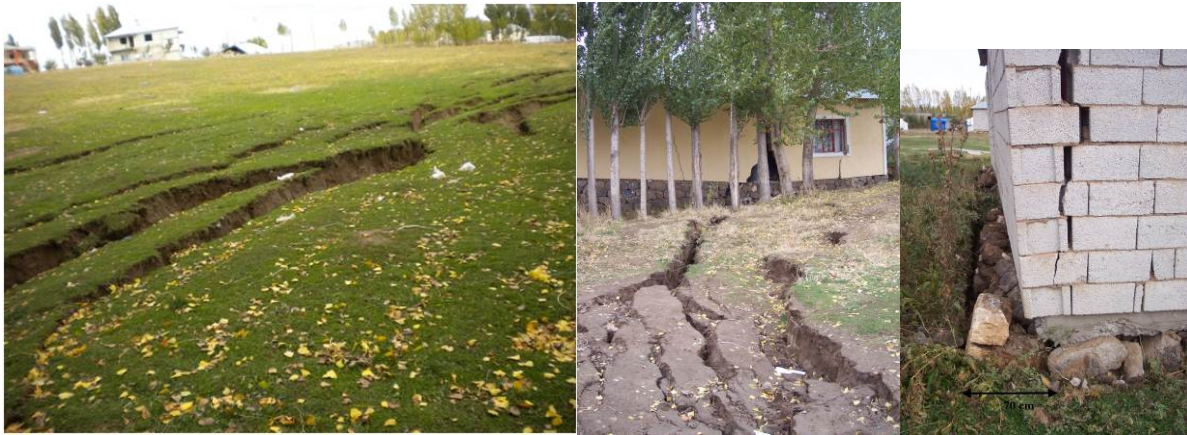
A widespread liquefaction and liquefaction-triggered lateral spreading cases, landslides and slope failures were observed. Specifically, in the near vicinity of the fault but especially on the hanging wall-side and at locations along Karasu River to the north of Van City and coastal sections of Van Lake where young alluvial deposits prevail, an extensive liquefaction phenomena manifested by sand boils, ground water eruption, lateral spreadings and settlements were encountered. Several liquefaction cases were observed that triggered landslides at steep slopes especially throughout Karasu Delta. It was observed that the backfill material at Van Port liquefied resulting in lateral displacement and settlements of 4 cm to 6 cm and a few centimeters, respectively. A severe liquefaction and lateral spreading case was observed in Ercis Plain, mainly at Çelebibağı and Kasimbağı. Previous studies showed that there is a high liquefaction potential for this area having a soil profile of loose silty sand layers with a high ground water table (Özvan et al., 2008). At İnönü district, the soil displacements reached almost one meter both laterally and vertically. Several adobe and brick houses, RC buildings of single to two stories and water ditches were heavily damaged while some houses were translated laterally 50 cm to 70 cm (Fig. 3.2).

**Figure. 3.2.** Extensive lateral spreading due to liquefaction and resulting damages at Çelebibağı, Erciş

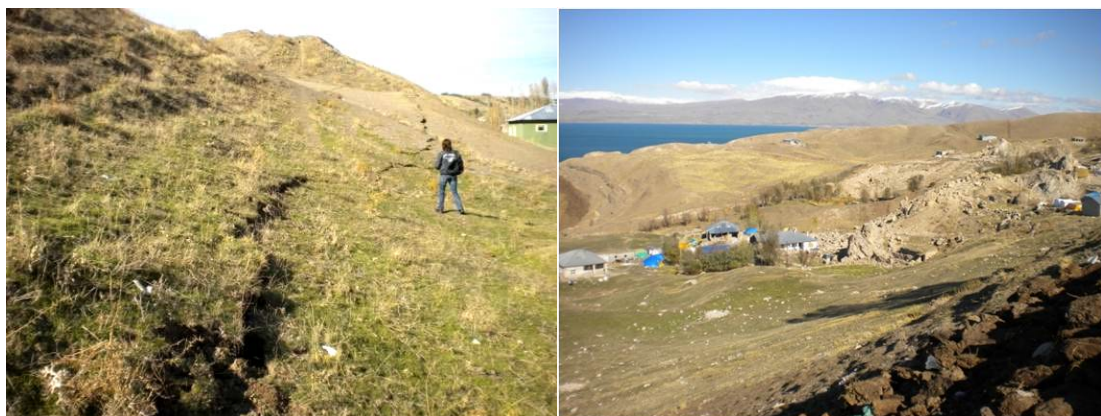
Widespread landslide and slope failure cases were reported especially in the near vicinity of the epicenter and at sections located on the hanging wall-side of the fault line. One particular case is the extensive slope failure near Gedikbulak village located 10 km north-east of the epicenter that caused damage along Van-Ağrı highway that was repaired immediately. Several head scarfs and cracks due to landslides and slope failures can be identified along the highway. Specifically, slope failures occurred along Karasu River in the near vicinity of Tirleşin Bridge which caused settlement of bridge abutments. Landslides triggered by liquefaction and rockfalls are also observed (Fig. 3.4)

**Figure. 3.4.** Liquefaction-triggered landslide at Topraktaş and damage caused by rockfall at Karağaçaç.

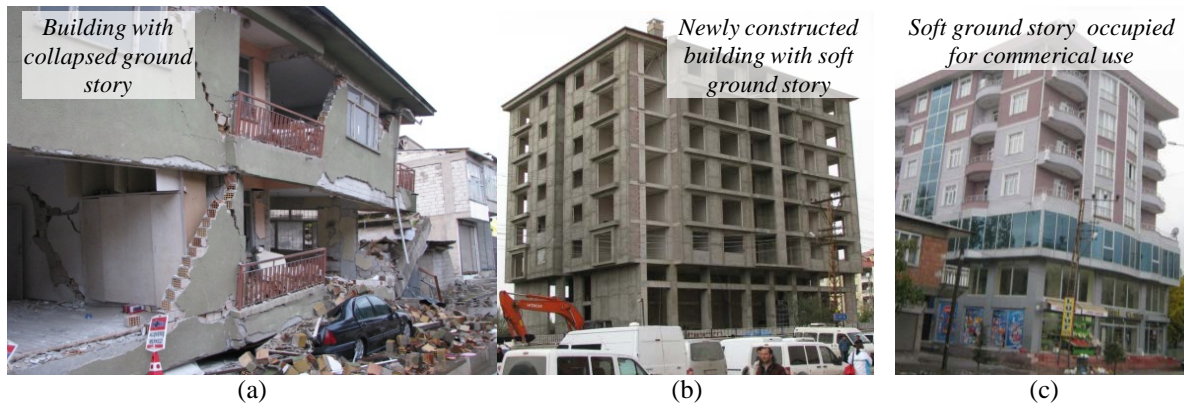
Collapse of the ground story was the most common failure mechanism in the collapsed buildings (Fig 4.1a) in the region. The soft/weak ground stories were conceived to be one of the major causes of these collapses. The buildings which are not only residential often accommodate shops in the ground floor (Fig 4.1b,c). This arrangement is often preferred by the building owners in order to profit from the higher rents. Higher story heights and wider open spaces (i.e. fewer infill walls) are typically preferred by the commercial users. This preference results in softer and weaker soft stories when the structure is not designed and constructed by properly accounting for the irregularity at the ground story.

**Figure 4.1.** Soft story reinforced concrete buildings in: (a) Ercis and (b,c) Van

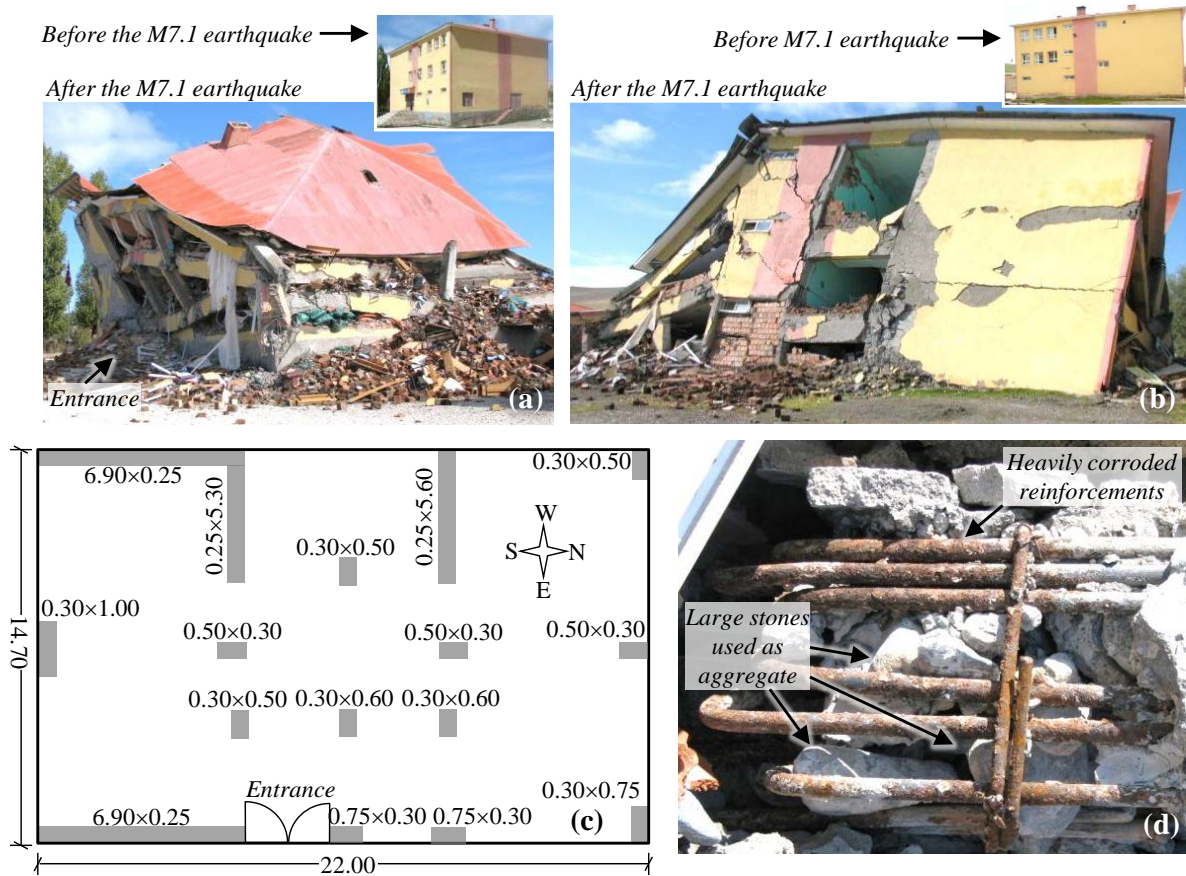
The structural members were observed to be laid out improperly in some of the buildings. Improper layout of the structural members was conceived to be one of the major causes of collapse of school building in Gedikbulak village (Fig 4.2). The three story school building had a reinforced concrete wall-frame structural system. The building had collapsed due to the earthquake even though it had a considerable percentage of structural walls. Two major factors that were perceived to have caused this collapse: (1) improper structural layout, and (2) poor material quality. The collapse has taken place in a torsional mode as seen in Fig 4.2a. The sketch of the plan layout the building (Fig 4.2c) reveals that stiffer RC members were densely located at the southern end of the building. Furthermore, concrete quality is estimated to be low and, bond between reinforcement and concrete was not established as Fig 4.2 clearly shows. In Van province, the Turkish government built a large number of schools. Especially performance of schools built recently has been found to be quite satisfactory.

**Figure 4.2.** Collapsed school building in Gedikbulak: (a) North-East view, (b) South-West View, (c) beam column joint detail and (d) structural layout (units are in m) (Photos of the building before the earthquake are from MEB (2010))

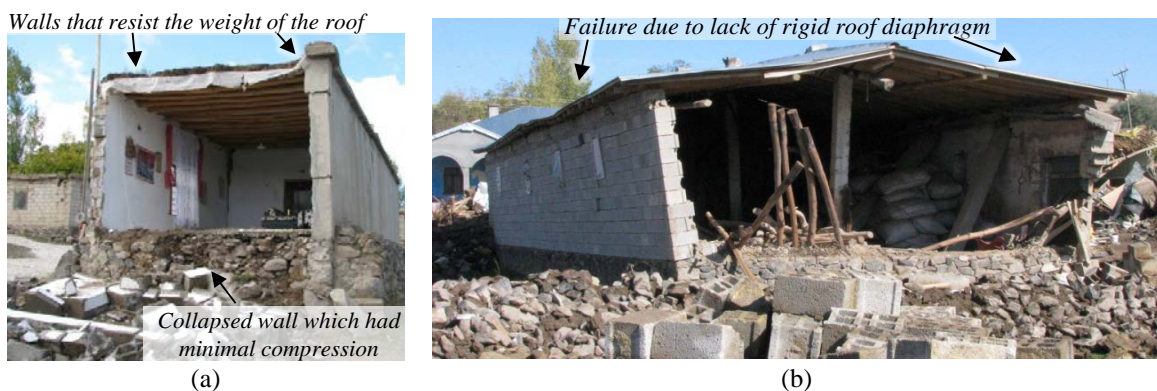
Most of the single story masonry houses have no ring beams. In these houses, the roof is supported by poplar tree trunks with diameters in the range from 20 to 30 cm. These wooden logs are simply seated on the masonry walls at the two ends. As a result, the walls that support the logs are subjected to axial compression while perpendicular ones have very minimal compressive load. When there is no ring beam to provide a diaphragm constraint, the walls without axial load deform separately when the system is excited by a strong ground motion. When the building deforms under inertial forces, these walls fail much earlier than the others (Fig 4.3a). In the dwellings with inclined roofs, failure progresses further as the roof pushes the adjacent walls apart (Fig 4.3b). These types of buildings are constructed for storage rooms. They have a rectangular planar shape and surrounding walls. The shorter walls have large door openings and the longer walls have small window openings. Often, they do not have any lateral wall to use the interior space effectively. The longitudinal walls are prone to out-of-the plane deformation, which can result in total collapse, as seen in Fig 4.3b.

**Figure 4.3.** Typical damage mechanisms observed in the regional unconfined brick masonry buildings

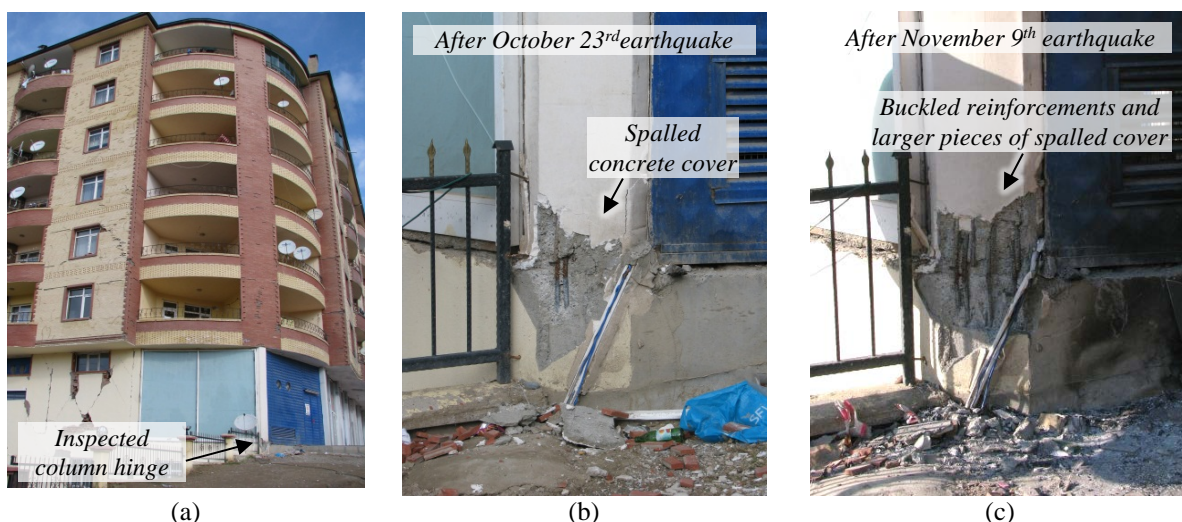
**Figure 4.4.** Progression of damage in a ground story column hinge: (a) location of hinge, (b) damage after the October 29<sup>th</sup> earthquake, and (c) damage after the November 9<sup>th</sup> earthquake.

The damages that were sustained after October 23<sup>th</sup> earthquake and that after November 9<sup>th</sup> earthquake are presented in Fig 4.4. In these figures, a column hinge from the ground story of a seven story

reinforced concrete building is considered. In Fig 4.5b, it is seen that parts of cover concrete has been detached due to October 23<sup>rd</sup> earthquake. The damage is seen to have progressed further during the subsequent November 9<sup>th</sup> earthquake (Fig 4.4c). Buckled reinforcement bars are observed and larger pieces of cover concrete has fallen off. Thus, it may be concluded that November 9<sup>th</sup> earthquake seems to have deformed this component further than the deformation exhibited during October 23<sup>rd</sup> earthquake.
