SeRFIn Seismic Retrofitting of RC Frames with RC Infilling

RC Infilling of Existing RC Structures for Seismic Retrofitting

C. Z. Chrysostomou, N. Kyriakides, P. Kotronis, P. Roussis, M. Poljansek, F. Taucer

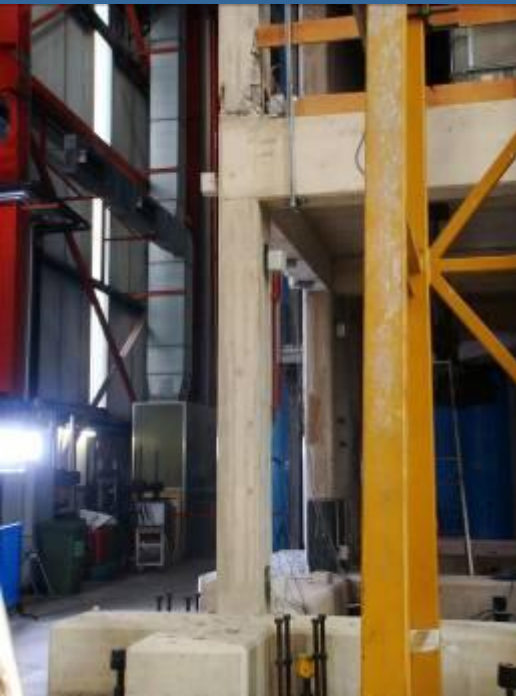
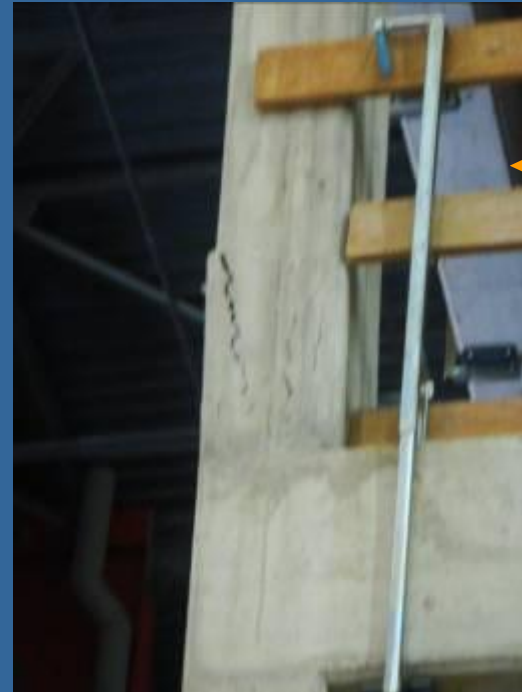
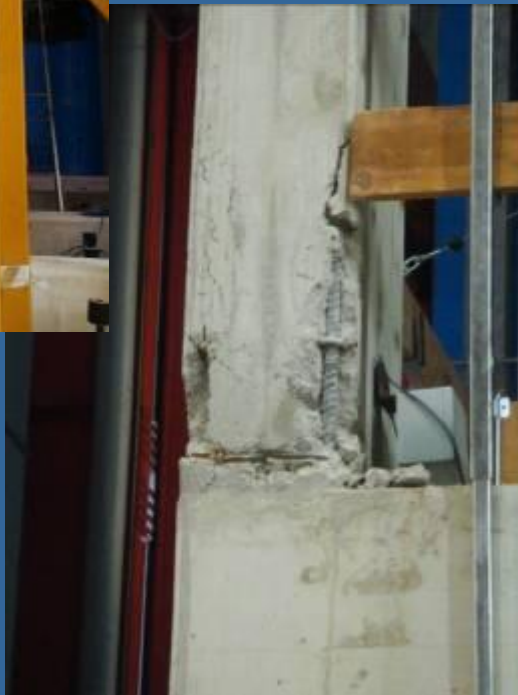
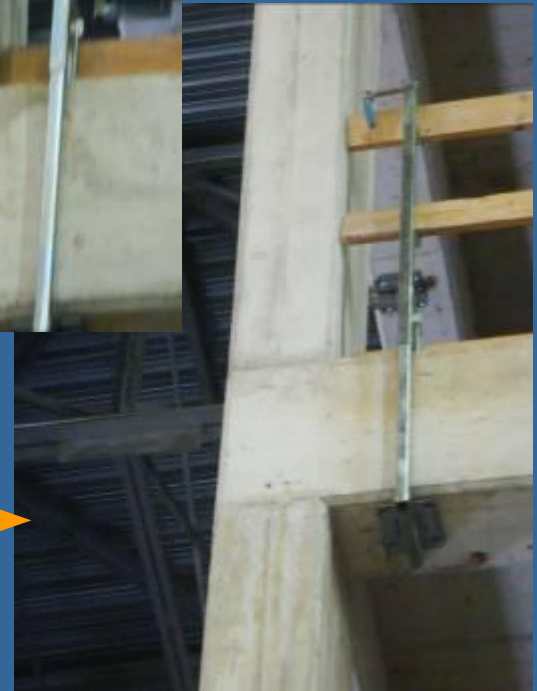
SeRFIn *Lap-splice failure – West column of North frame*

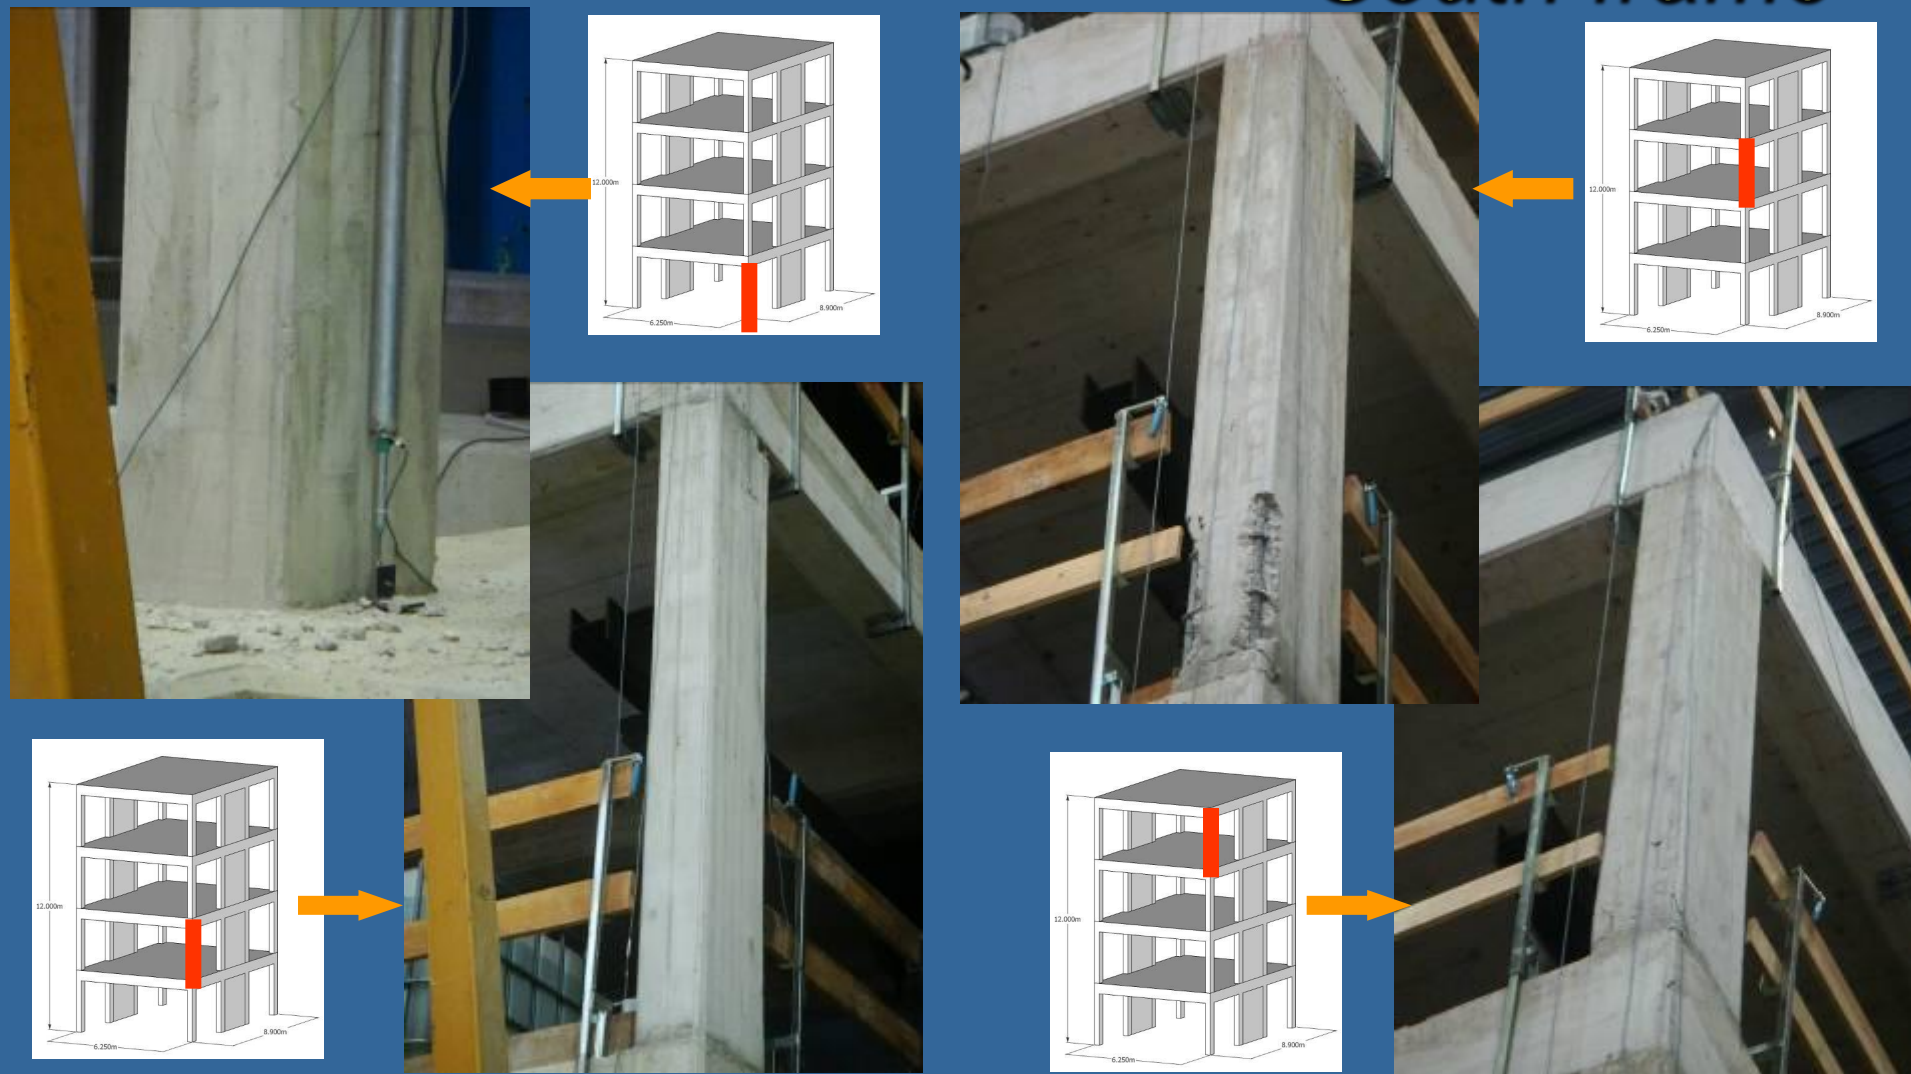
SeRFIn *Lap-splice failure – West column of South frame*

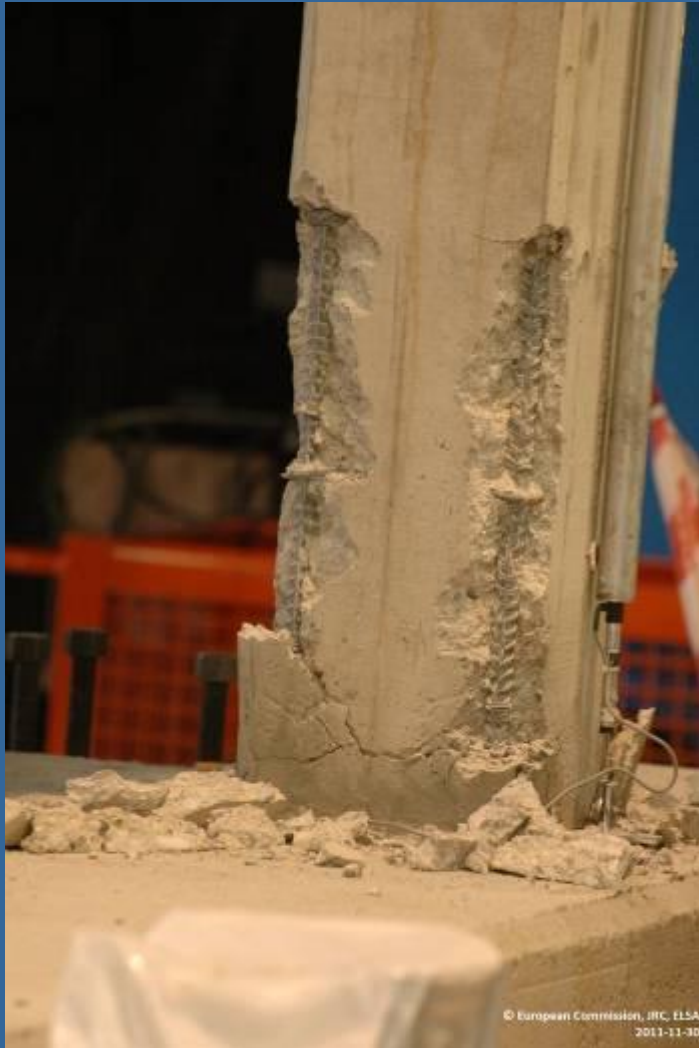
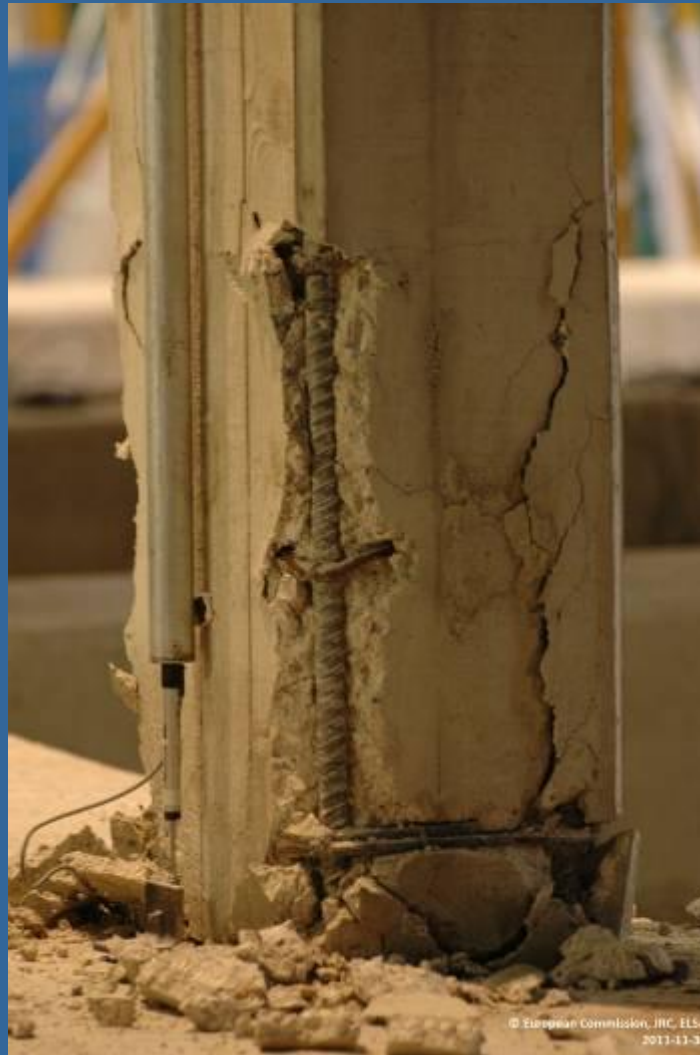
SeRFIn *Lap-splice failure – East column of South frame*

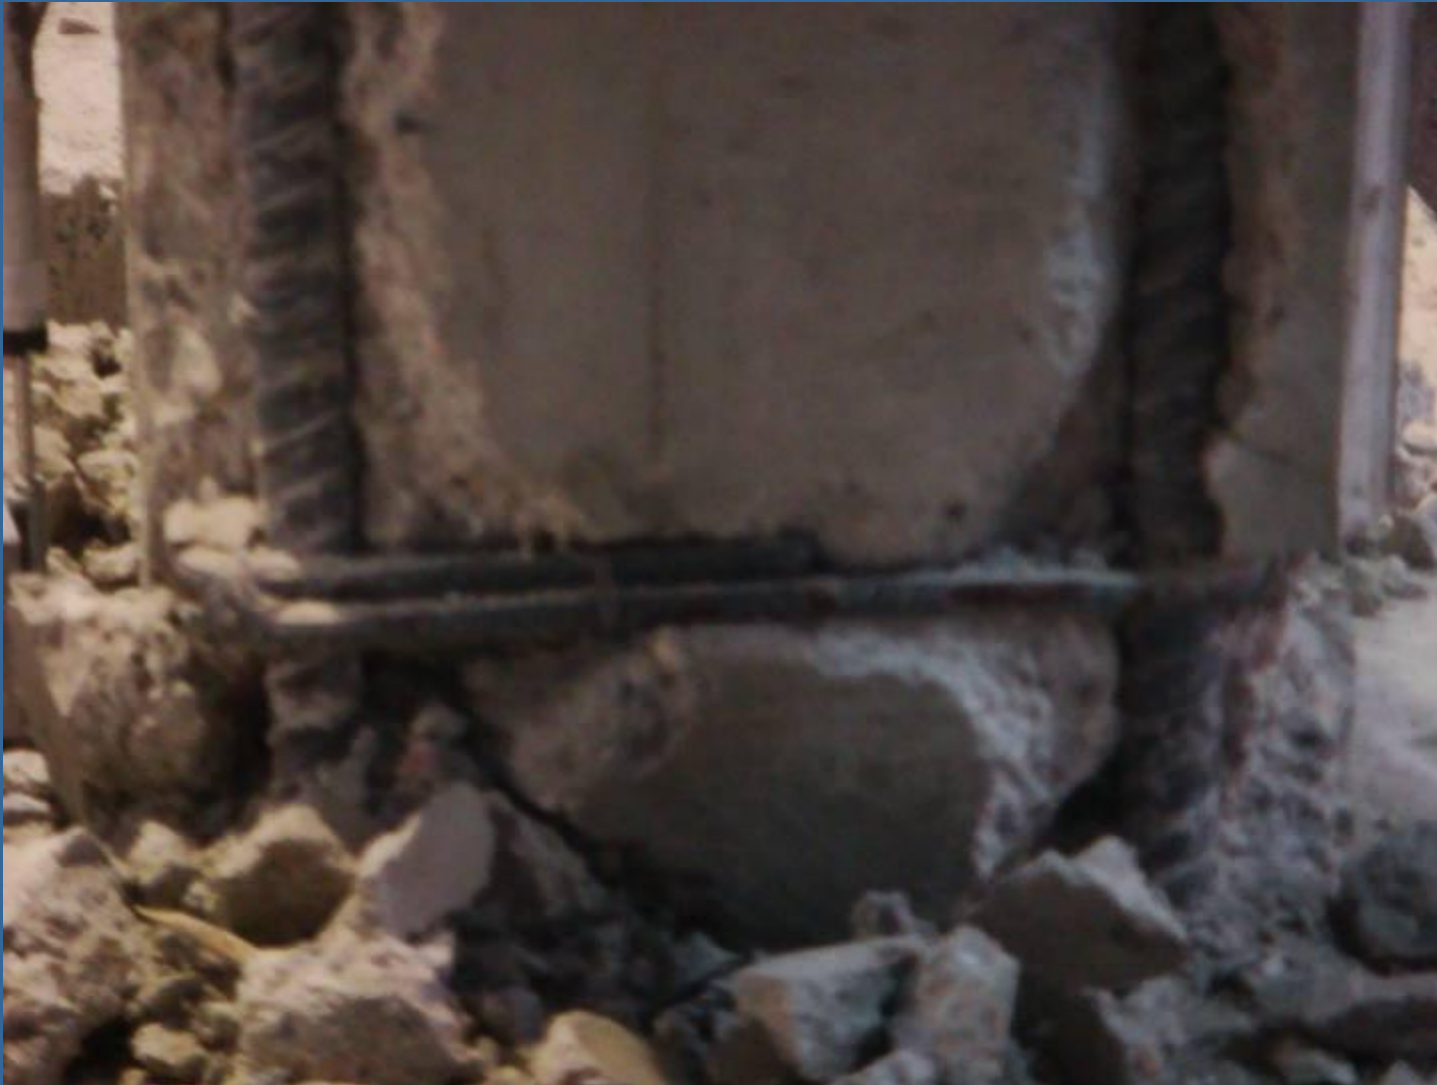
SeRFIn *Lap-splice failure – East column of South frame*

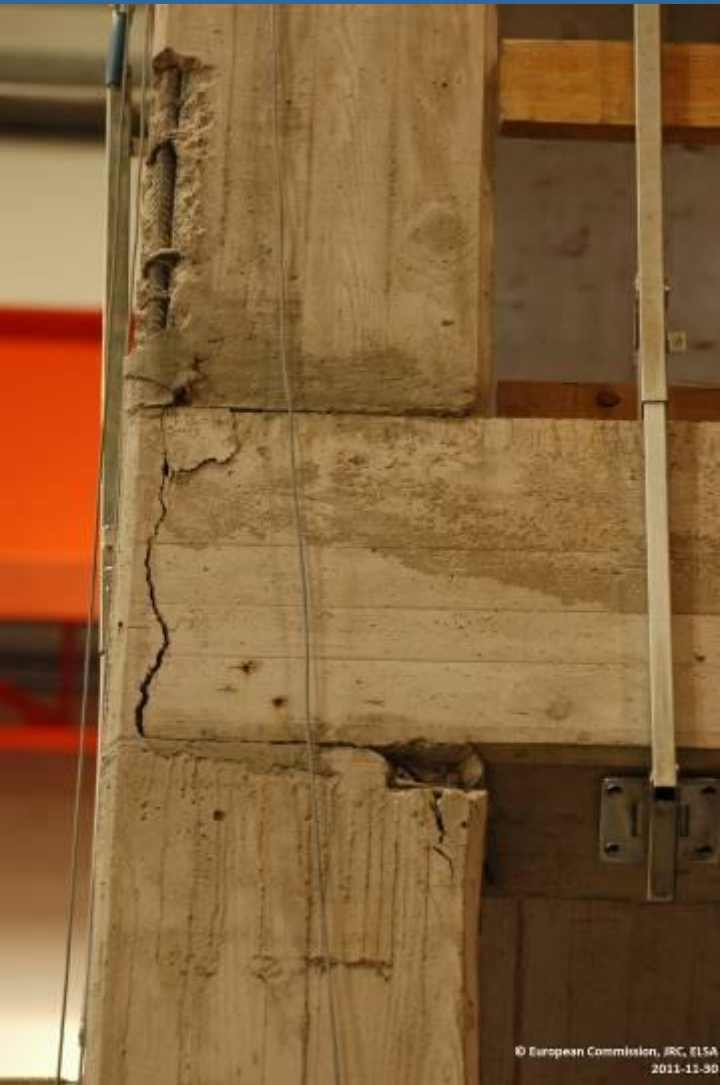
Beam cracking

- Some vertical cracks appeared at the connection of the beams to both the exterior column and the wall columns
- A horizontal crack appeared at the ground beam of the walls, and it was the main reason for loss of strength of the south frame
- The proposed system seems to behave in a satisfactory manner

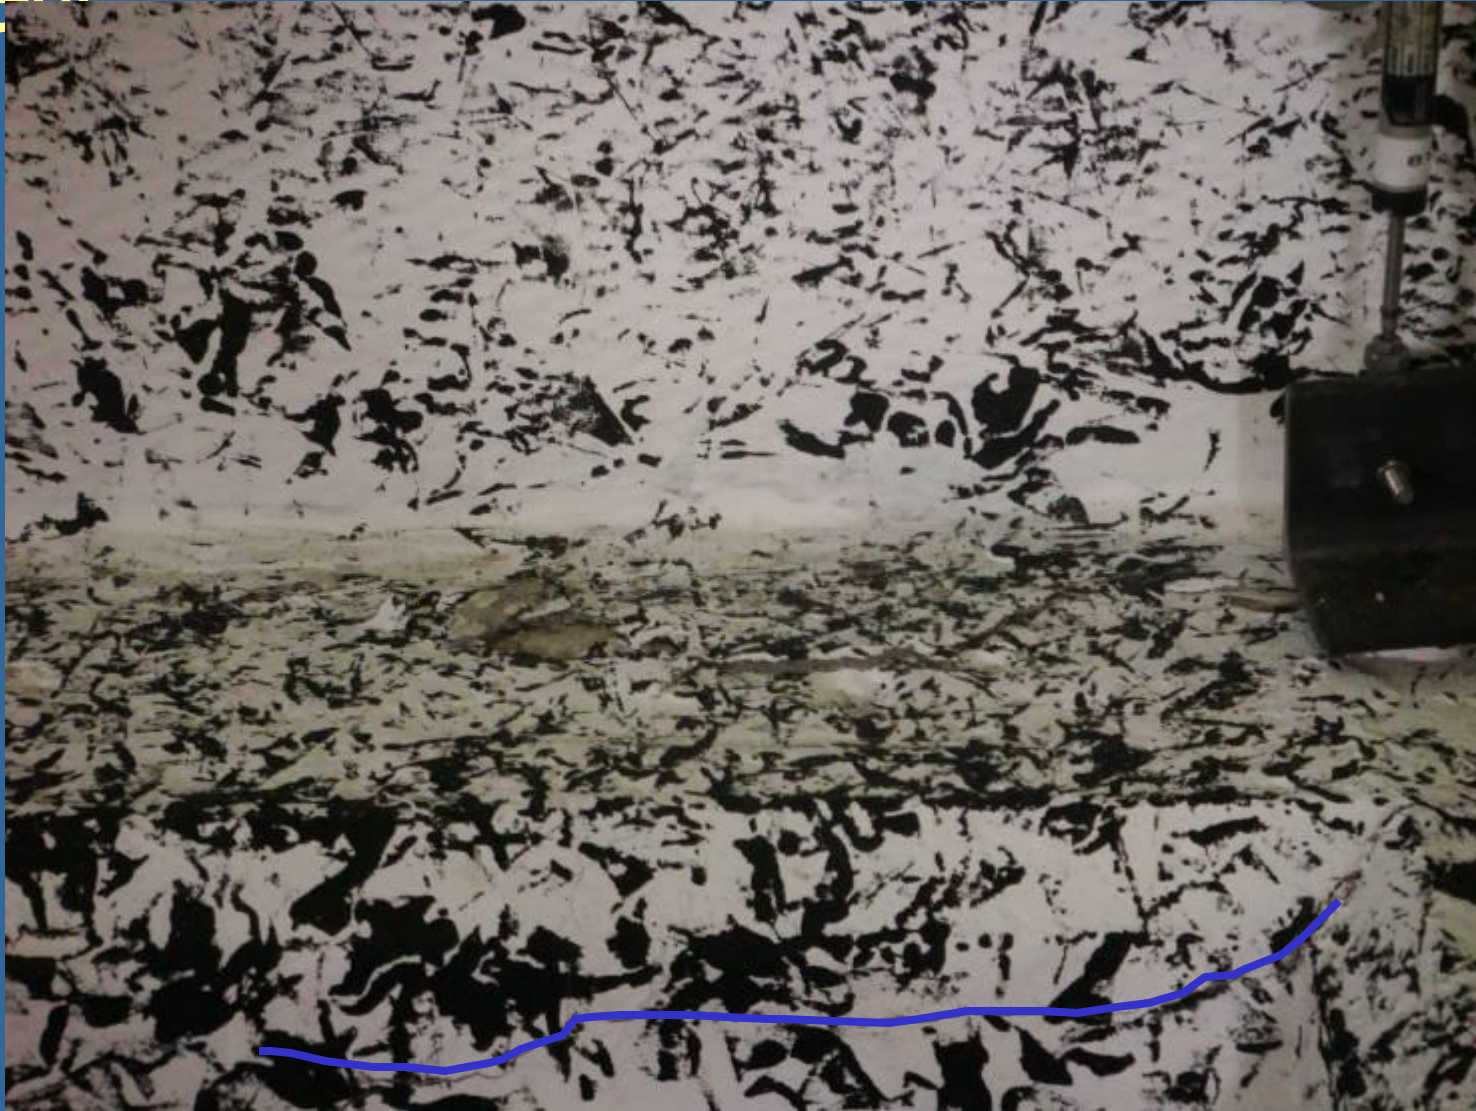
Ground beam cracking – North wall
