# **Seismic Response of the School Buildings in Van to the Earthquake October 23, 2011**

**(Observations and evaluations)**

**Zekai Celep  
Yavuz Durgun**

**Istanbul Technical University, Faculty of Civil Engineering**

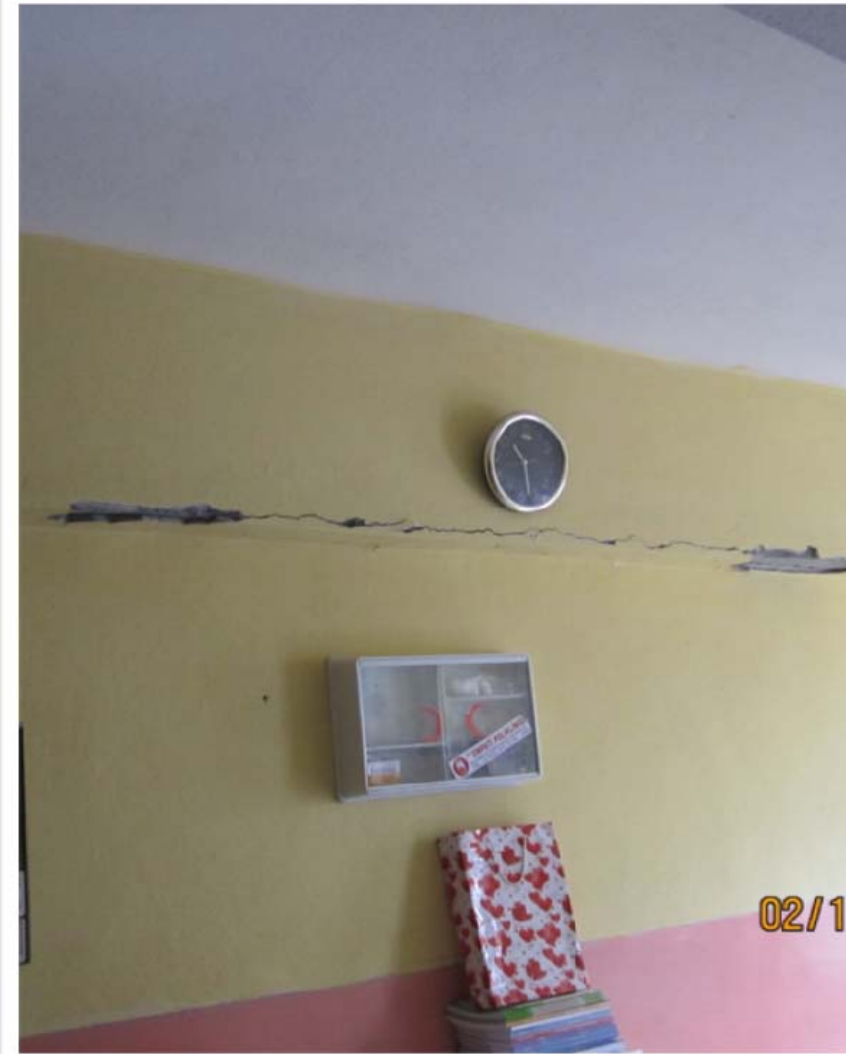
## Damage in concrete cover

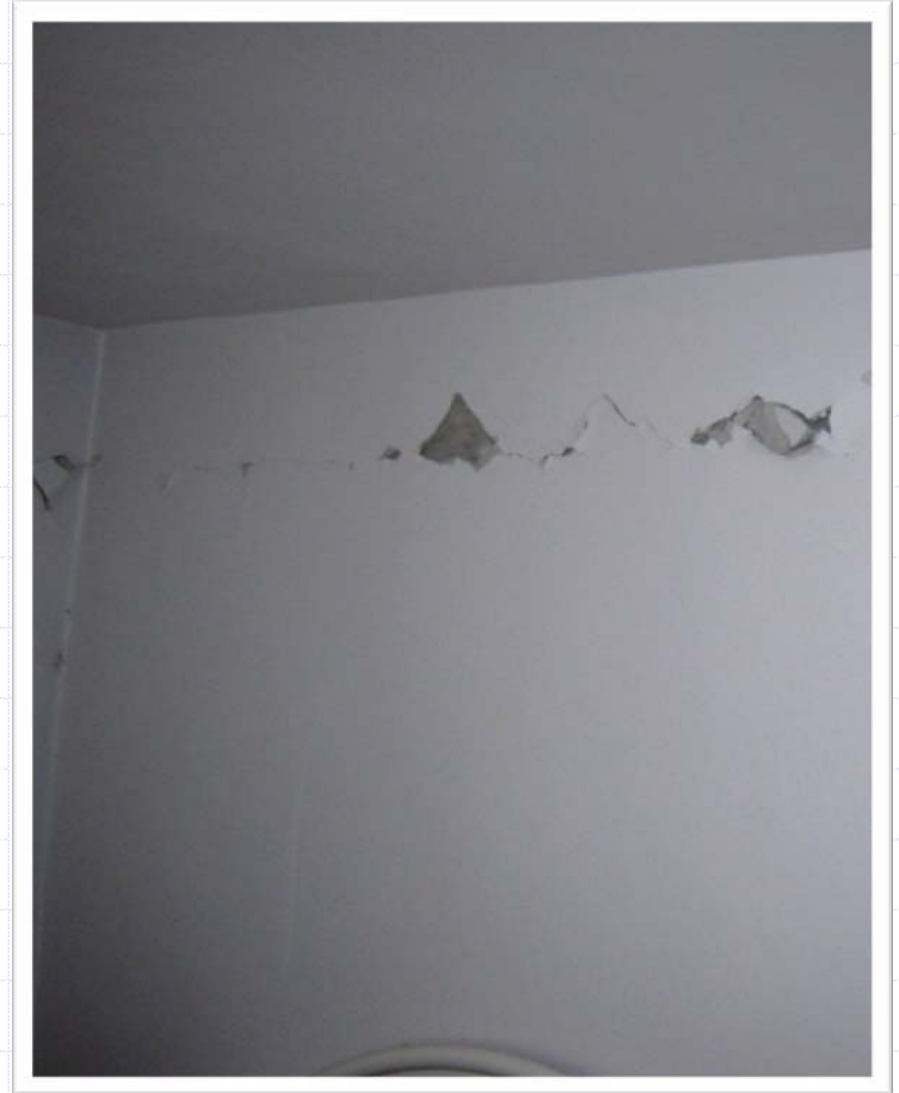
## Cracks in Partition walls

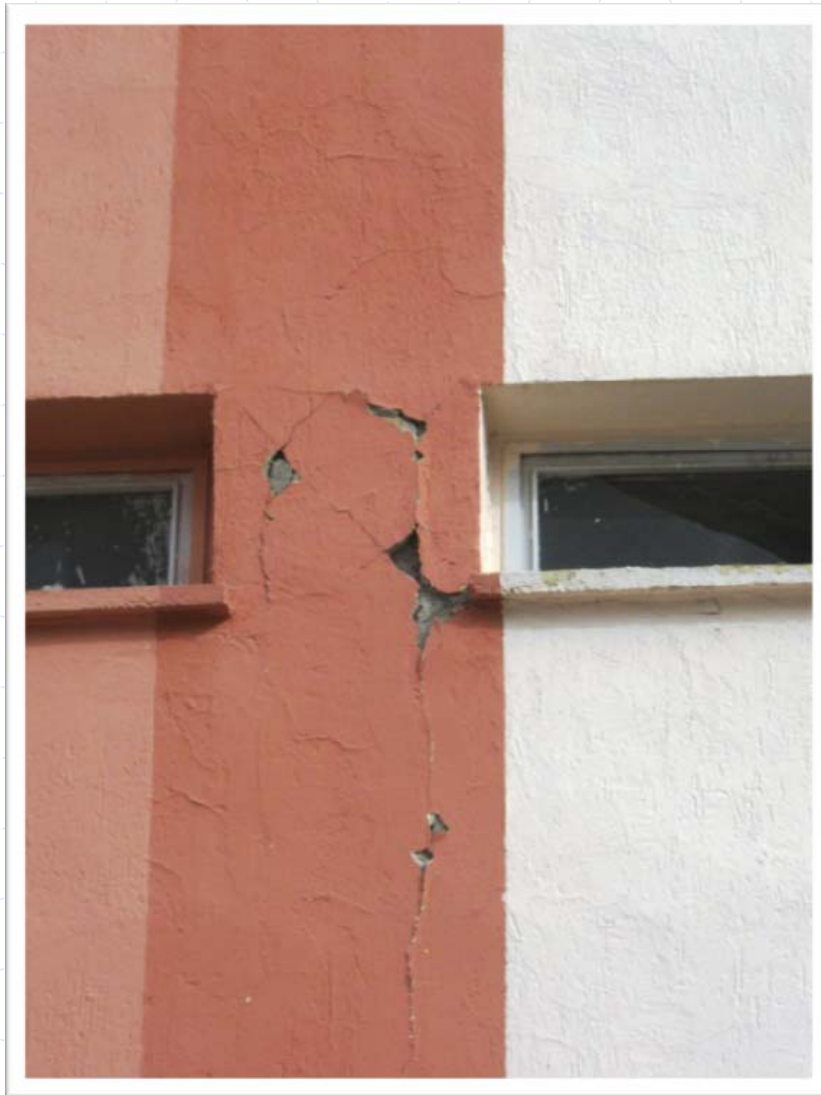
## Short column damages

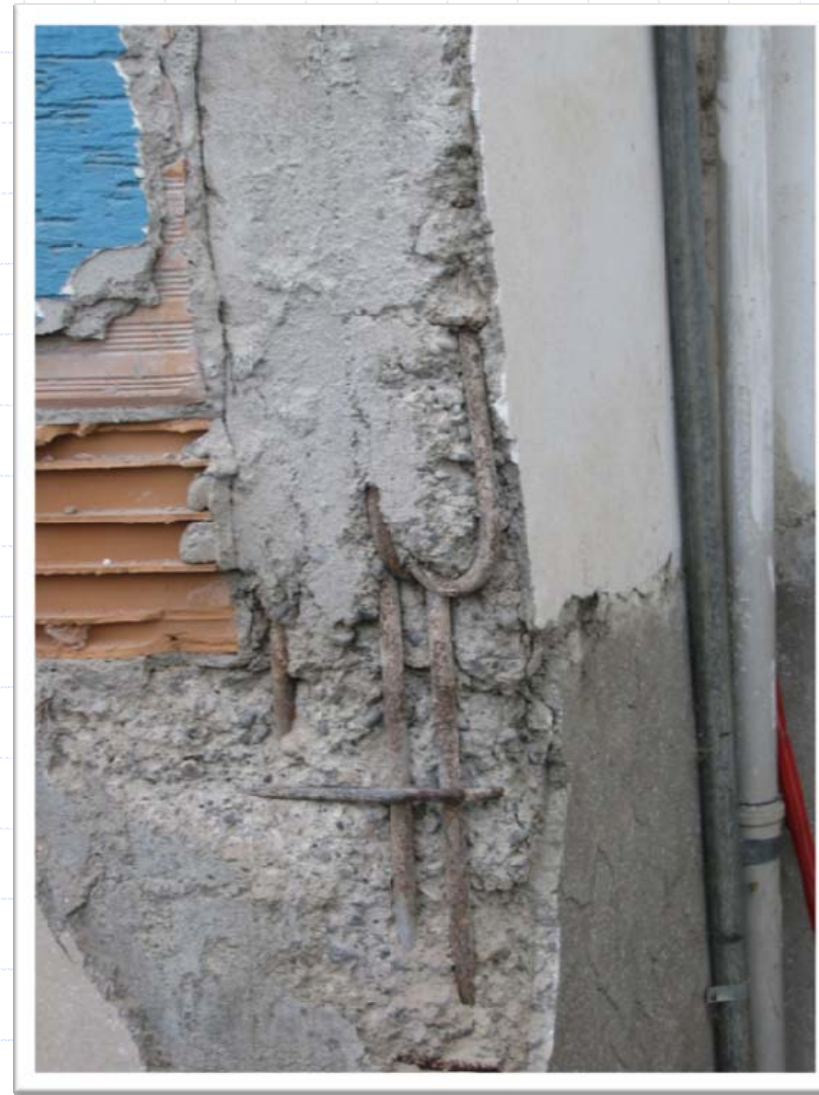
## Inadequate splice

- Damages are due to deficiencies which have been seen in the previous events as well.
- Most of them due to simple engineering errors done in worksites. In other words buildings do not received adequate engineering attention.
- Low concrete quality, inadequate granulometry
- Low bond strength, inadequate workmanship,
- Inadequate lateral reinforcement detailing
- Inadequate lap splice length

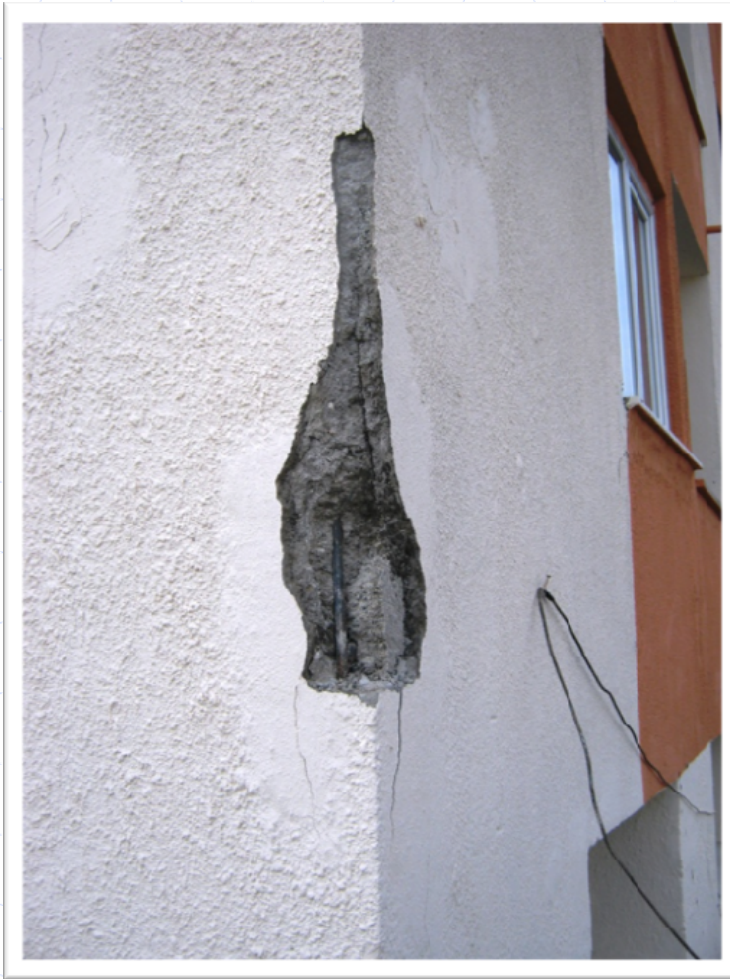
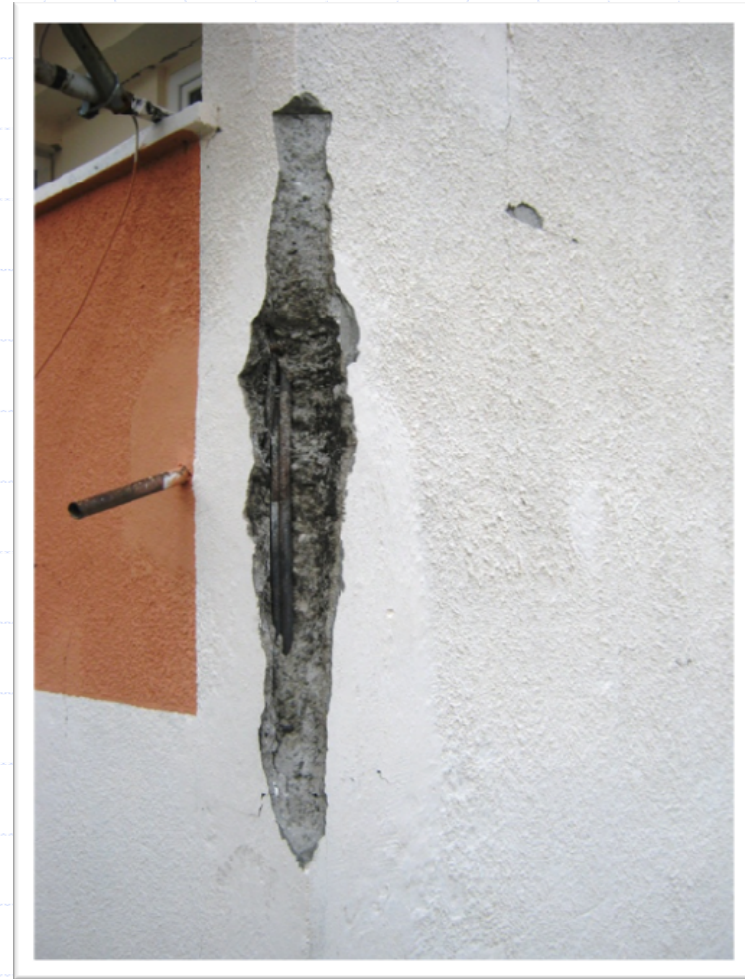
## Inadequate concrete cover

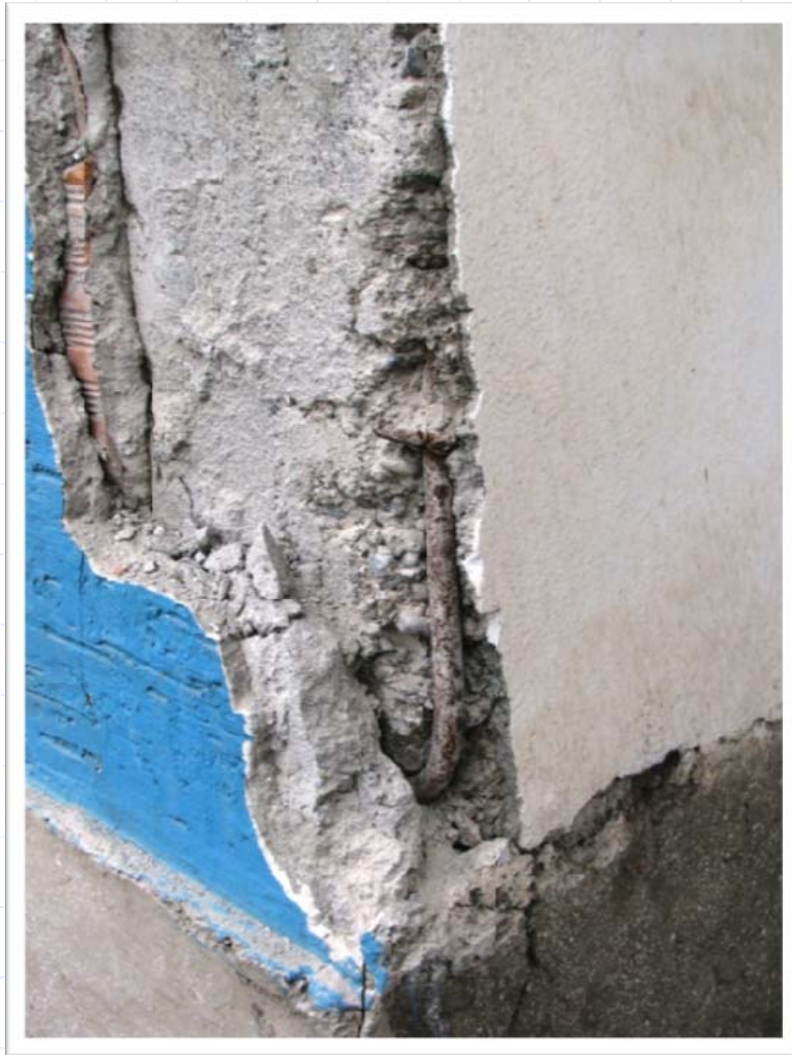
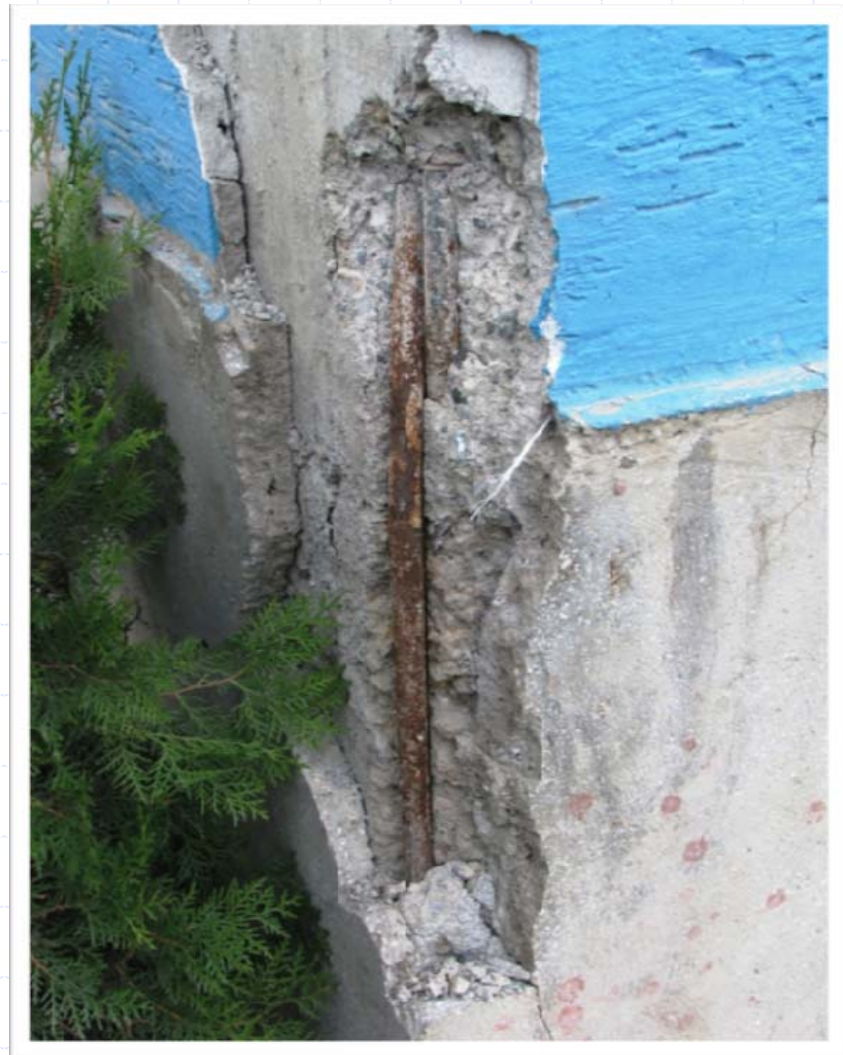
## No ties in beam-column joints

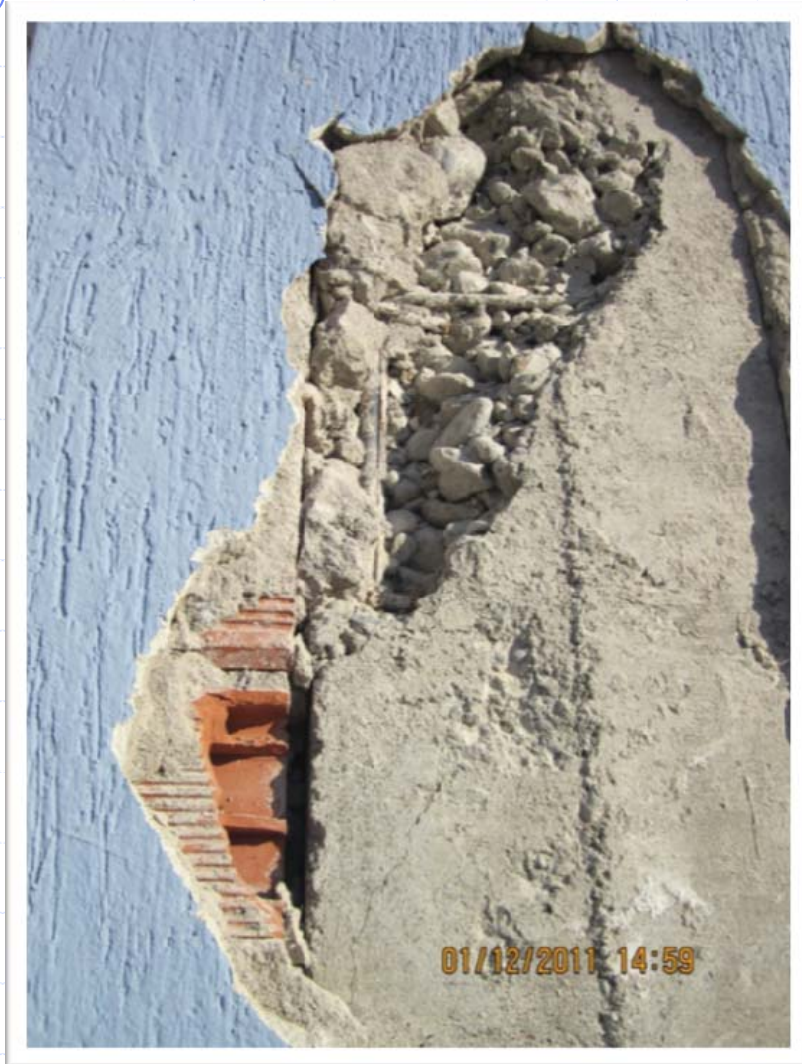
## Segregation in concrete

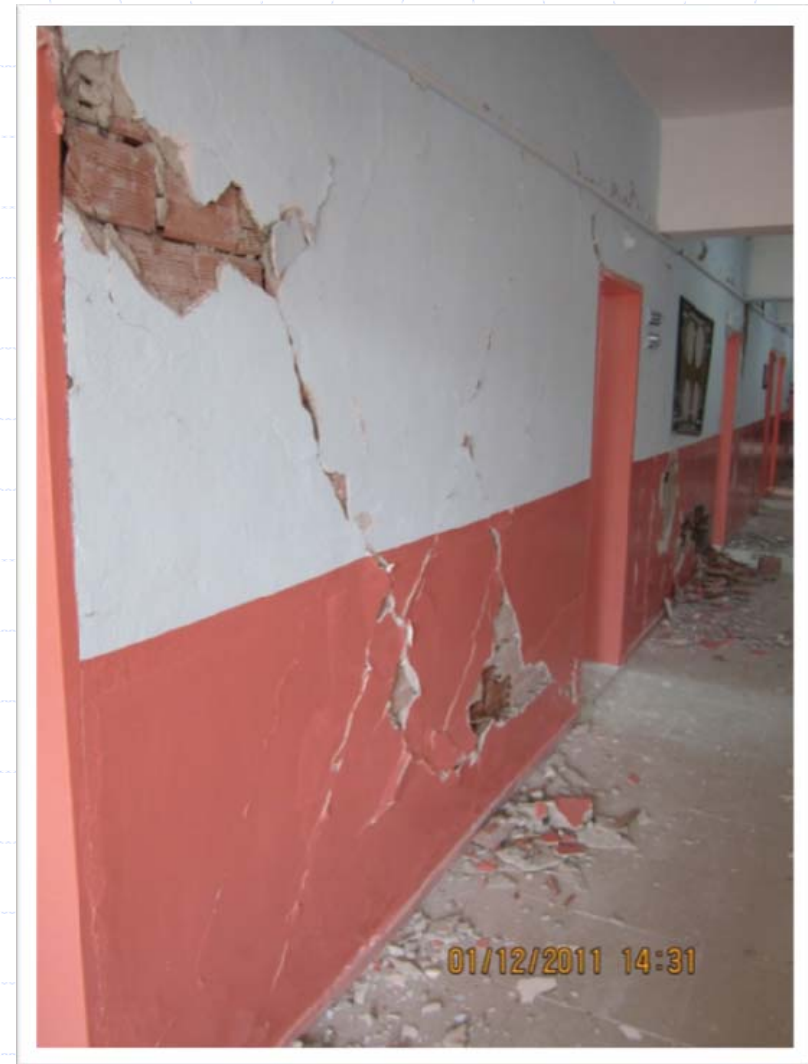
## Partition wall damage

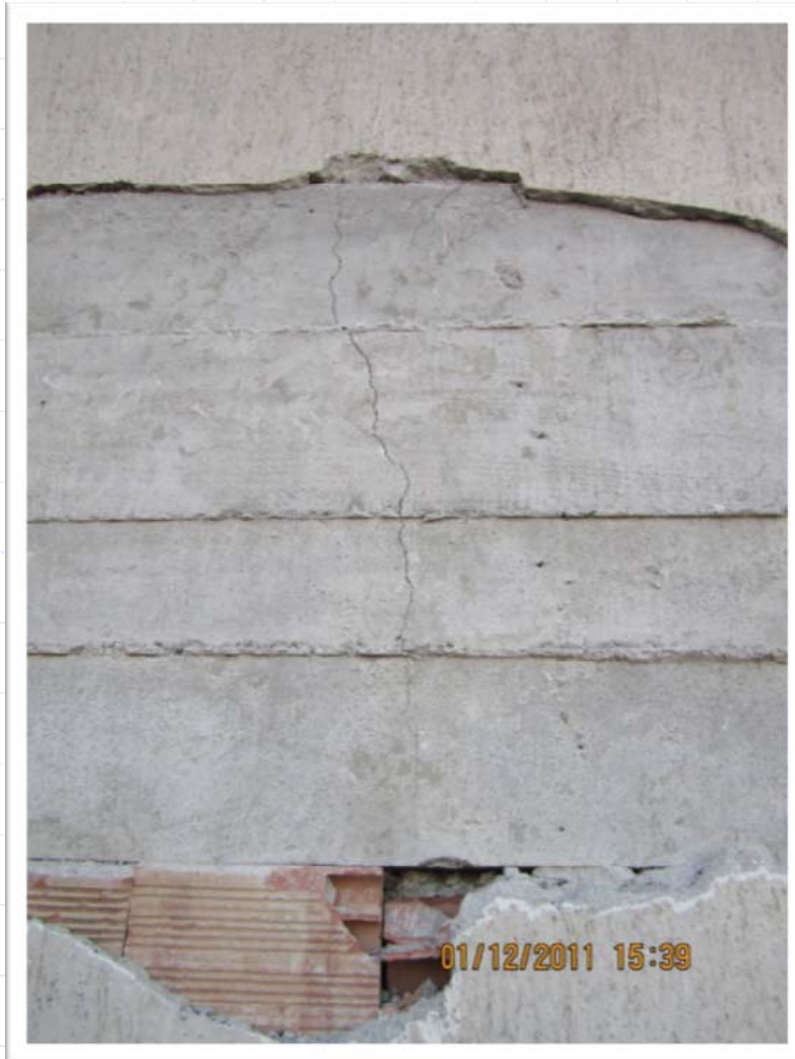
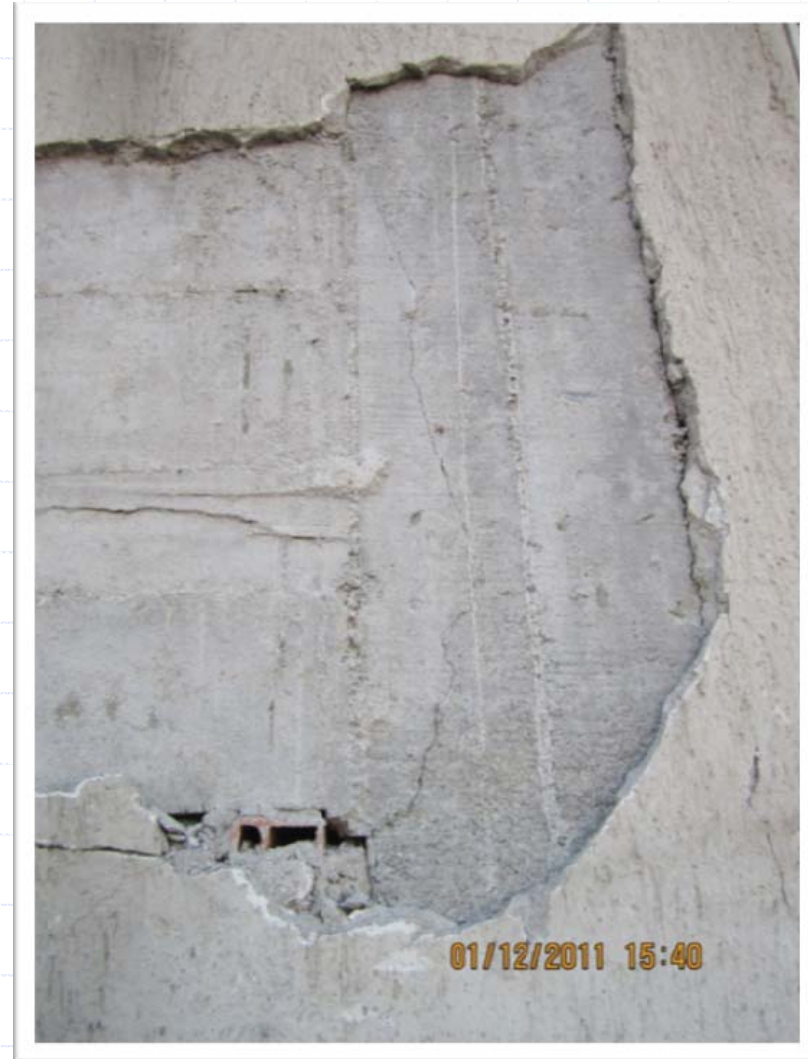
## Cracks in beams

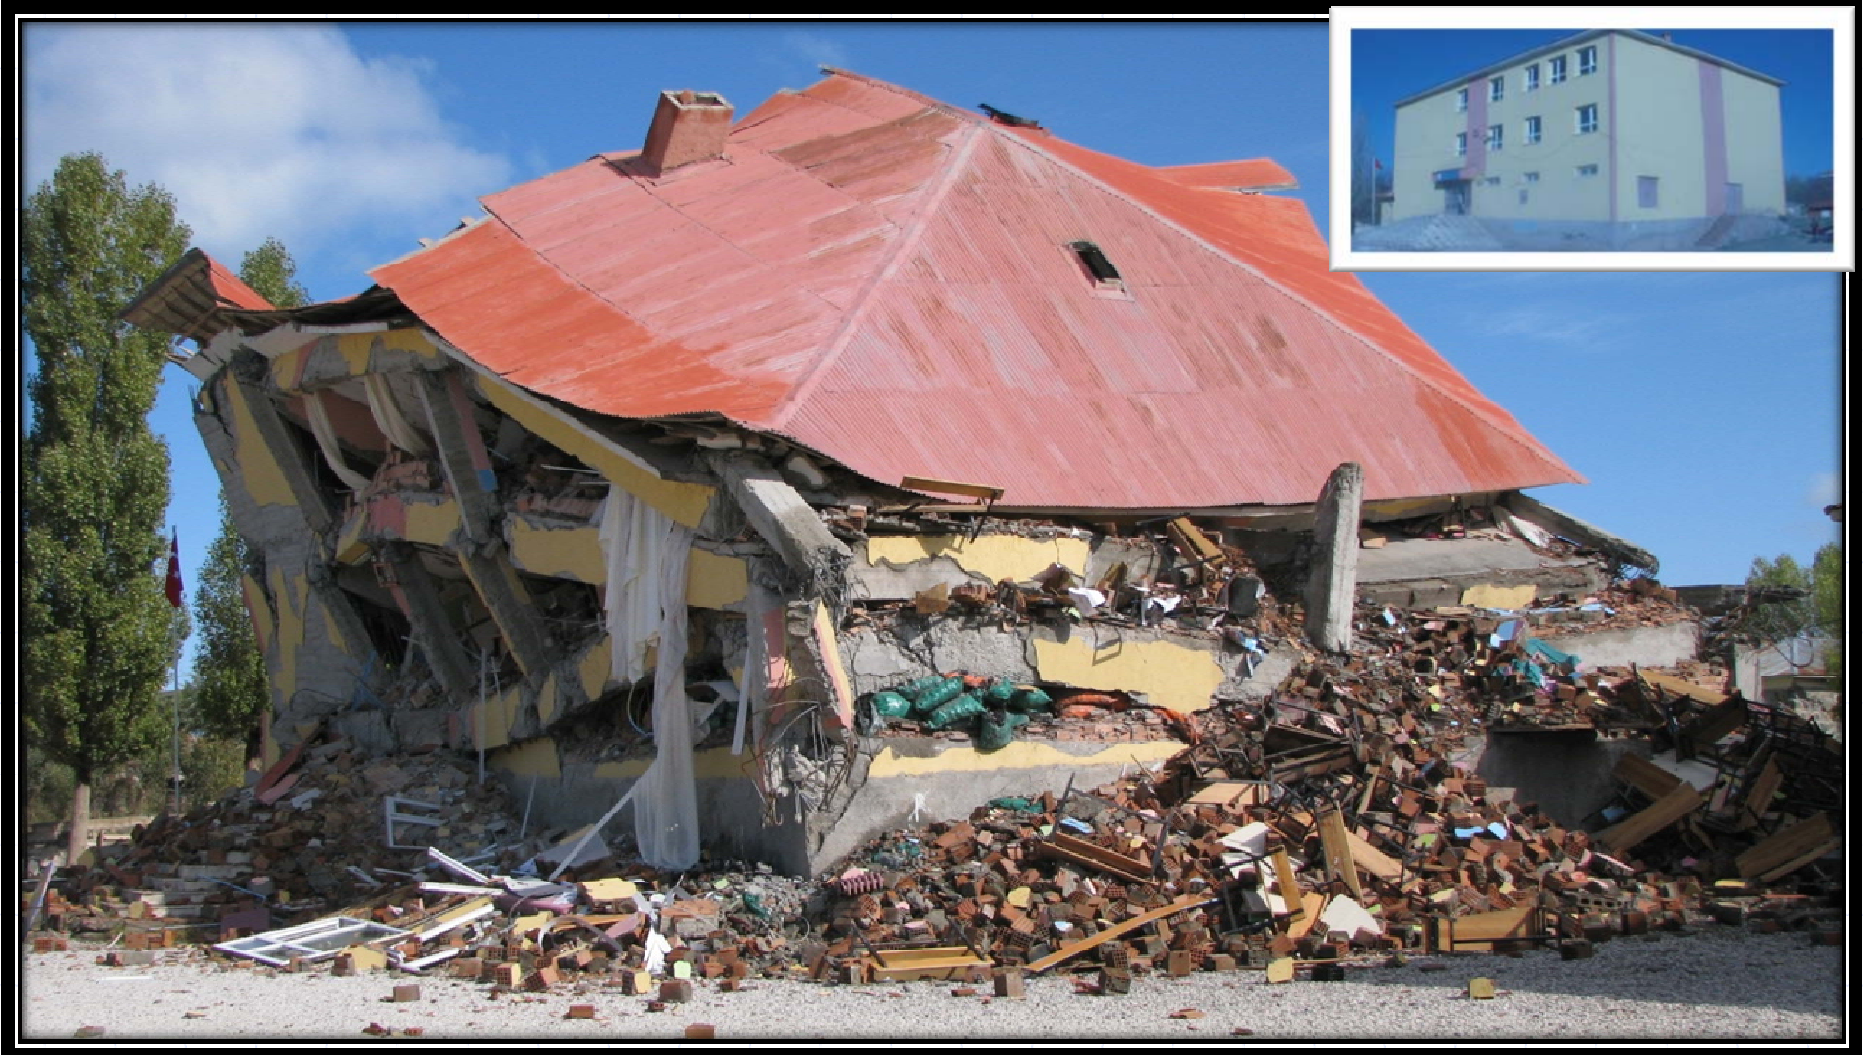
## Total collapse (Gedik Bulak School)

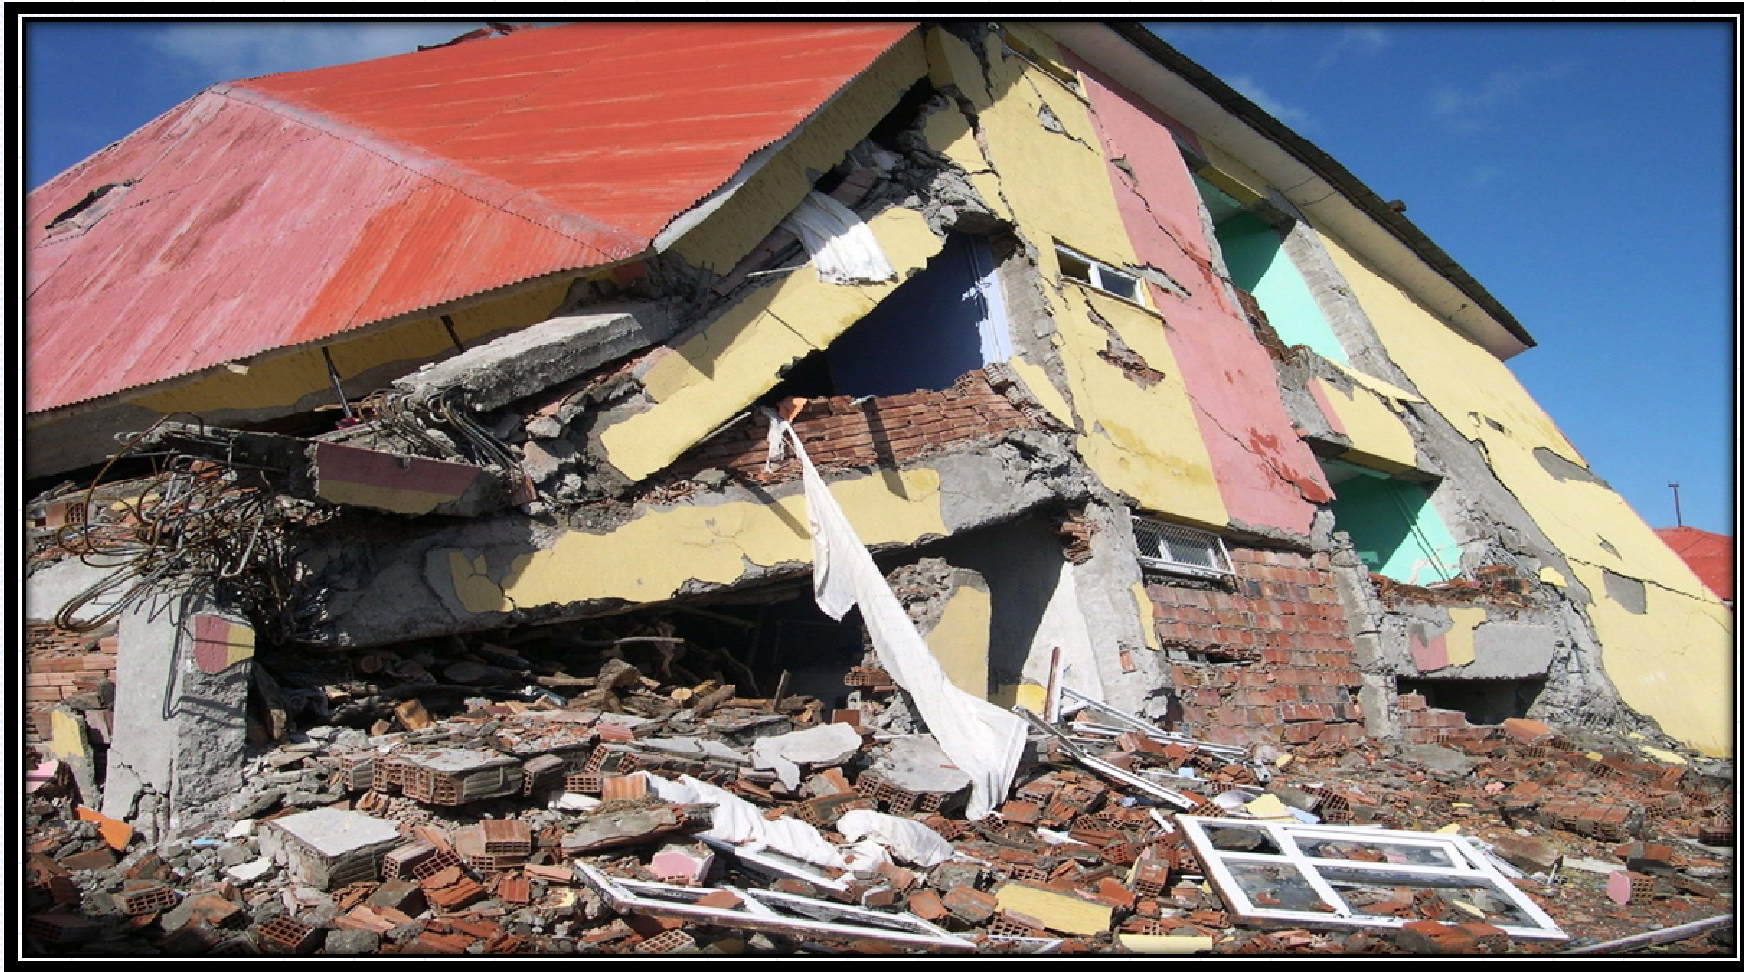
## Total collapse (Gedik Bulak School)

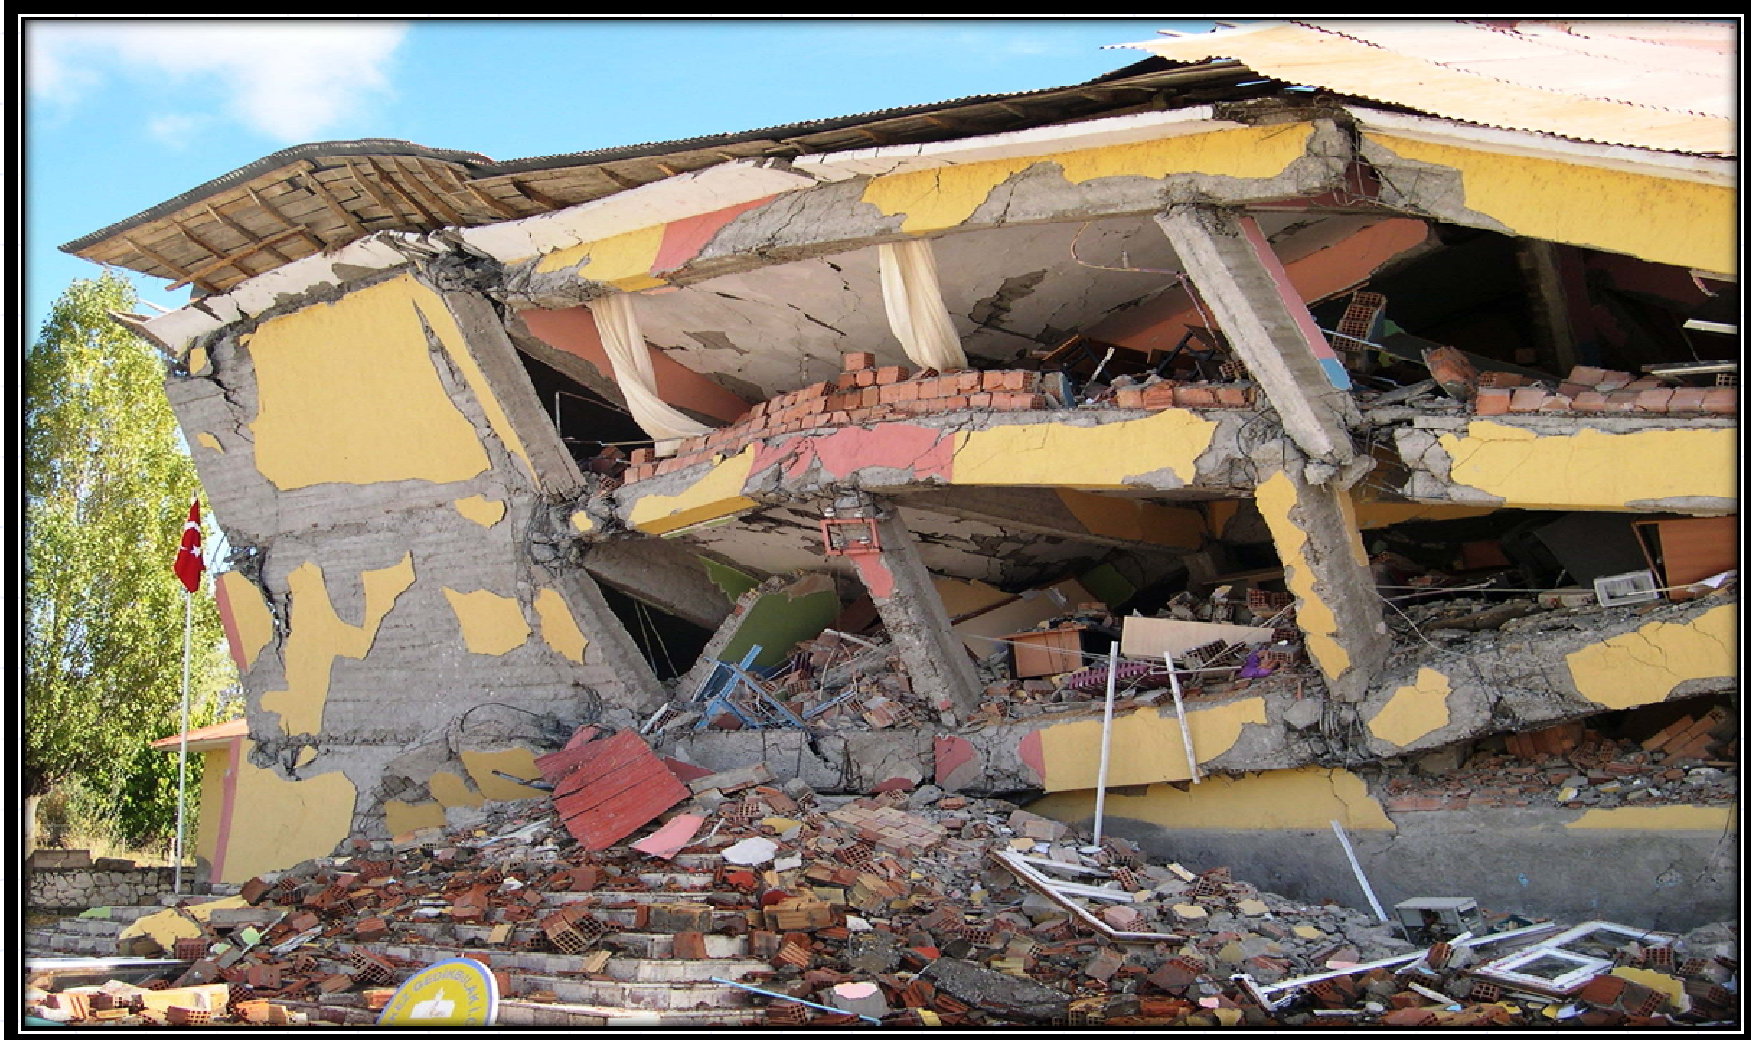
## Total collapse (Gedik Bulak School)

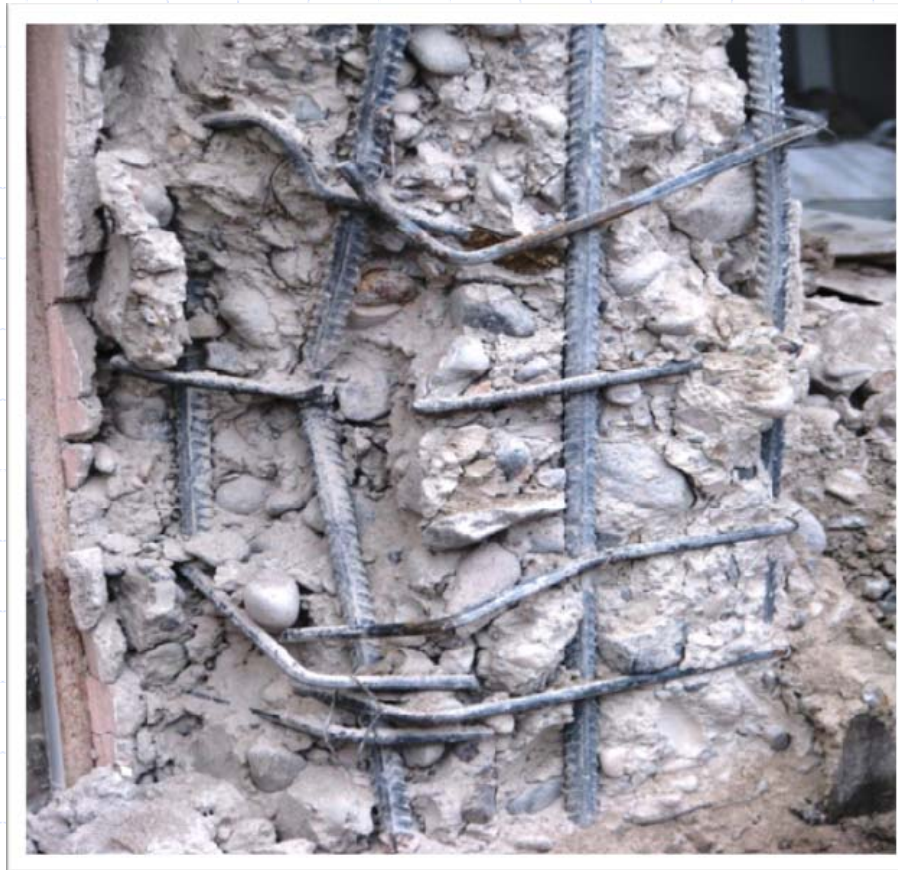
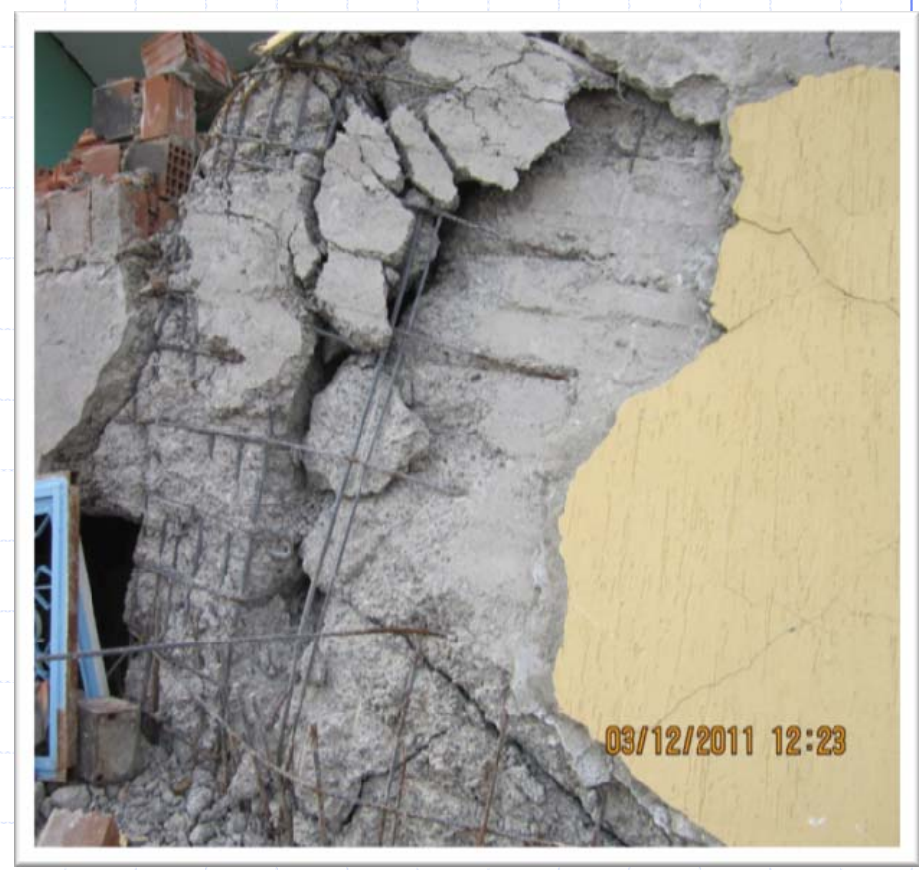
## Inadequate hooks configuration (Gedik Bulak School)

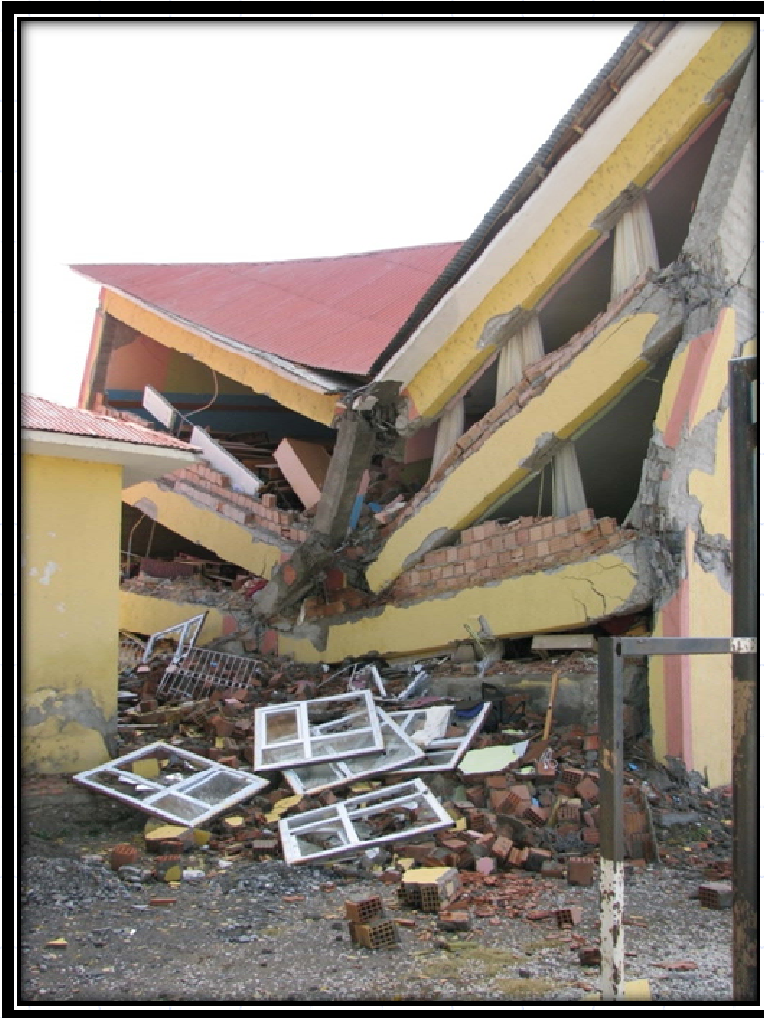
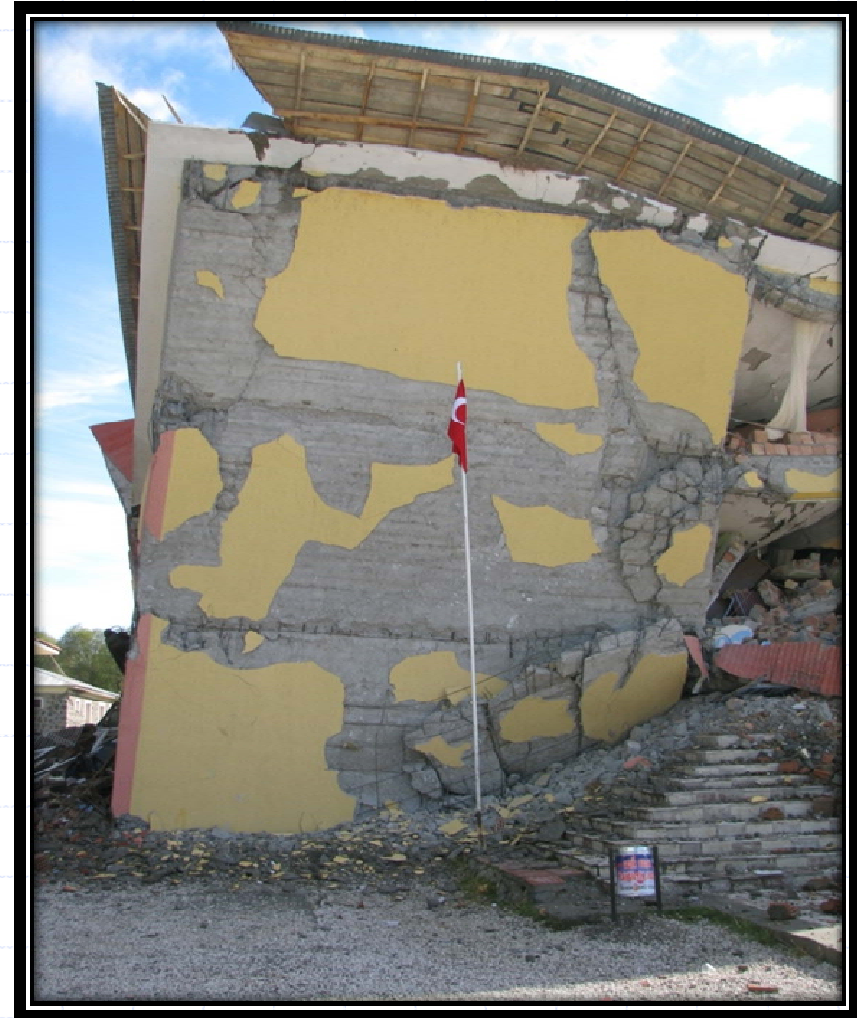
# Inadequate ties in the beam-column joints and damages in the shear wall (Gedik Bulak School)

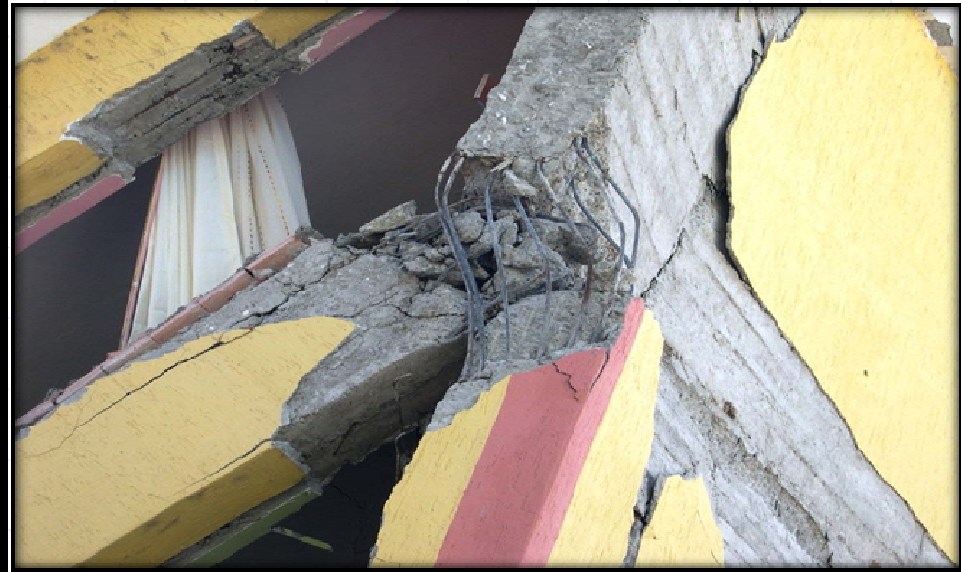
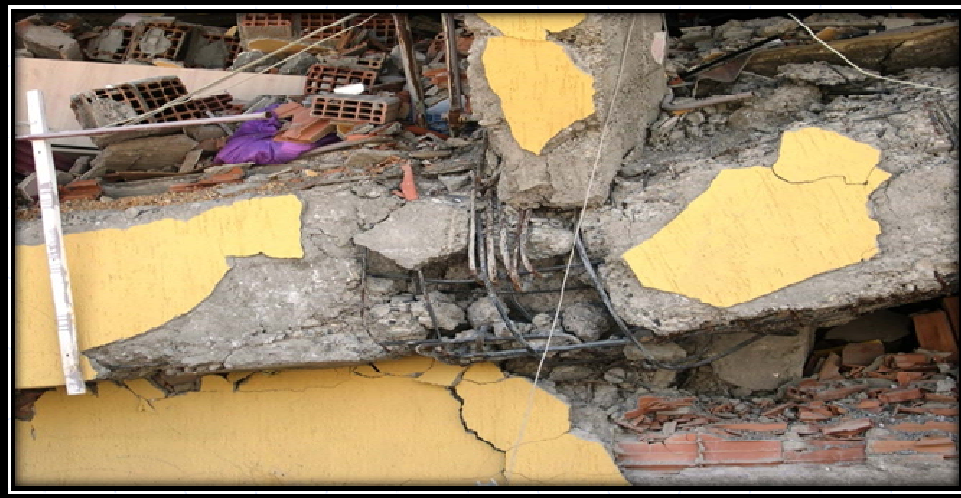
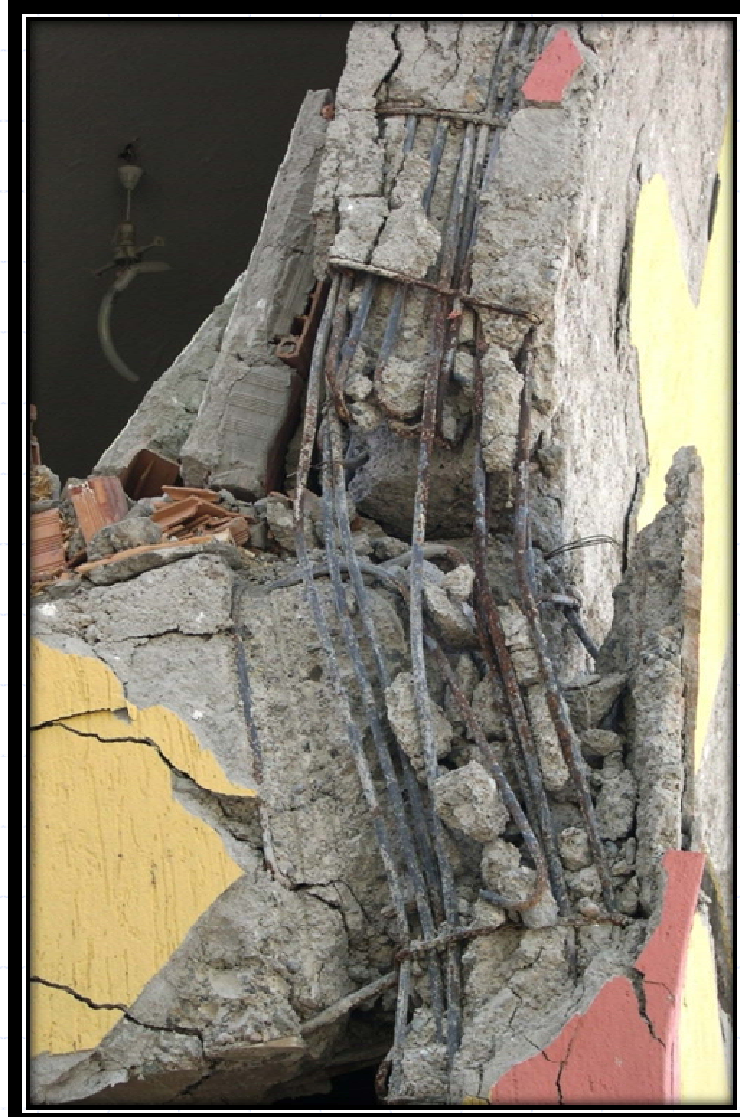
# Inadequate ties in the beam-column joints (Gedik Bulak School)

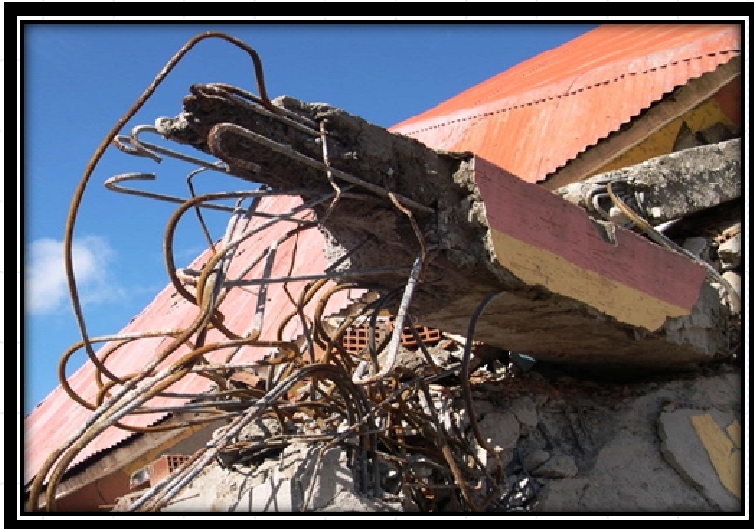
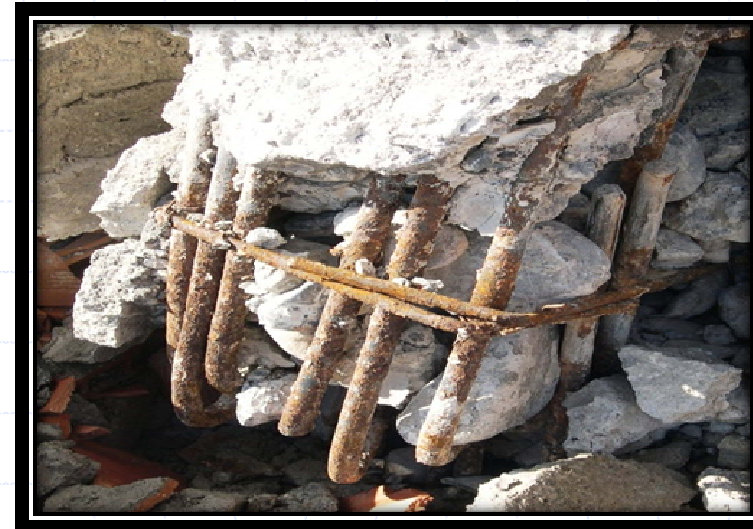
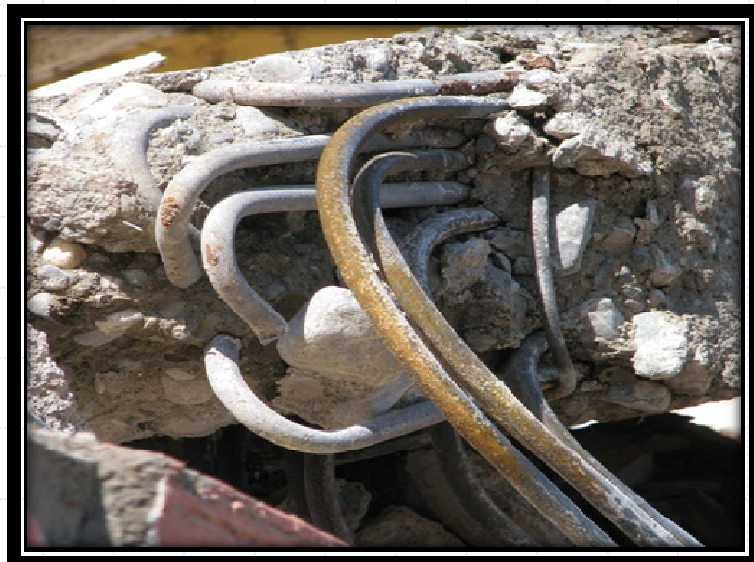
## (Gedikbulak school)

- **Improper granulometry in concrete**
- **Low concrete strength,**
- **Low bond strength**
