Surface Rupture and Slip Distribution along the Karadere Segment of the 17 August 1999 İzmit and the Western Section of the 12 November 1999 Düzce, Turkey, Earthquakes

by Ross D. Hartleb, James F. Dolan, H. Serdar Akyüz, Timothy E. Dawson, Allan Z. Tucker, Barış Yerli, Thomas K. Rockwell, Erkan Toraman, Ziya Çakır, Aynur Dikbaş, and Erhan Altunel

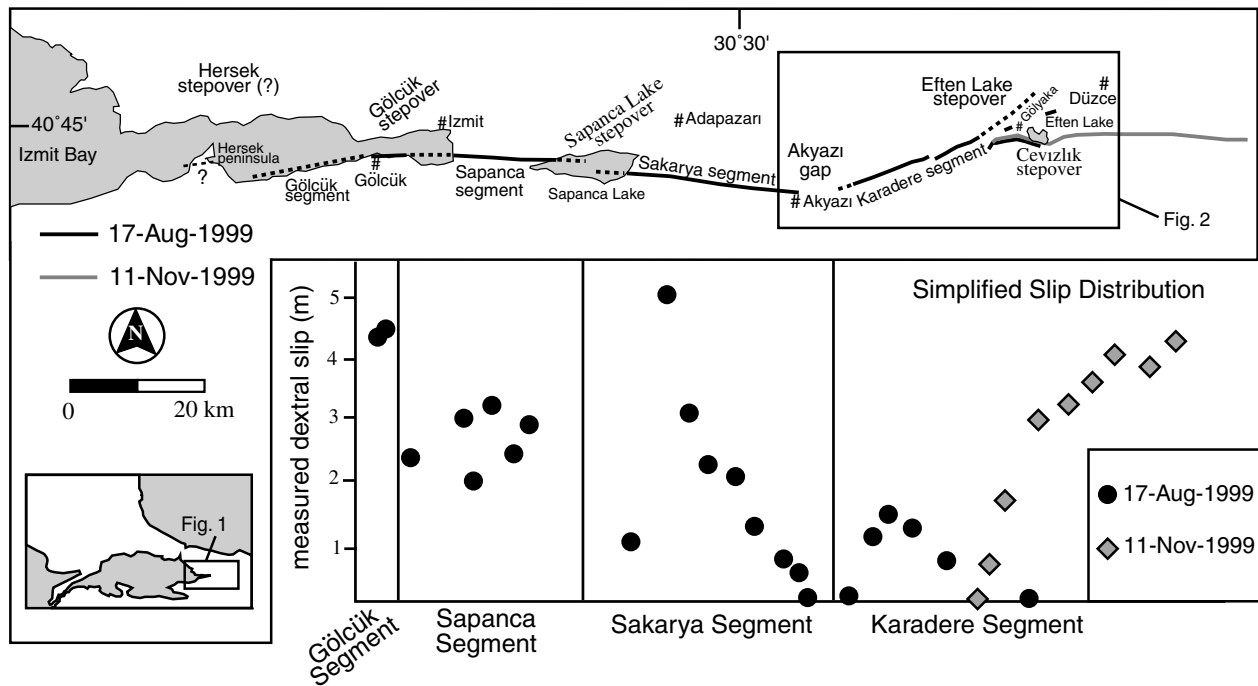
Figure 1. Simplified surface rupture map and slip distribution of the 17 August 1999 Izmit and 12 November 1999 Düzce, Turkey, earthquakes. The fault rupture trace has been dashed, where inferred. (Barka, 1999; Barka *et al.*, 1999; Fumal *et al.*, 1999; R. D. Hartleb, unpublished data).

known. Surface slip was observed to be almost pure right-lateral strike slip, and a maximum observed slip of about 5 m was measured near the town of Arifiye, about 10 km east of Sapanca Lake (Fig. 1). Vertical components of displacement, most notably normal faulting in the Gölcük and Eften Lake areas, are related to local fault geometry. Mapping teams identified four distinct rupture segments. The boundaries of these segments are coincident with fault stepovers, changes in strike, and/or other geometric complexities (Barka, 1999; Barka *et al.*, 1999; Fumal *et al.*, 1999; Langridge *et al.*, 2002). The rupture segments are, from west to east, the Gölcük, Sapanca, Sakarya, and Karadere segments (Fig. 1).

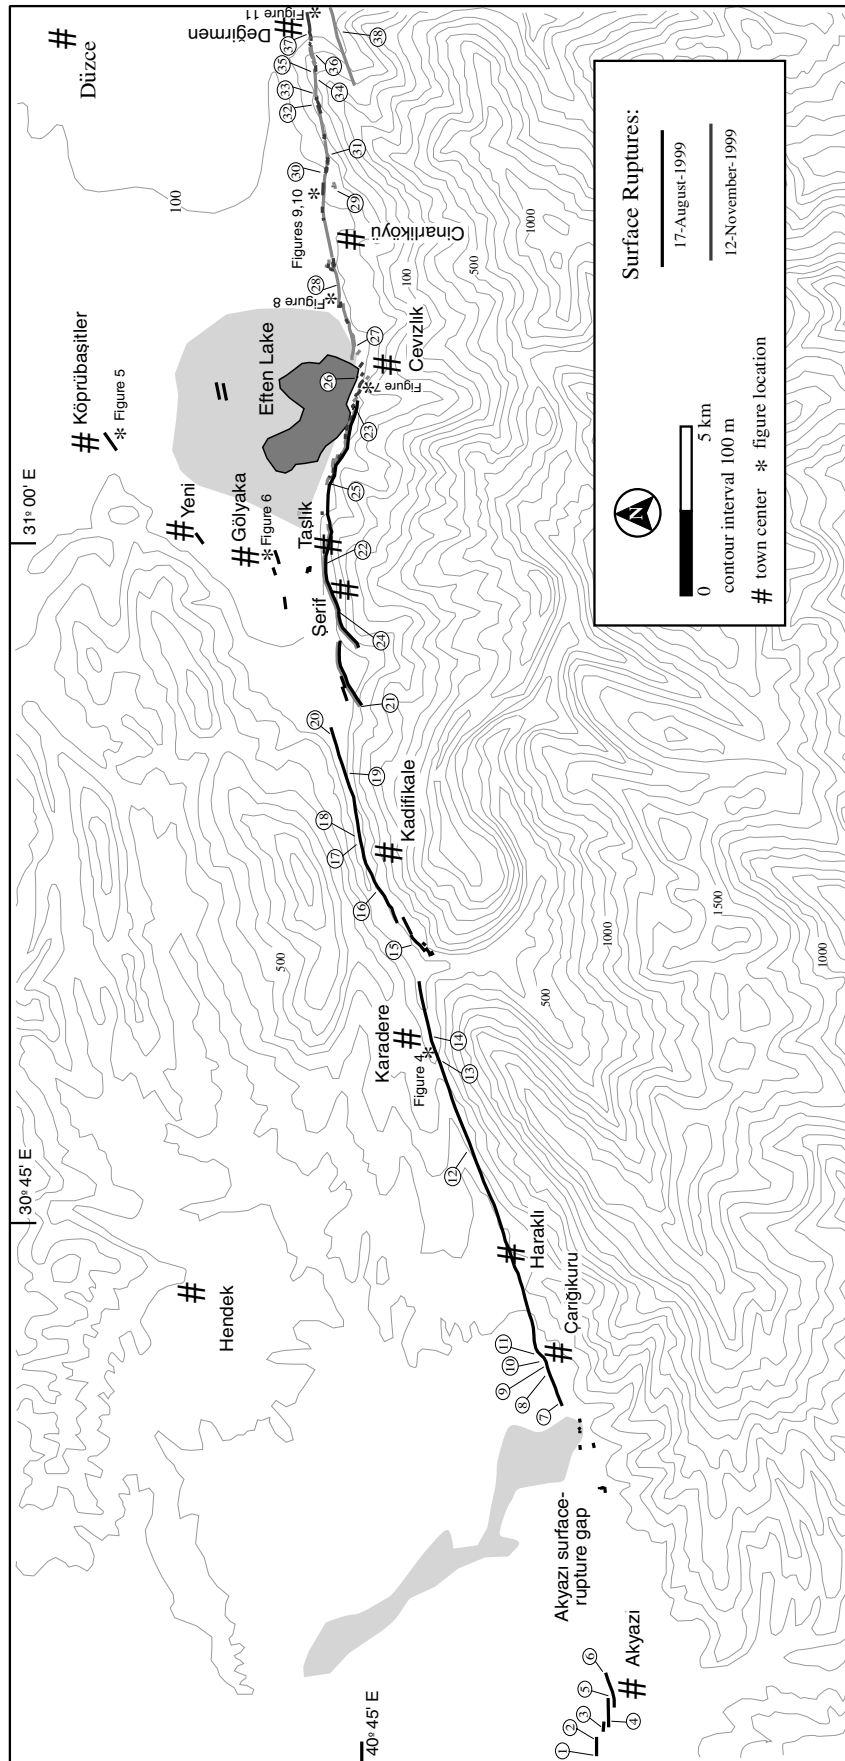
The 40-km-long Karadere rupture segment is the easternmost segment of the 17 August 1999 rupture and extends from 5 km east of the town of Akyazı to the town of Cevizlik, south of Eften Lake (Figs. 1 and 2). Our mapping efforts were concentrated here, and we collected approximately 40 slip measurements along this segment (Fig. 3 and Table 1). A maximum dextral slip of 1.55 ± 0.10 m was recorded along this segment at a site located 6 km west of the town of Gölyaka. At this location, the fault trends N50°E, and the measurement was made on a wooden-post, barbed-wire fence oriented at N55°W. The fault zone at this location is approximately 1–1.5 m wide. Average surface slip on the Karadere segment as a whole is close to 1 m.

Figure 2. Detailed rupture map of the Karadere rupture segment of the 17 August 1999 İzmit earthquake and the western section of the 12 November 1999 Düzce earthquake. Circled numbers correspond to locations detailed in Table 1. Pale gray shading denotes marshy areas.

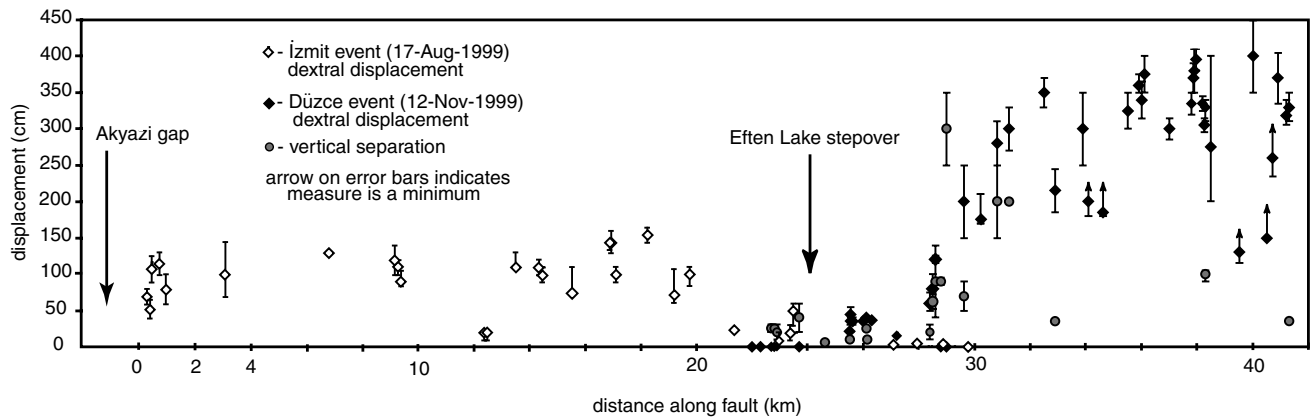
Figure 3. Slip distribution of the Karadere rupture segment of the 17 August 1999 İzmit earthquake and the western section of the 12 November 1999 Düzce earthquake.

Figure 3 shows the slip distribution data for the Karadere segment of the 17 August 1999 İzmit earthquake and the slip measurements for the western half of the 12 November 1999 Düzce earthquake. For the August event, this distribution is fairly smooth and regular, with a maximum dextral slip of 1.5 ± 0.10 m and an average of about 1 m. Estimated surface slip near and within the diffuse zones of cracking associated with the Akyazı surface rupture gap and the Eften Lake step-over is relatively low, in part because the methods we used to estimate slip (tape measure and compass) are best suited to measuring narrow, near-field zones of deformation. The observation of the ends of the rupture segments, as mapped after the 17 August 1999 event, suggests the generality that surface rupture patterns tend to splay from a narrow, discrete fault zone into a broad, horsetail pattern near step-overs. This may be a primary effect of rupture dynamics, or, alternatively, may represent a manifestation of differing surface rupture patterns in different near-surface materials. It is assumed that thicker unconsolidated sediment packages are associated with step-overs, and perhaps observed rupture patterns reflect differences in near-surface materials.

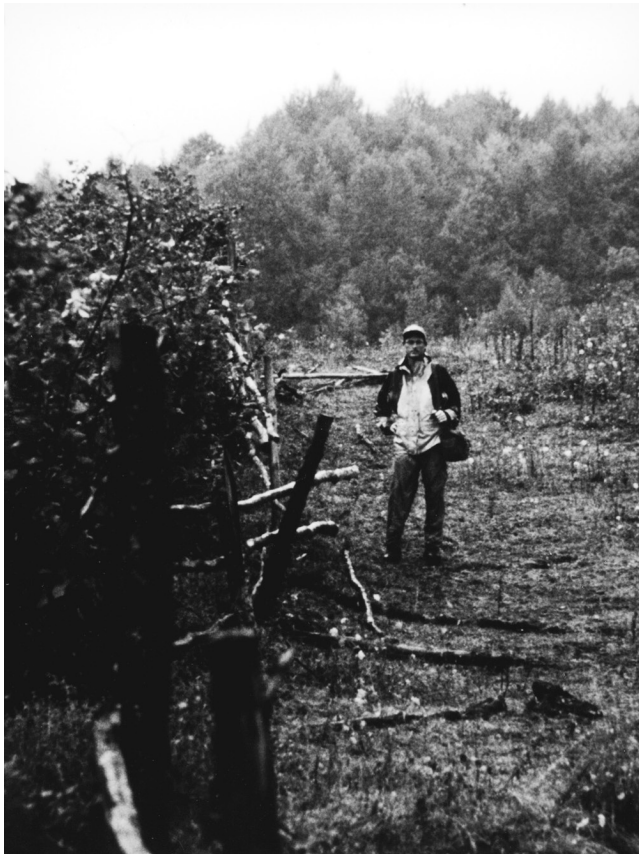
N65°E for 10 km along this reach and is restricted to a 1- to 3-m-wide zone. Right-lateral slip varies between 0.90 ($+0.15/-0.05$) and 1.30 (± 0.05) m (Fig. 4). Four kilometers east of the town of Kadifekale, there is a 400-m-wide compressional step-over or bend (Fig. 2). Within a few hundred meters to the east and west of this compressional step or bend, faulting is distributed throughout a wide zone of surface cracking, each crack having less than a few centimeters of displacement.

Figure 4. Photograph of offset fenceline (1.20 ± 0.20 m dextral) near the town of Karadere, 17 August 1999 event. View south. See Figure 2 for location.

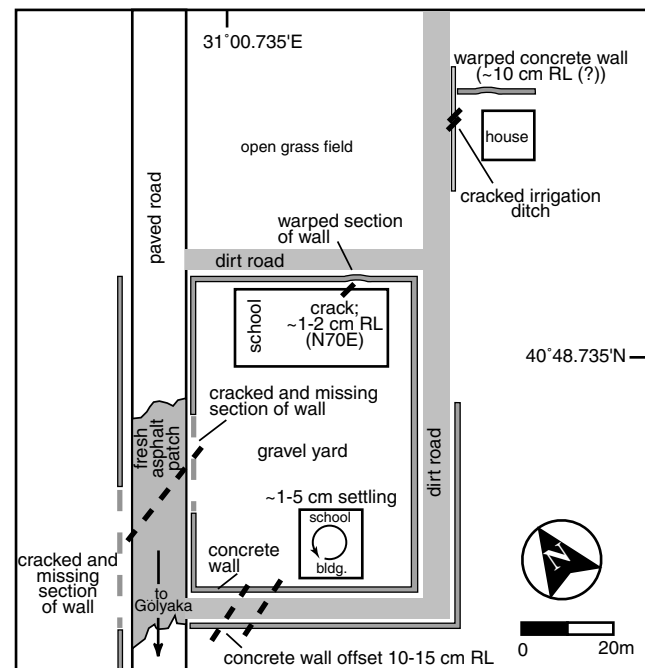
Figure 5. Sketch map of the Köprübaşıtlar (İçmeler) school site, showing northeastern terminus of the 17 August 1999 İzmit earthquake surface rupture. Surface faulting and cracking shown in heavy black lines. See Figure 2 for location.

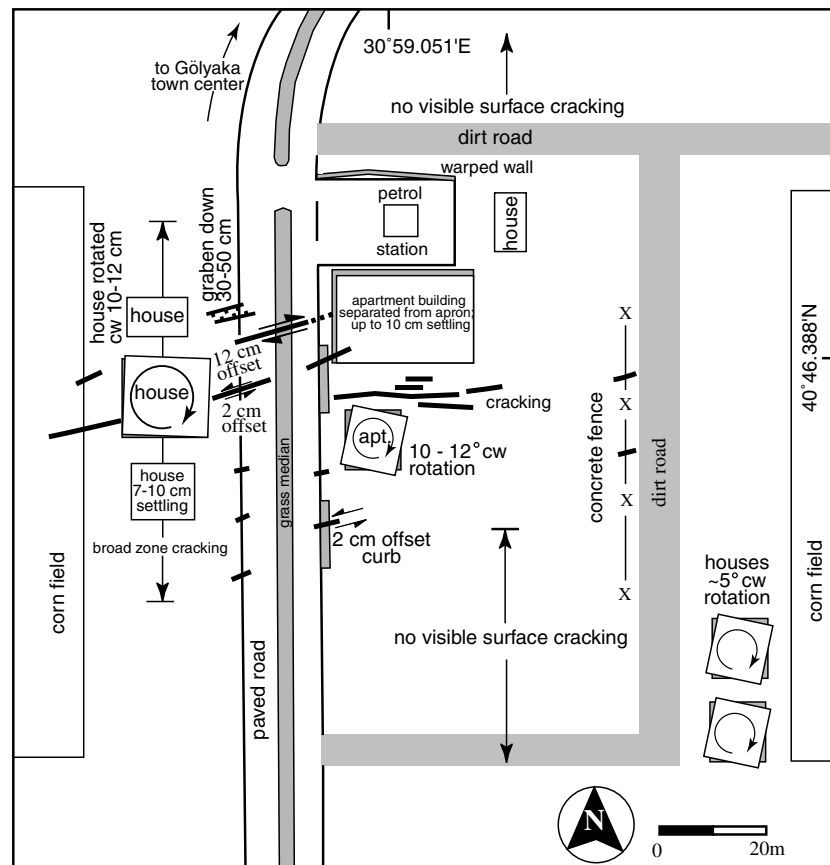
Additionally, diffuse ground cracking and rotational deformation were noted just south of the town of Gölyaka (Fig. 6). At this site, we mapped a 60-m-wide zone of discontinuous surface faulting and ground cracking. Dextral displacements on individual strands ranged from 0 to 12 cm, and two small strands, each having a sinistral displacement of about 2 cm, were observed. A 5-m-long, 2-m-wide graben with 30–50 cm of relief was mapped within this zone of faulting. Within and adjacent to this zone of faulting, we also noted at least four buildings that had experienced clockwise rotation between 5° and 12°. Two buildings experi-

Figure 6. Sketch map of broad zone of dextral shear and clockwise rotation at Gölyaka, 17 August 1999 İzmit earthquake. Surface faulting and cracking shown in heavy black lines. See Figure 2 for location.

enced significant settling, perhaps as much as 7–10 cm. Local residents reported that this settling seemingly increased with time for up to a week after the 17 August 1999 event.

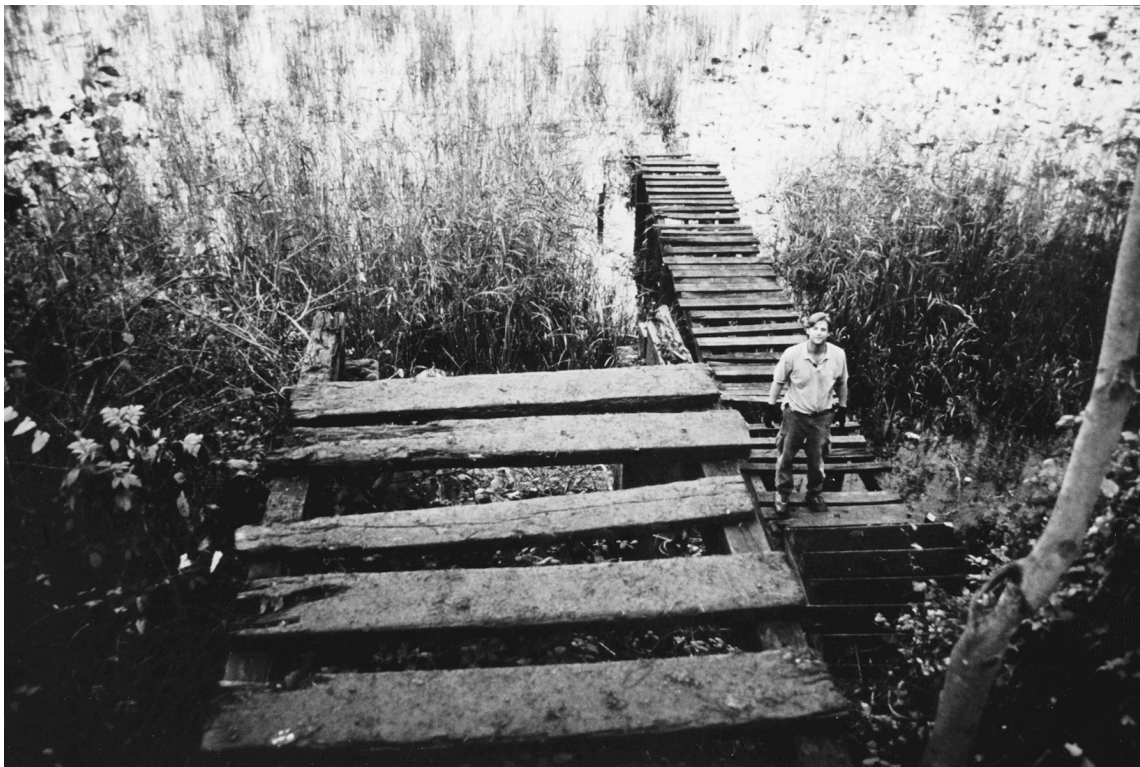
Figure 7. Photograph of the offset pier (2.70 ± 0.50 m dextral, 2.00 ± 0.25 m down-to-the-north) located on the southern edge of Eften Lake, 12 November 1999 event. View north. See Figure 2 for location.

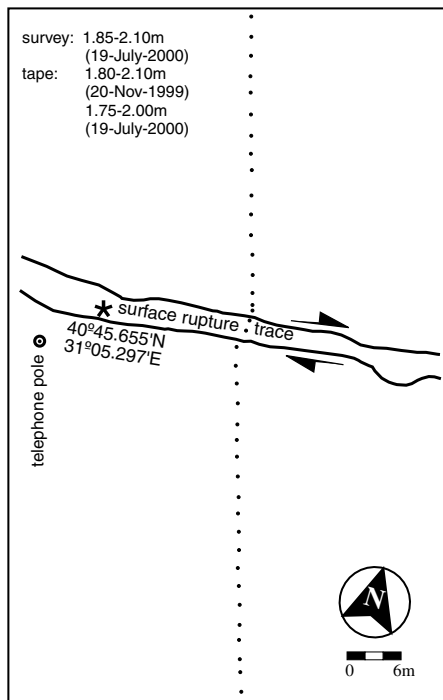
A detailed instrumental survey of an offset fence located 1.5 km west of the town of Çınarlıköyü (in the town of Yeni) was conducted in August 2000 (Fig. 2). At this location a wooden-post, barbed-wire fence at a high angle to the surface rupture was surveyed for approximately 35 m north and south of the fault (Fig. 9). The fault zone at this location is about 2.5 m wide, and the fence is remarkably straight, with

no evidence of any distributed slip outside of the narrow fault zone. The survey map shows 1.85–2.10 m of dextral displacement, an amount that is in good agreement with the 1.75–2.00 m of displacement estimated in November 1999 by the traditional method using a tape measure. This finding does not obviate the conclusions of Rockwell *et al.* (2002) but merely suggests that in some cases all or nearly all of the surface slip can, in fact, be accommodated in a narrow (few meters wide) zone.

Figure 8. Instrumental survey map of the offset wooden-post, barbed-wire fence at Yeni village. Asterisk marks survey shot point, with GPS-derived latitude and longitude. Estimates of offset derived from tape and compass method and instrumental survey as noted. See text for details, see Figure 2 for location.

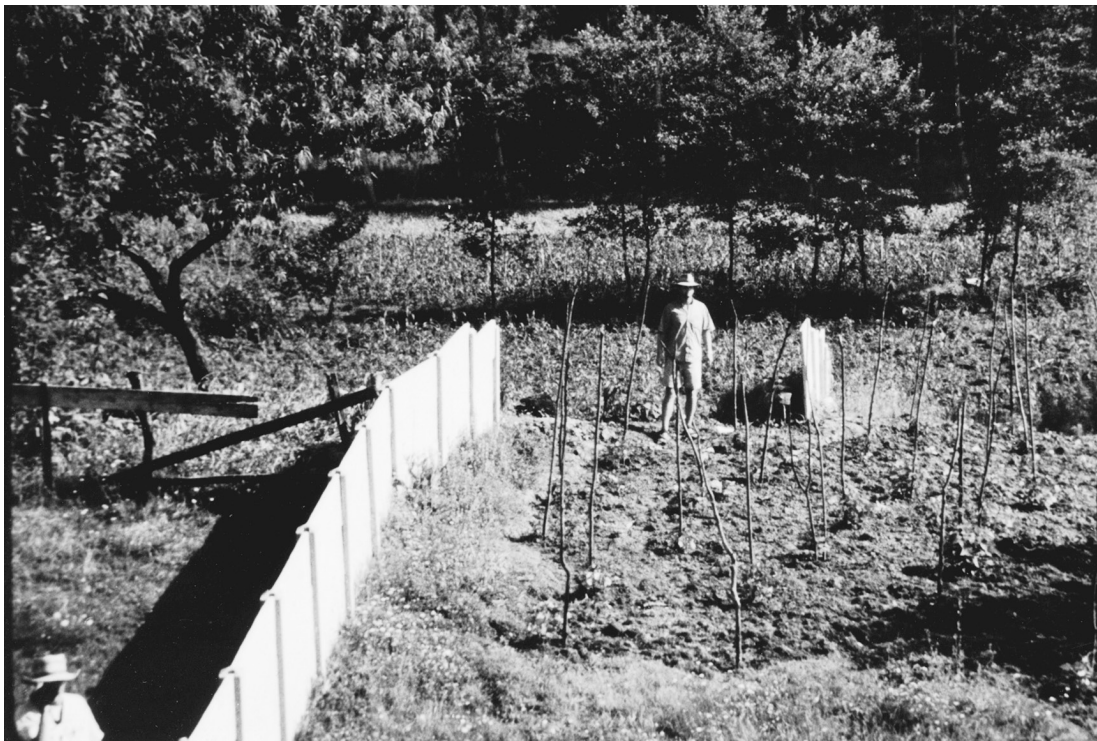
Another detailed instrumental survey was conducted in August 2000 in the town of Çınarlıköyü. At this location, a straight concrete wall at a high angle to the rupture trace extends more than 25 m north and 12 m south of faulting (Figs. 9 and 10). The main fault zone is 1.5–2.5 m wide, with a discontinuous secondary strand 2–3 m to the north. This survey shows 3.60–4.50 m of dextral offset on the two strands, a number that is somewhat larger than the 3.50–3.70 m estimated on 19 November 2000 by the traditional method of using a tape measure. Part of this discrepancy is caused by the difficulties associated with eyeballing the concrete wall across the fault zone, as well as the uncertainty associated with local strike of the fault zone. Though it is less clear here than at the Yeniköy offset fence site, there does not appear to be significant off-fault distributed deformation at Çınarlıköyü. Indeed, the tape measure estimate of offset is less than that determined from the survey, but the survey

shows the concrete wall to be remarkably straight on either side of the faulting. This discrepancy is thought to be primarily the result of human error during our initial field mapping.

Figure 9. Photograph of the offset concrete wall in the town of Çınarlıköyü, 12 November 1999 event. View south. See Figure 2 for location and Figure 10 for instrumental survey map.

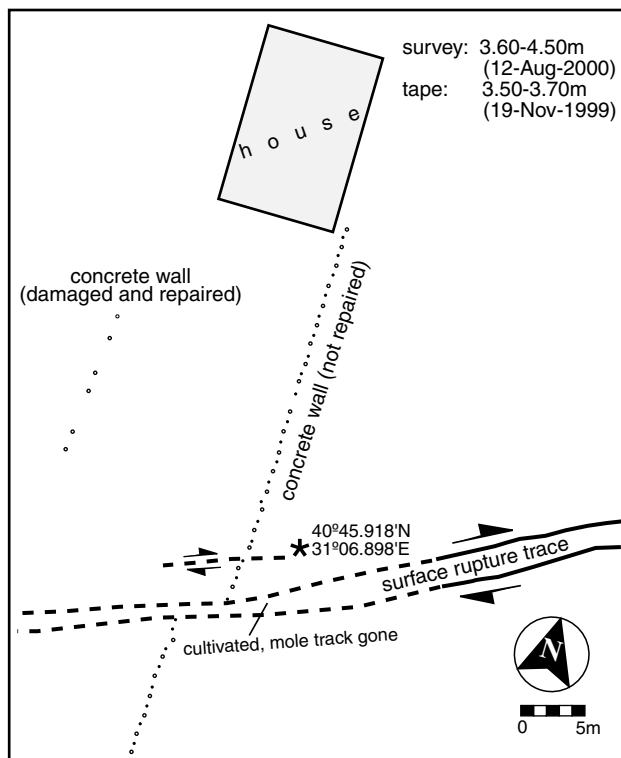
Figure 10. Instrumental survey map of the offset concrete wall at Çınarlıköyü. Asterisk marks survey shot point, with GPS-derived latitude and longitude. Estimates of offset derived from tape and compass method and instrumental survey as noted. The surface rupture trace has been dashed, where inferred. See text for details, see Figure 2 for location.

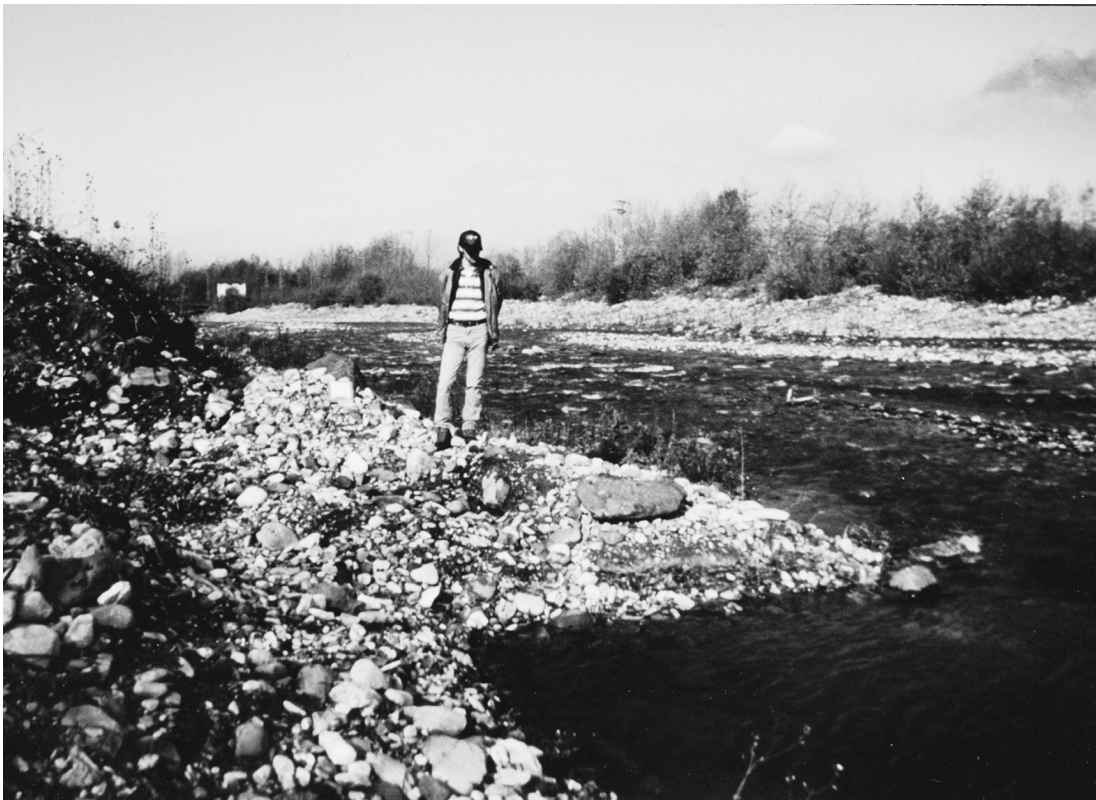
Surface rupture between Çınarlıköyü and Değirmen is predominantly pure dextral strike slip with displacements ranging from 2.5 to 4.5 m. A small (<100 m wide) extensional step located 2.5 km east of Çınarlıköyü is accommodated by a series of en-echelon, northwest-trending normal faults. South of the town of Değirmen, there is a 1.5-km-long fault strand parallel to, and 1 km south of, the main rupture trace. Displacements on this southern strand do not exceed 0.15 m. The eastern channel margin of the Develisuyu River (at the eastern edge of our study area) is offset dextrally to the extent of 3.30 ± 0.20 m, and the western channel margin is offset dextrally by $3.30 (+10/-0.25)$ m (Fig. 11).

Figure 11. Photograph of the Develisuyu River offset channel margin ($3.30[+0.10/-0.35]$ m dextral), 12 November 1999 event. View north. See Figure 2 for location.
