EFFECTS OF WATERJET APPLICATION ON JOINING SURFACES OF EXTERNAL RETROFITTING TECHNIQUE

Onur Gedik, Ryusei Hikiji, Akira Tasai

SERIES, 8 Feb. 2012

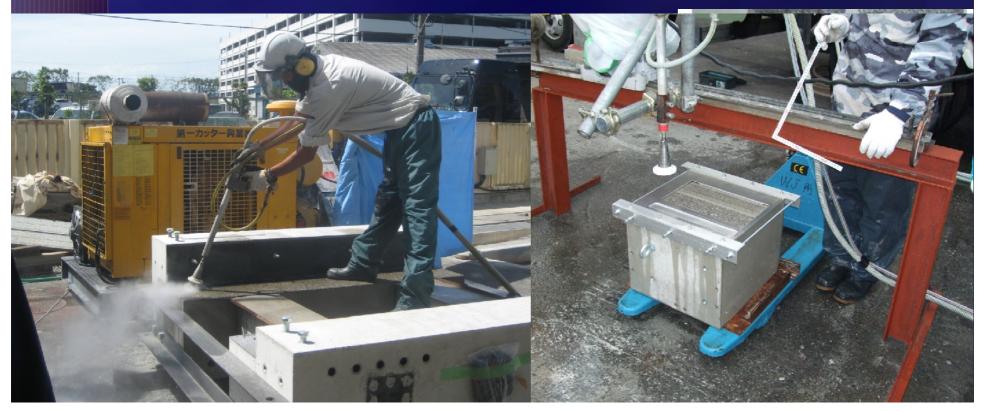
Waterjet (WJ)

Waterjet is the high pressured water spray, which is usually used to cut/smash the concrete elements.

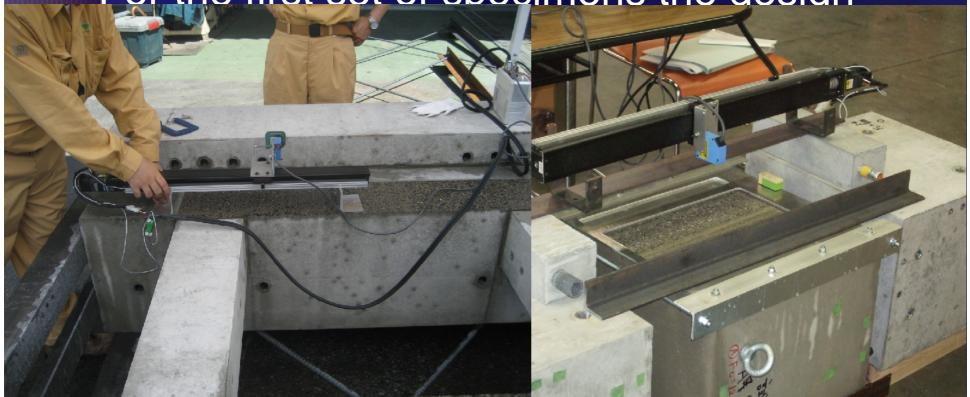
Roughness

The roughness term is used to identify the average depth of the friction surface.

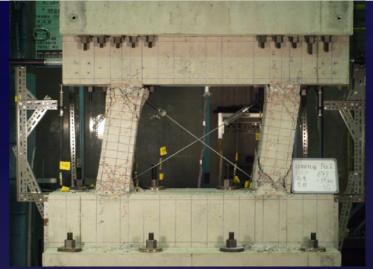
- Pa=2.33%, K=0.
- Max. applied shear force values are 713.9 kN and -688.8 kN in 1/67 and -1/100 cycles, respectively.
- Due to eccentricity, severe damages observed.
- No.2, designed according to the manual, achieved the maximum efficiency by increasing the capacity 5.15 times.

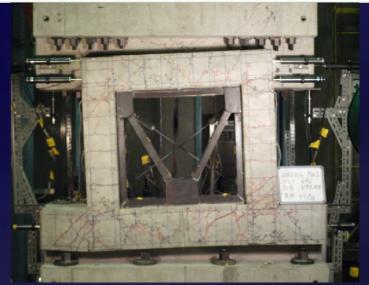
- Pa=0.69%, K=1.70mm.
- Max. applied shear force values are 633.9 kN and -603.4 kN in 1/100 and -1/100 cycles, respectively.
- Increased the capacity by 4.54 times with only 30% of the required amount of the anchorage bars.

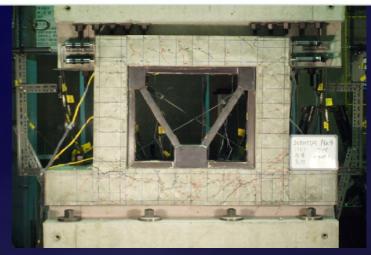
- Pa=0.26%,
 K=2.45mm.
- Max. applied shear force values are 511.9 kN and -536.1 kN in 1/100 and -1/100 cycles, respectively.
- Increased the capacity by 3.85 times with 10% of the required amount.
