International Workshop:
“Role of research infrastructures in seismic rehabilita
Istanbul, February 8-9, 2012

**IMPLEMENTATION OF EXPERIMENTALY DEVELOPED
METHODOLOGY FOR SEISMIC STRENGTHENING IN
HISTORIC MONUMENTS**

University Ss. Cyril and Methodius in Skopje
Institute of Earthquake Engineering and Engineering Seismology (UKIM-IZIS) - Skopje

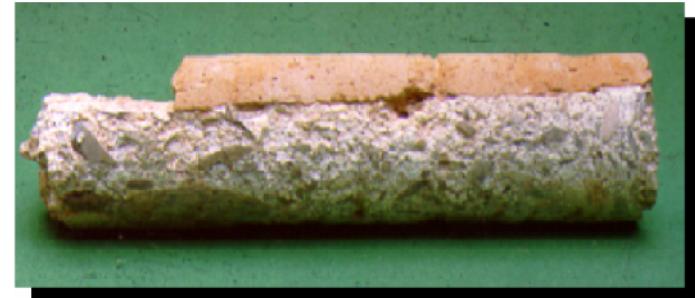
- Experimental and Laboratory Tests:

Mechanical and chemical characteristics
of stone, brick and mortar

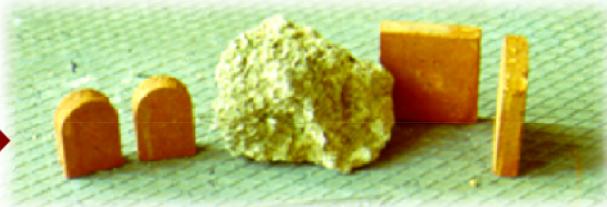
- **OBJECTIVES** → Investigation of seismic resistance and verification of the proposed strengthening concept
- Selection of the geometrical scale → $L_r = 1:2.75$
- Investigation of the model materials →

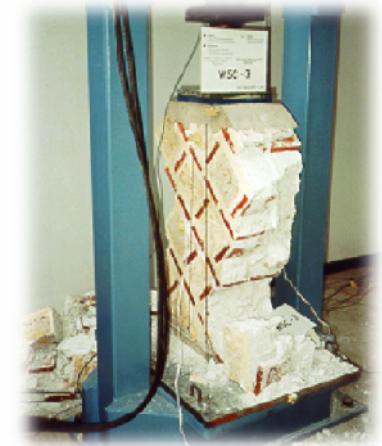
- Experimental testing of wall elements →

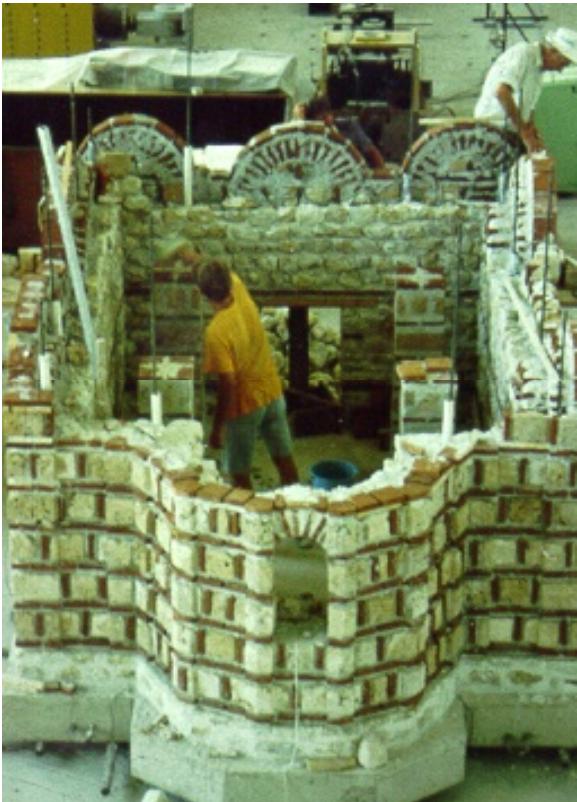
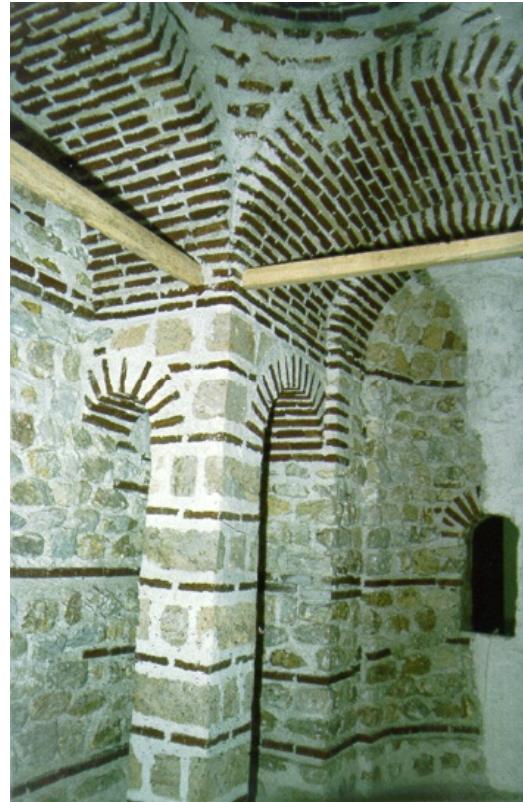
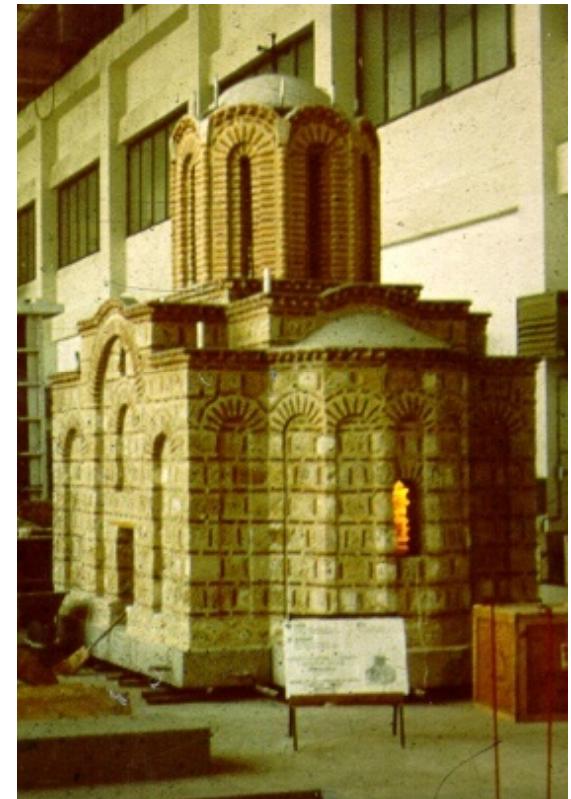
Construction of the model

- Design of the church model

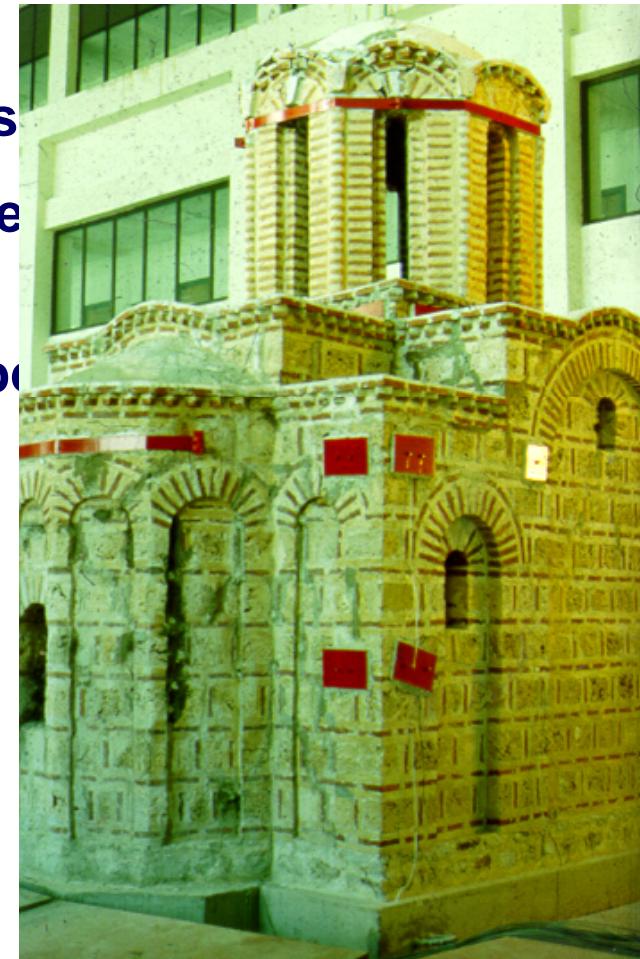
Selected method for strengthening:

- ← incorporation of horizontal steel ties
- ← systematic injection of elements
- ← incorporation of vertical steel ties

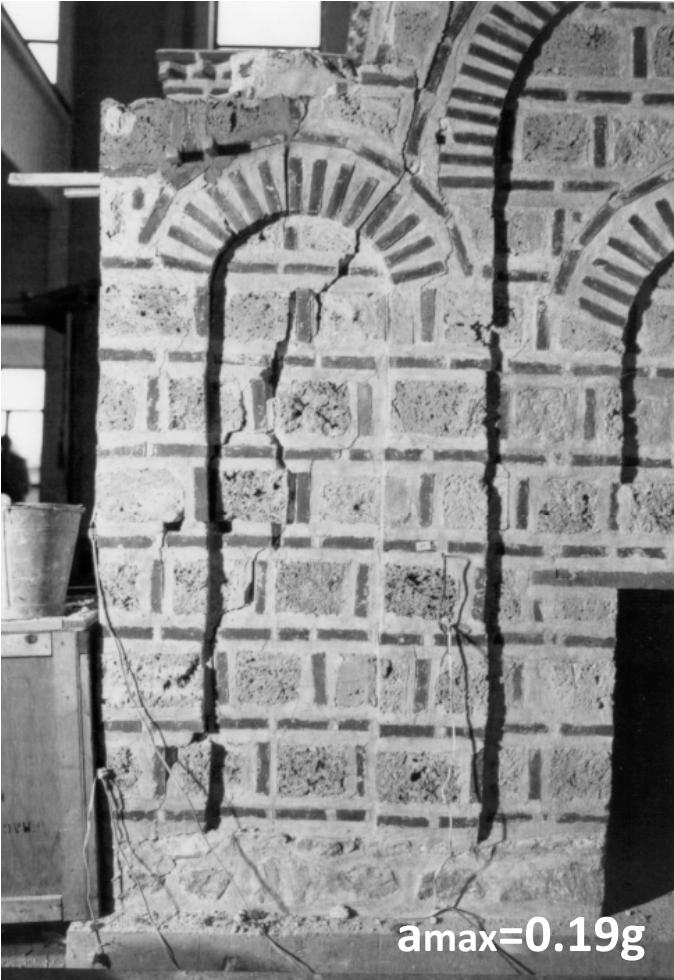
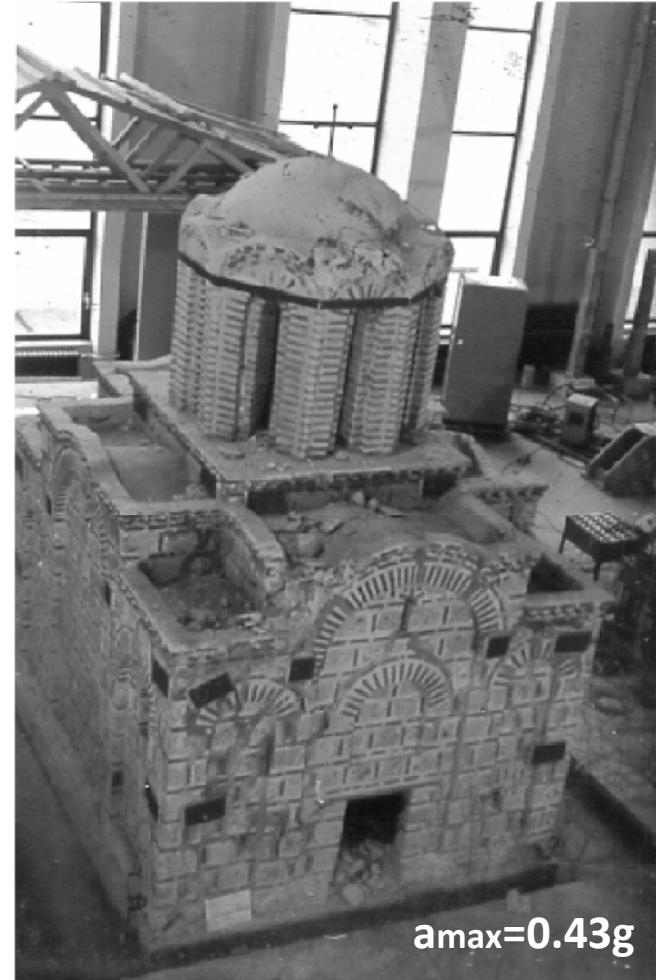
Experimental verification of methodology

lower damage level even under higher level of input excitation

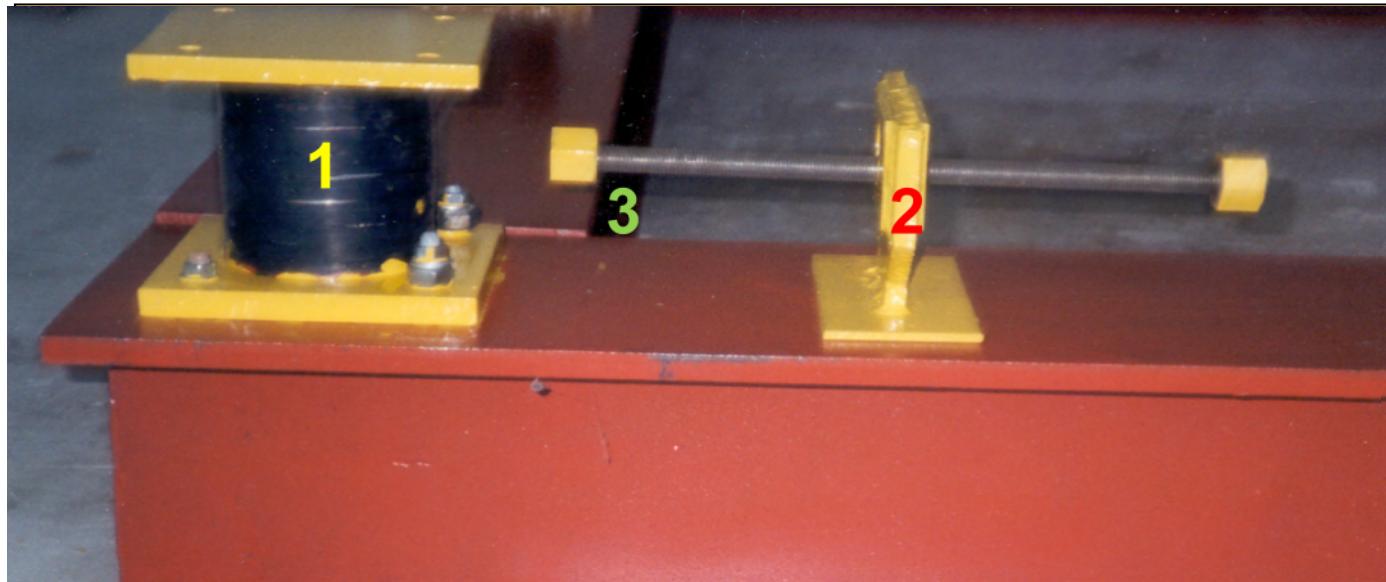
element 1: Laminated rubber bearing element

element 2: Steel plate damper (hysteretic behavior)

element 3: Stopper element (limited displacement)

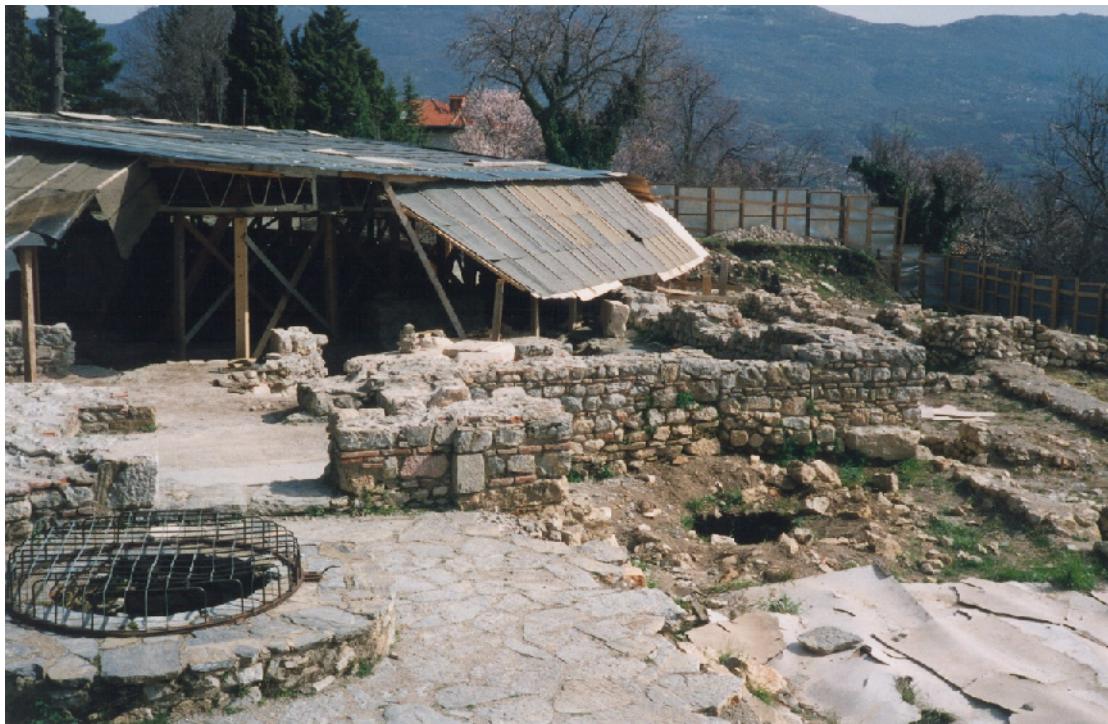
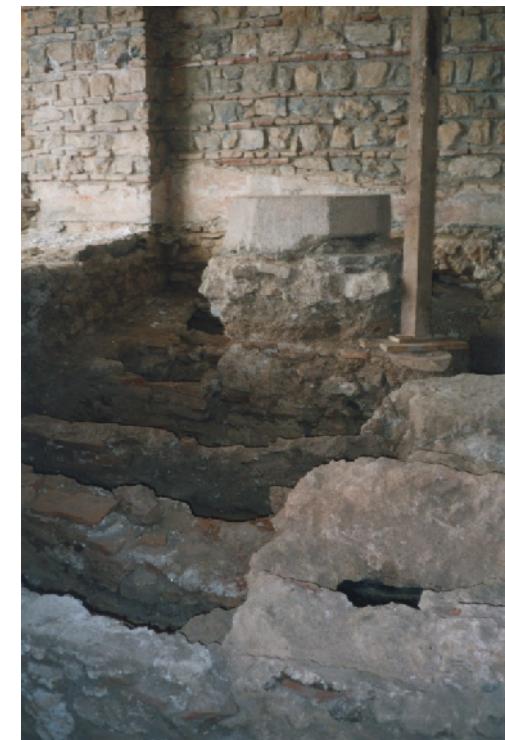
Consolidation and Reconstruction of the Structure of the St.Pantelymon Church in Plaoshnik, Ohrid

Concept for Consolidation and Rebuilding

- ✓ Definition of design criteria (3 levels)
- ✓ Injection of the walls:
 - Walls below the floor level with cement emulsion
 - Walls over the floor by use of lime-based emulsions
- ✓ Contact between the existing and the rebuilt walls
- ✓ Strengthening and the consolidation of the existing foundation walls up to level 0.00
- ✓ Reinforced concrete floor slab with a thickness of 20 cm
- ✓ Construction of the church as massive stone and brick masonry in lime mortar with incorporated **horizontal and vertical steel ties**

- ✓ Analysis of the bearing and deformability capacity
- ✓ Nonlinear dynamic analysis for maximum expected actual earthquake effects ($a_{max}=0.36g$ for $t_p=1000$ years)
- ✓ Static and equivalent seismic 3D – FE analysis (SAP 2000)

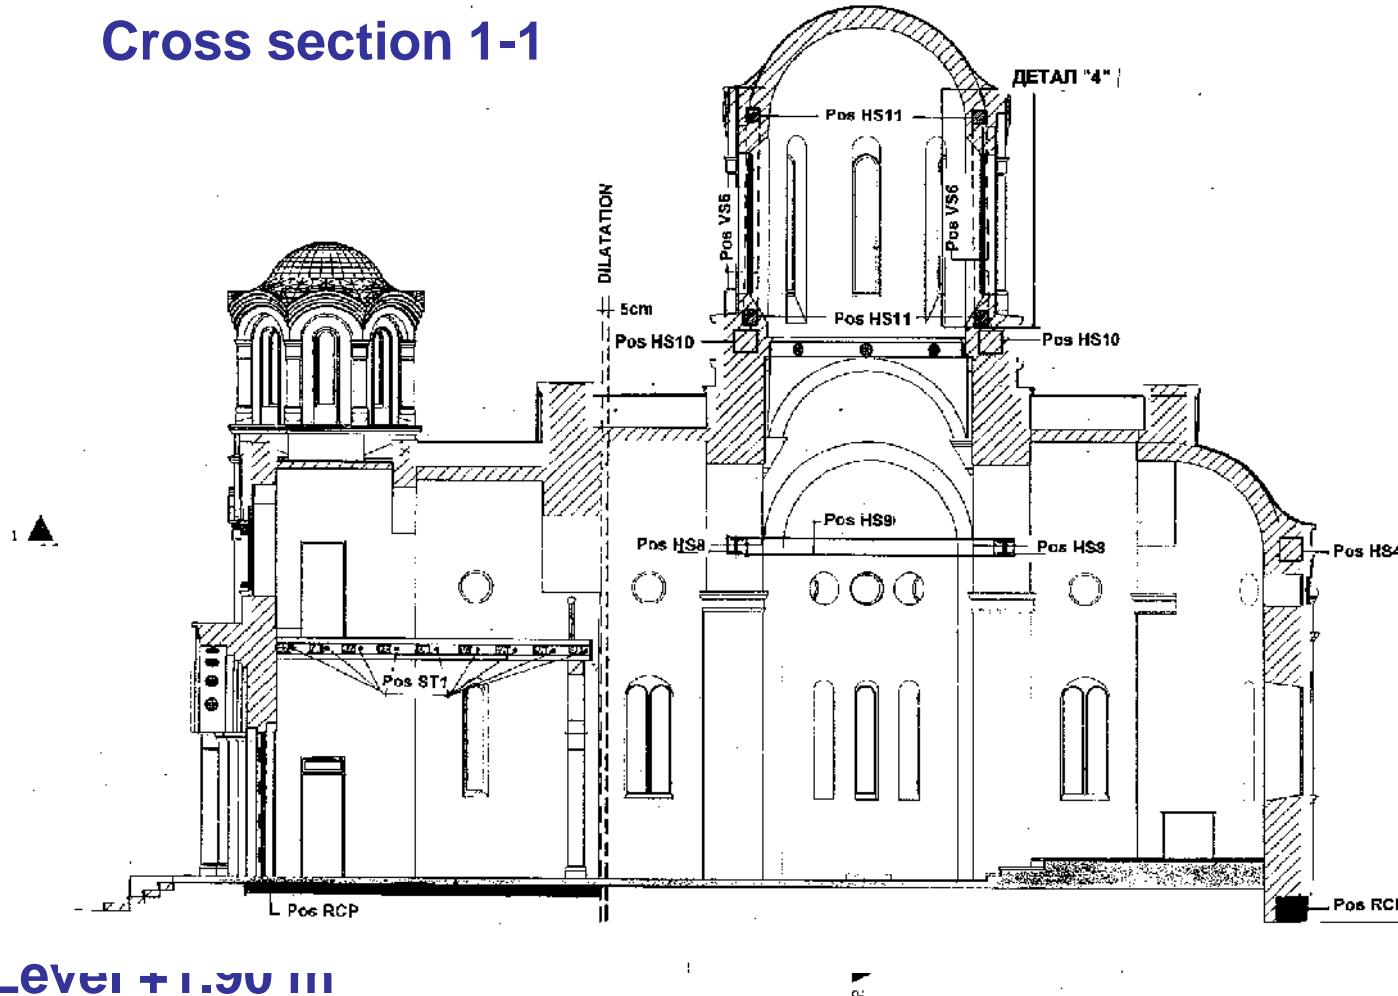
Cross section 1-1

1. Definition of design criteria (3 levels)
2. Repair and structural strengthening up to the design level of seismic safety for the **damaged existing part**
3. Complete reconstruction by maximum possible use of selected material in lime mortar plus structural strengthening elements for the design level of seismic safety for the **demolished part**
4. Dilatation (not less than 3 cm) between the structural units

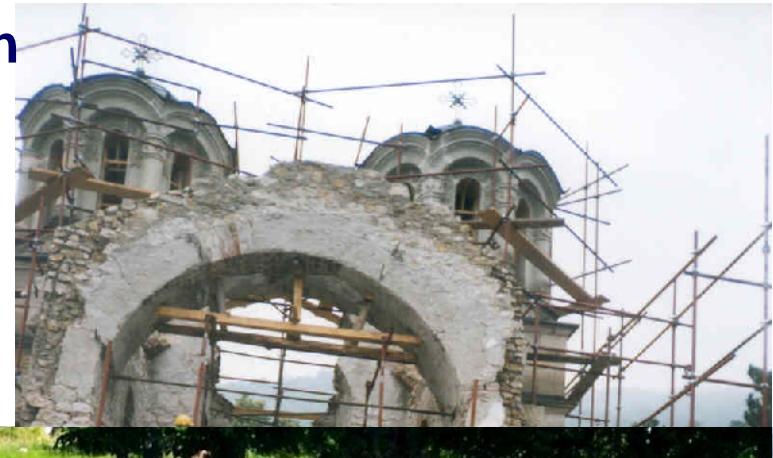
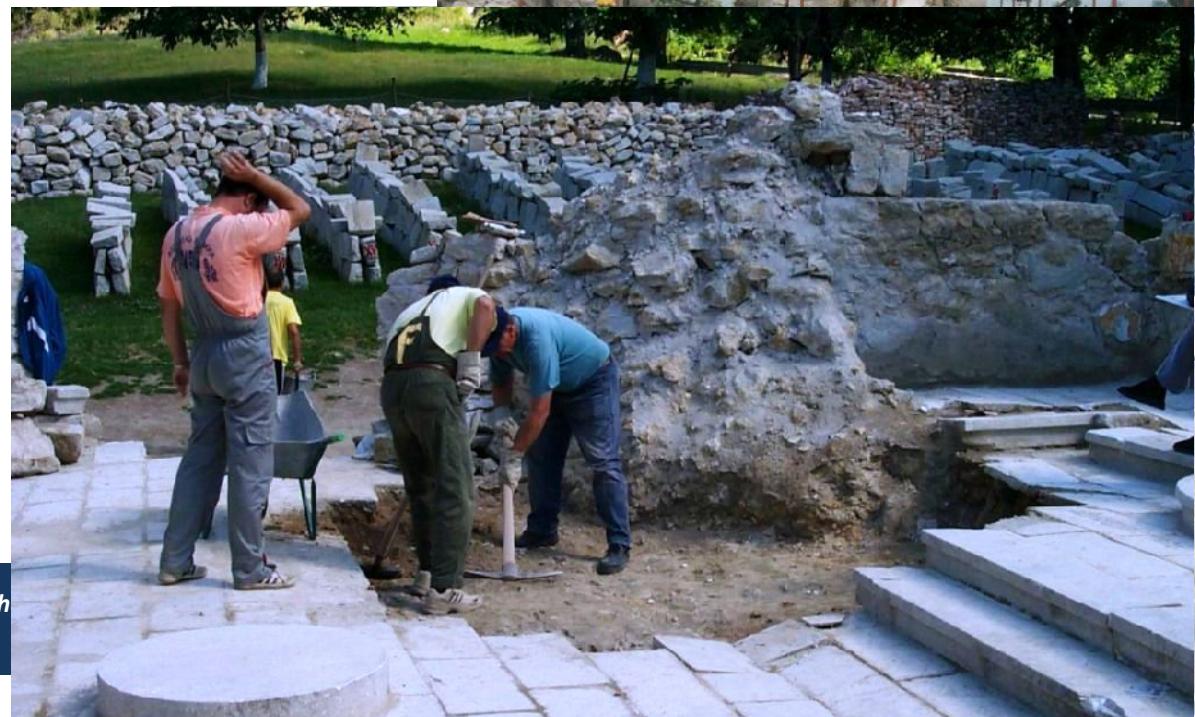
Implementation..... In reconstruction

- Providing architectural documentation
- Cleaning up and identification
- Urgent preventive measures
- Archeological investigations
- Chemical analysis
- Other investigations

- ✓ Analysis of the bearing and deformability capacity
- ✓ Nonlinear dynamic analysis for maximum expected actual earthquake effects ($a_{max}=0.24g$ for $t_p=1000$ years)
- ✓ Static and equivalent seismic 3D – FE analysis (SAP 2000)

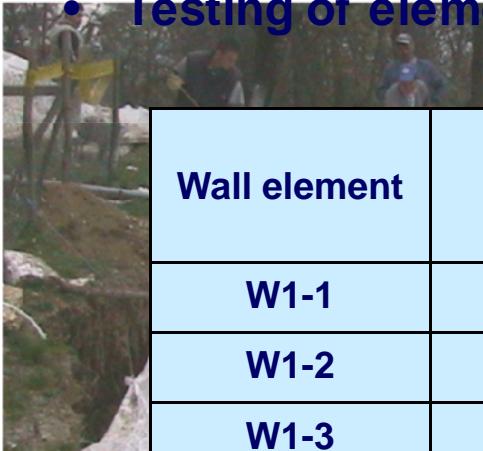
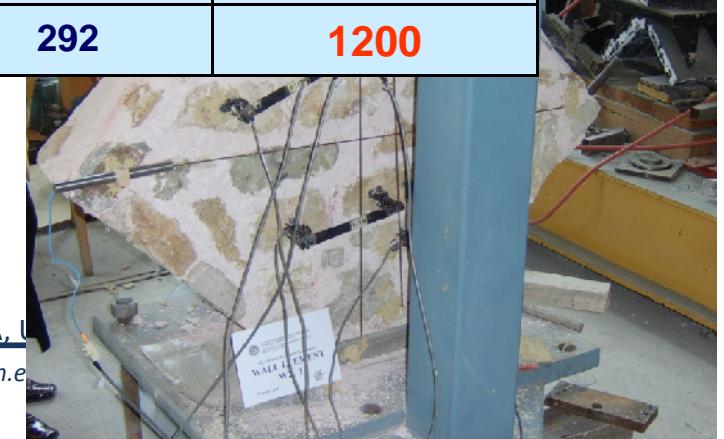
● Experimental verification of Input Design Strength of Lime

Mortar mix formula for lime mortar

M = 1 (slaked lime) : 1 (broken half-backed brick) : 1 (sand)

- Building of wall elements
- Testing of elements under axial pressure
- Testing of elements under diagonal pressure

Wall element	Age of element (months)	Cross-section A (m ²)	Maximal force P _{max} (kN)	Compressive strength σ _c = P _{max} /A (kPa)
W1-1	4	0.243	372	1530
W1-2	4	0.243	355	1460
W1-3	4	0.243	292	1200

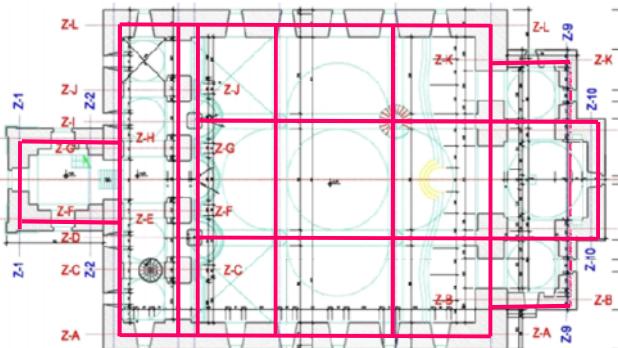
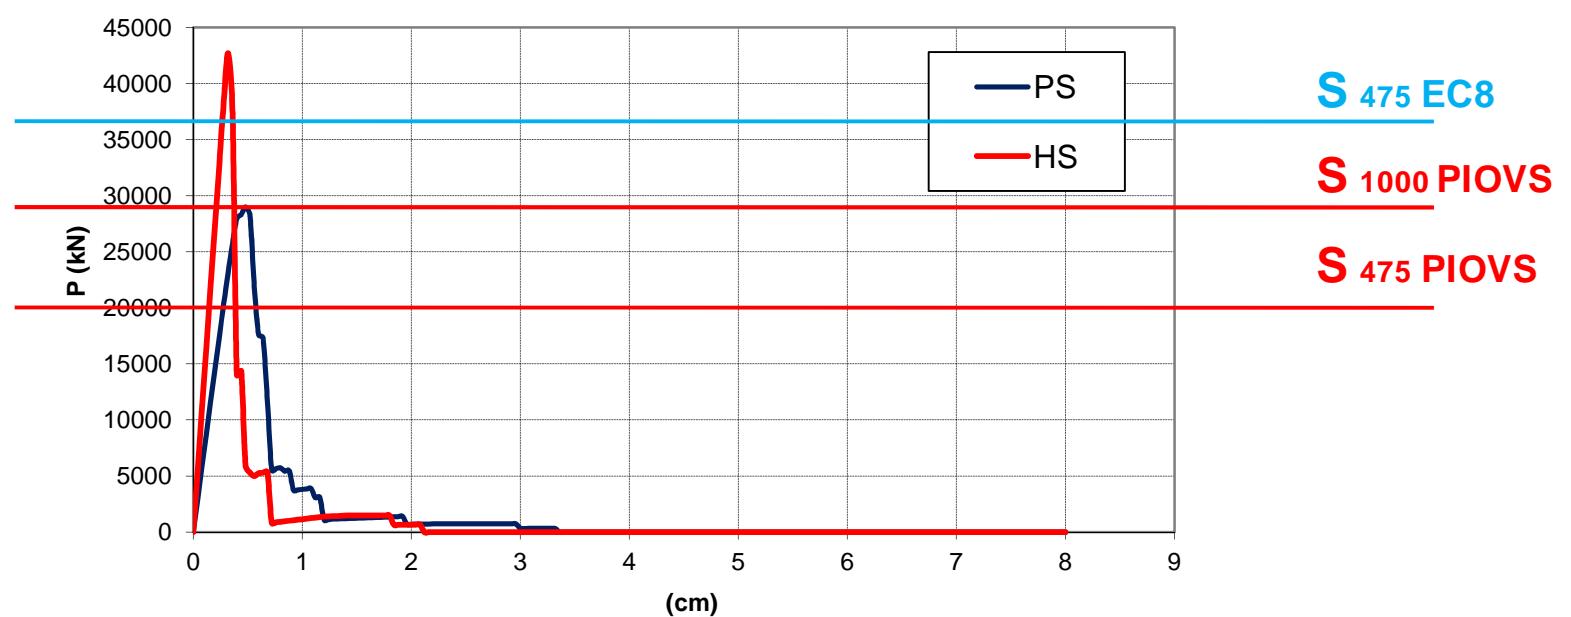
Strengthening with horizontal strengthening elements

1. Definition of design criteria
2. Full reconstruction with maximum possible use of the existing preserved material and minimum additional intervention
3. Three general states have been analyzed:
 - (1) structural system of plain stone masonry (PS);
 - (2) strengthened structure by horizontal steel element (HS)
 - (3) strengthened structure by horizontal & vertical steel strengthening elements -confined masonry (HVS)

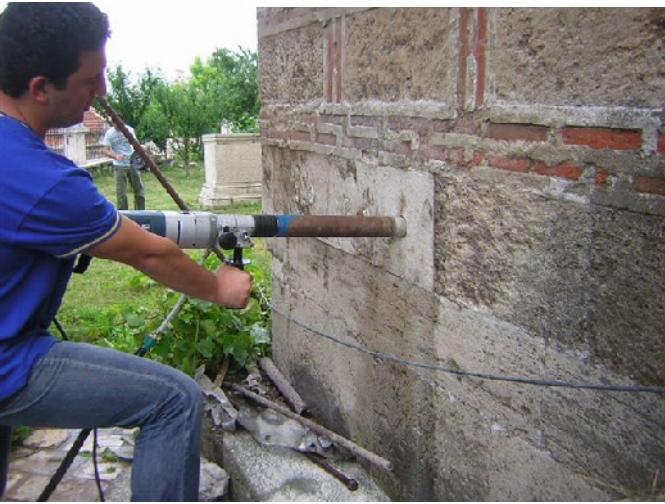
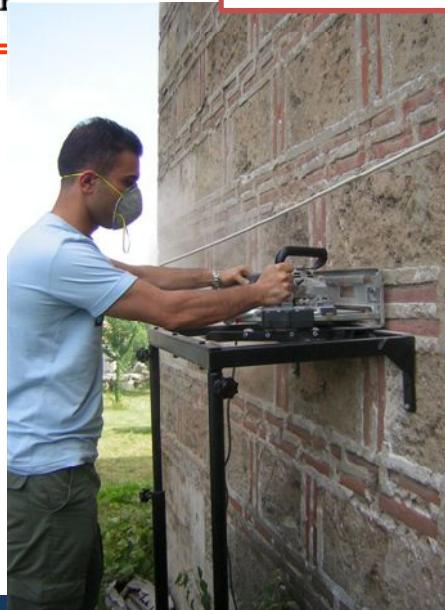
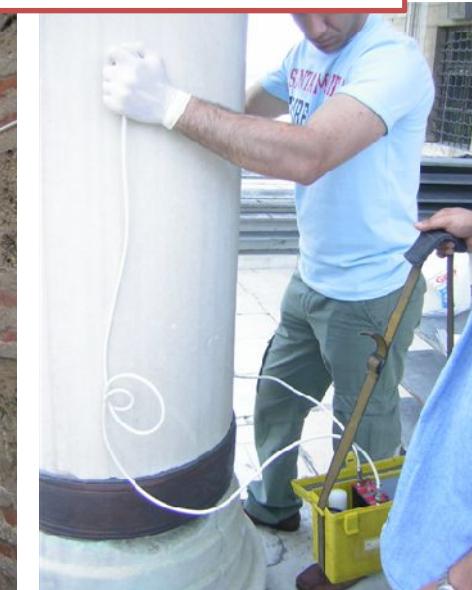
YILDIZ Technical University & IZIIS In-situ investigation

stone: $F_{\text{cube}} = 19.6 \text{ Mpa}$
 $E_{\text{stone}} = 15467 \text{ MPa}$

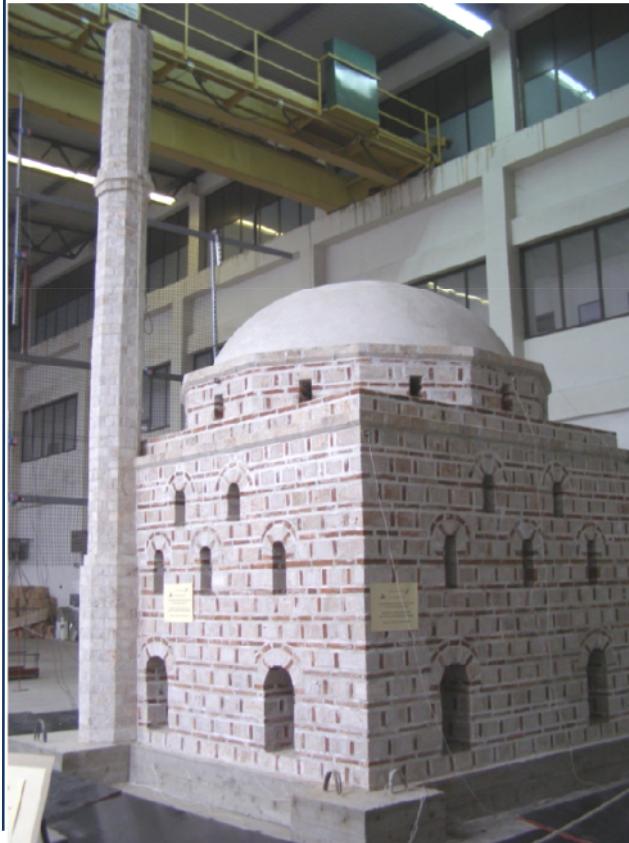
original state

Shaking table testing of the mosque model (2006-2007)

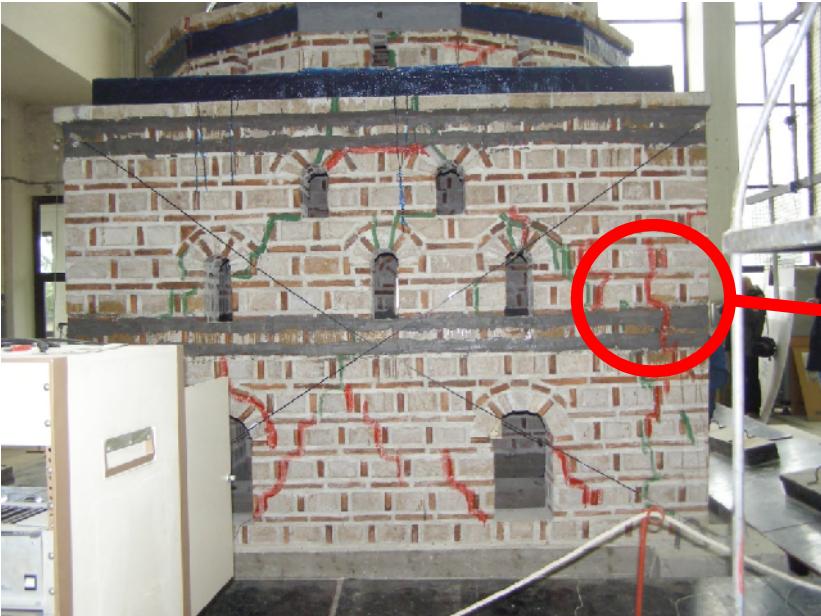
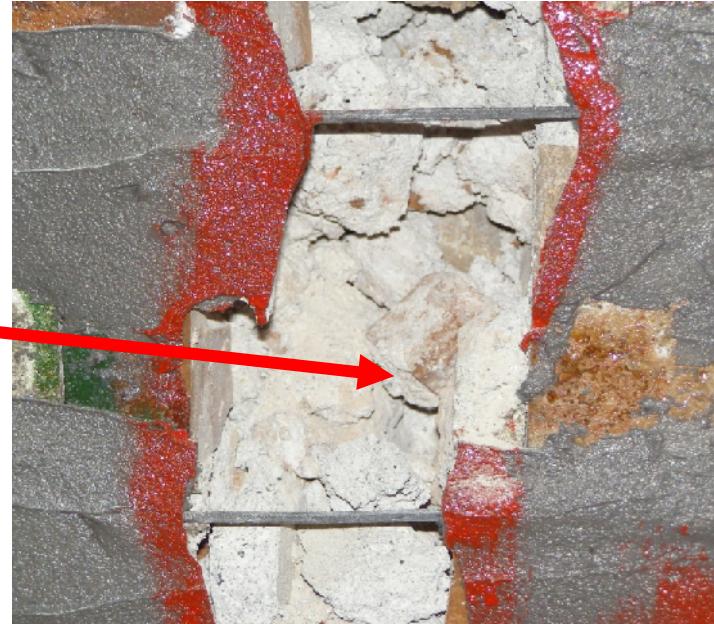
The applied strengthening was very efficient even for higher input excitation

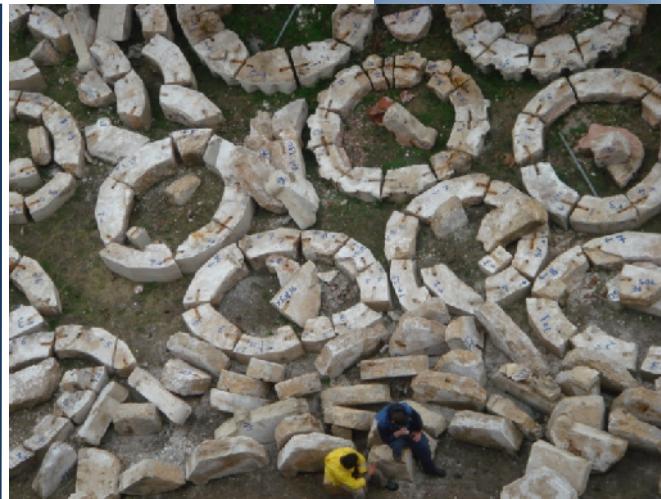
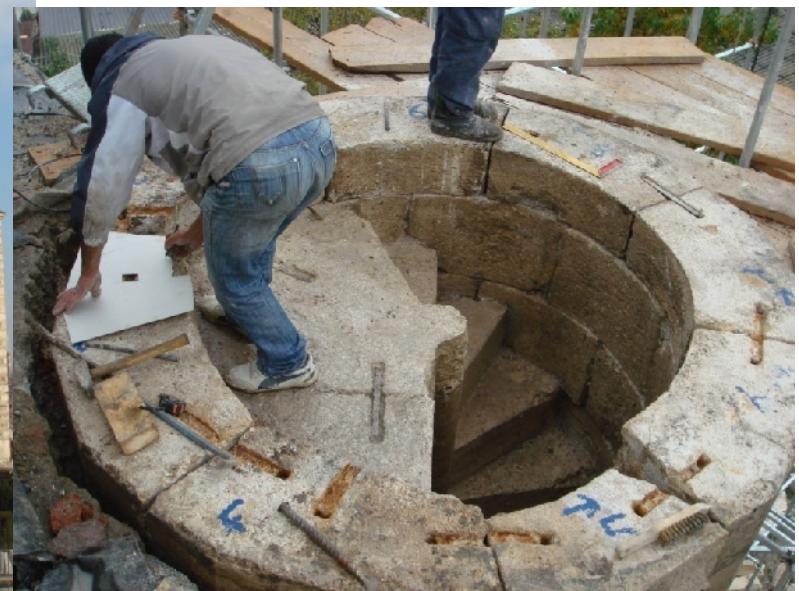
Repair of minaret

Strengthening of foundation

- ✓ Injection of the cracks by lime mortar
- ✓ Incorporation of RC wall (25cm) along the perimeter of the foundation walls
- ✓ Separation of RC wall from the existing foundation by polyurethane coating
- ✓ Placement of chrome steel in previously formed openings filled with epoxy mortar

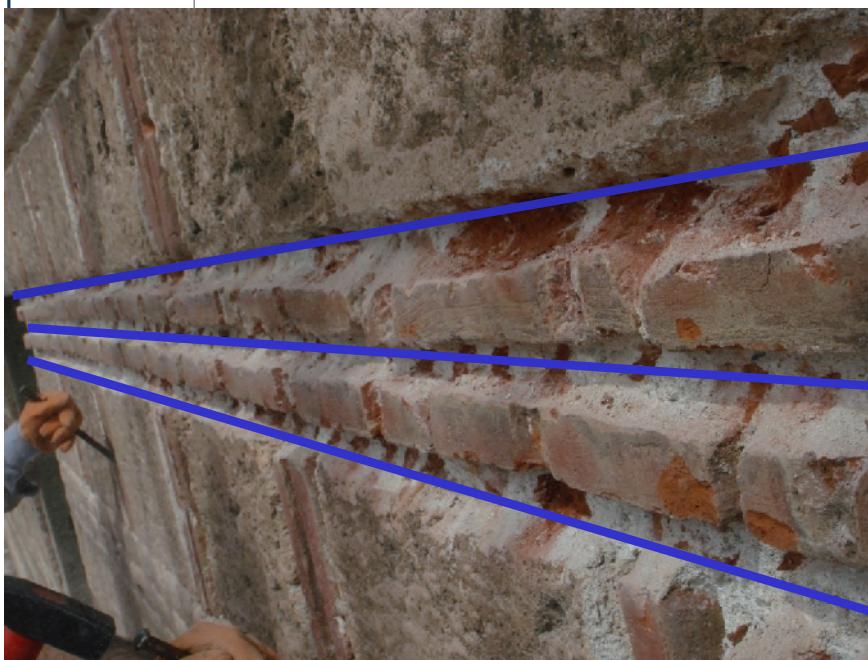
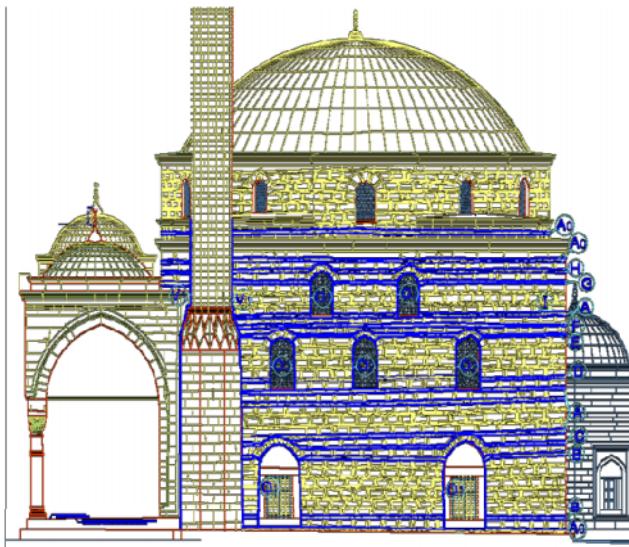
Strengthening of bearing walls

- ✓ Cleaning of all joints on the outside with a depth of max 7-8 cm
- ✓ Placement of CFRP bars ($d=1\text{cm}$) in an epoxy mortar layer
- ✓ Filling of the joints with pointing lime

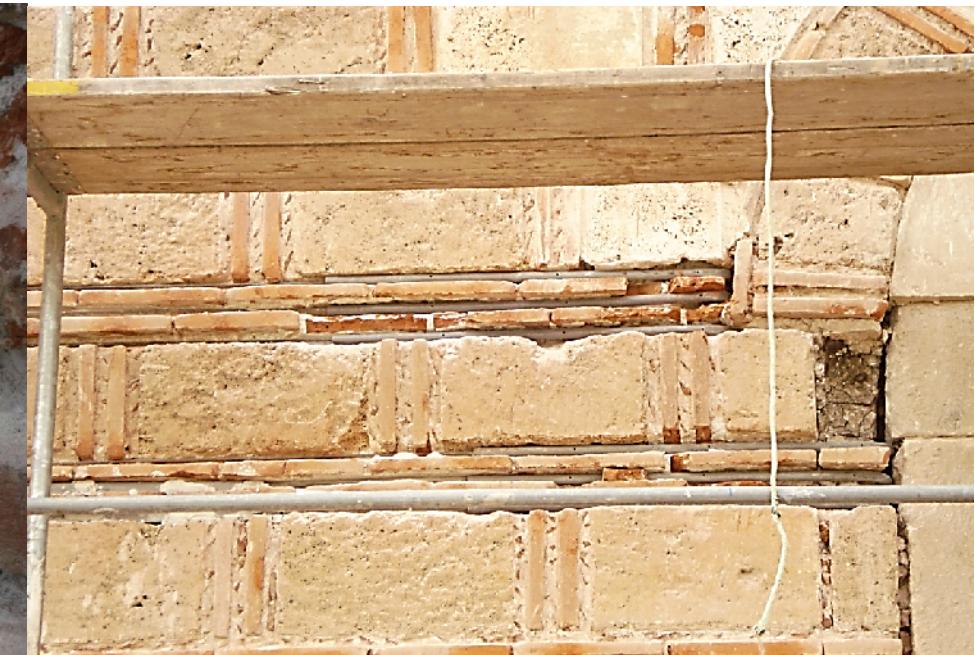
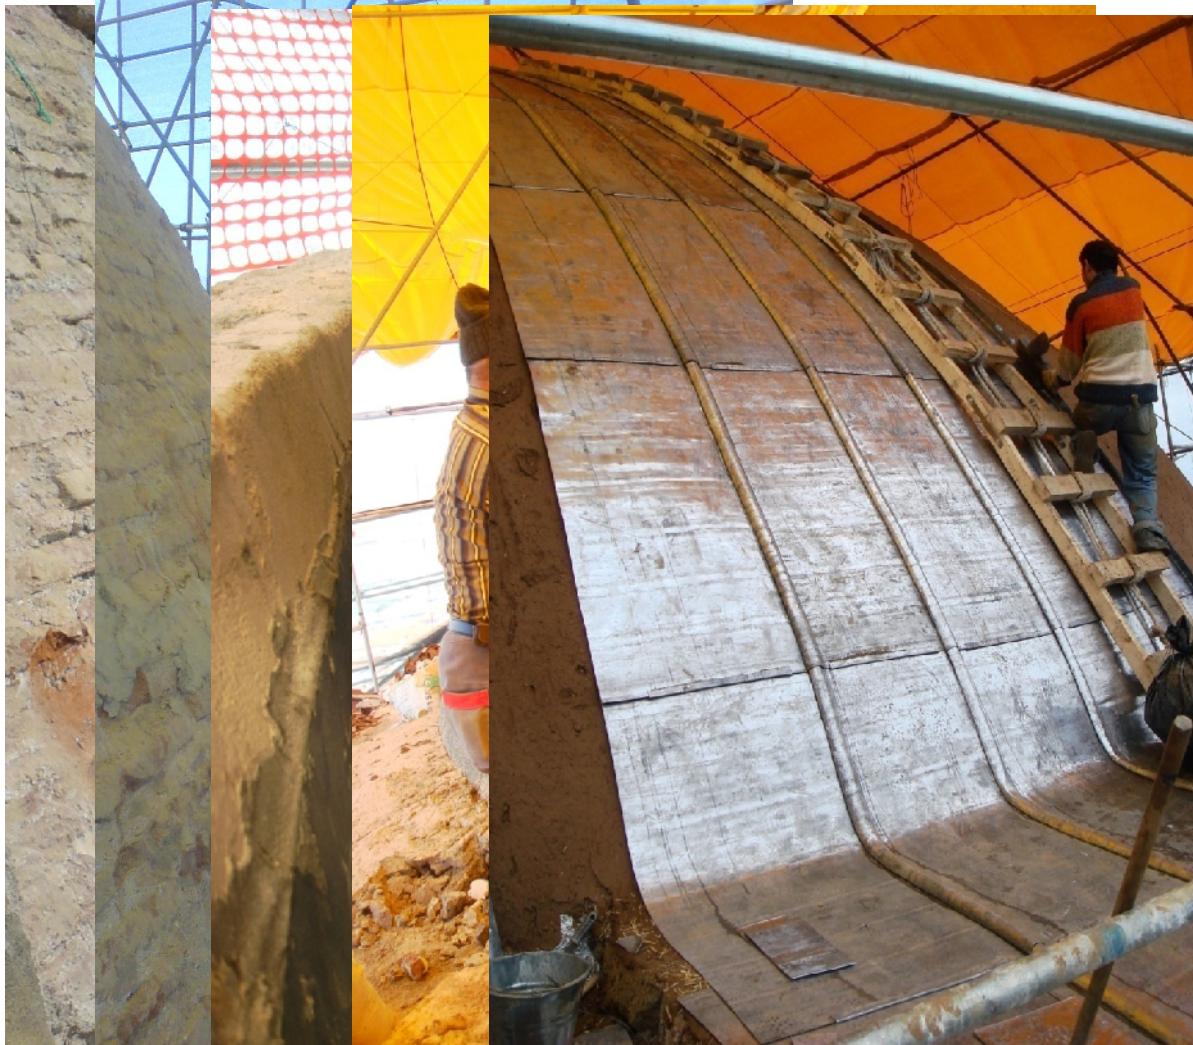
Strengthening of central dome

- ✓ Removal of the cement mortar layer
- ✓ Coating of existing rc ring with injection mixture based on lime mortar
- ✓ Placement of CFRP wrap in a layer of epoxy glue along the perimeter with the width of 3m
- ✓ Coating of entire dome with a protective layer of lime mortar
