# Shaking Table test of a pre-damaged masonry building retrofitted with a mortar-textile composite material

Dipl.- Ing. Moritz Urban, Prof. Dr.- Ing. Lothar Stempniewski

Institut für Massivbau und Baustofftechnologie – Abteilung Massivbau

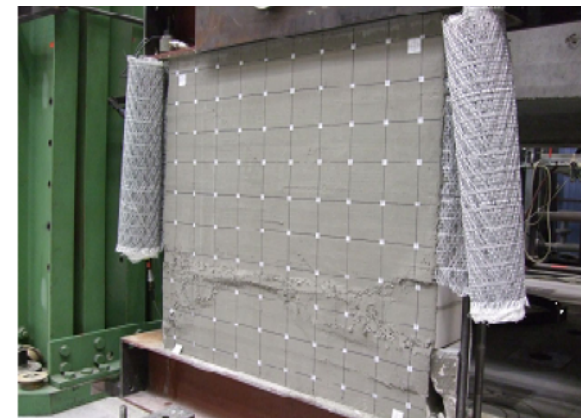
# Results - Wall Tests - In-plane

## Comparison of results:

Related to the increase of **strength**:  
92.22 kN to 237,88 kN

-> **258 % of URM**

But more important is the increase of  
the **deformation before collapse**:  
16.08 mm to 39.05 mm

-> **243 % of URM**

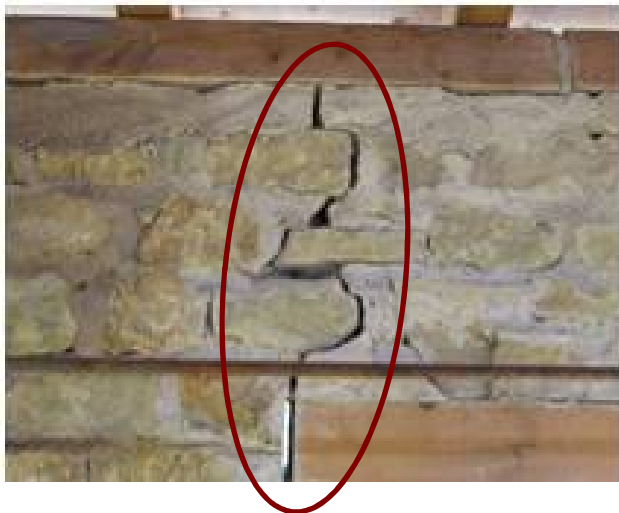
max. PGA 0.40 g

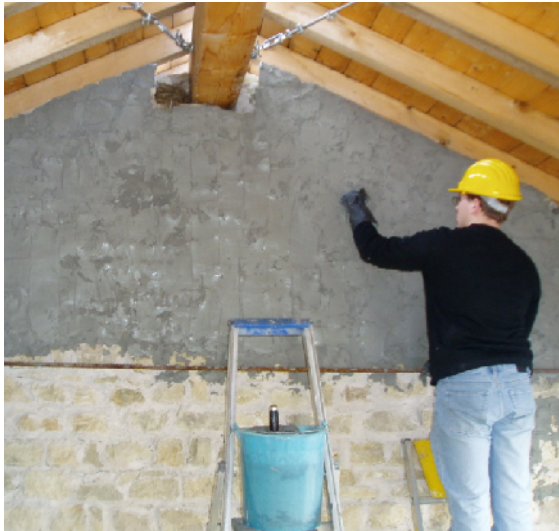
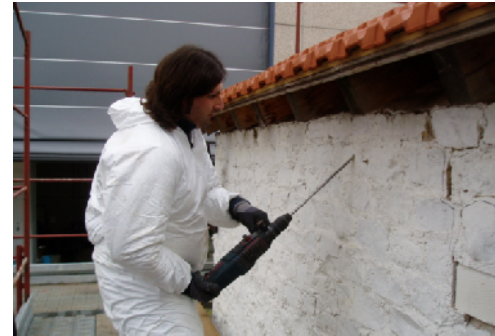
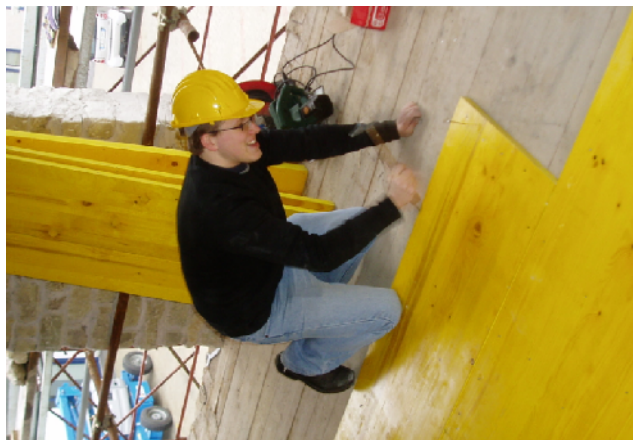
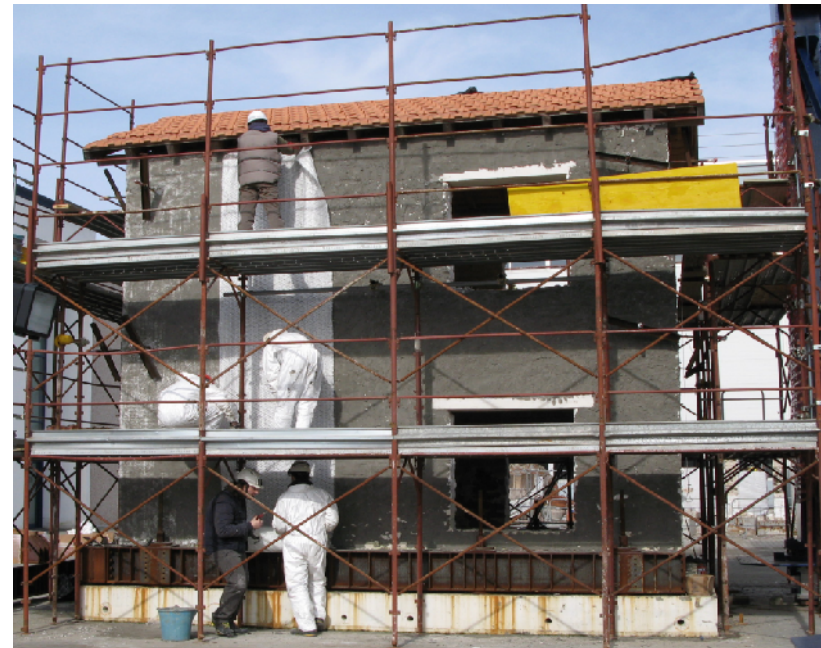
# Repairing of the URM building

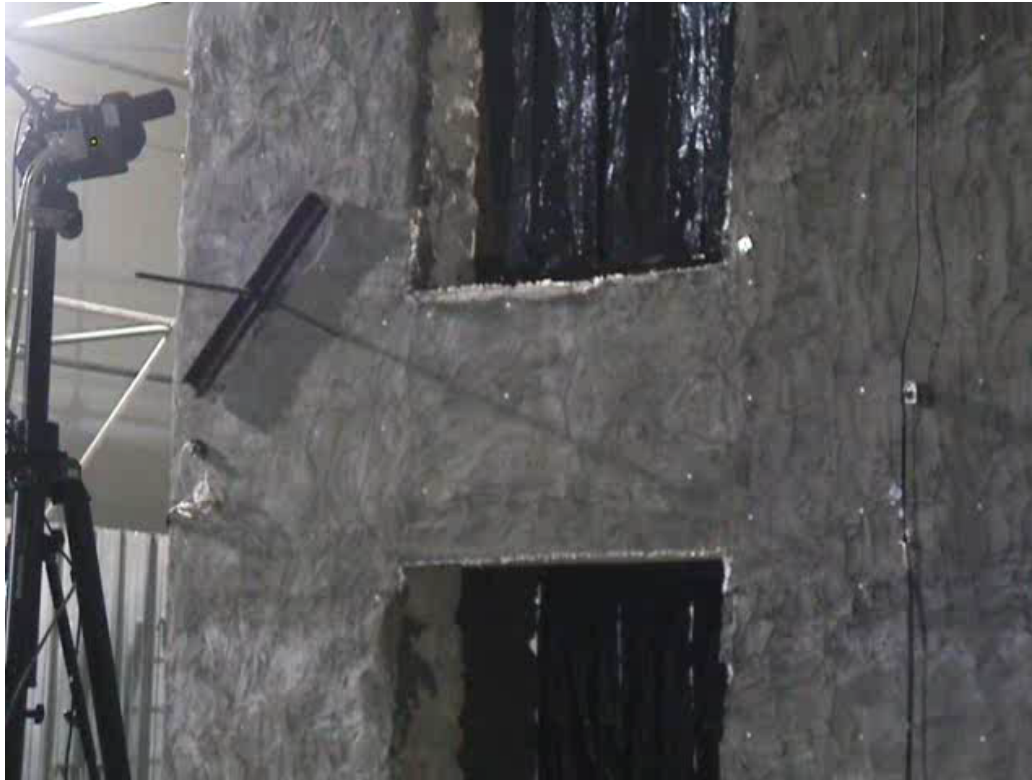
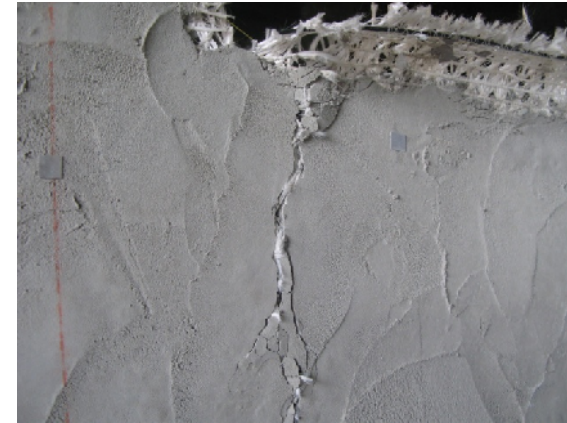
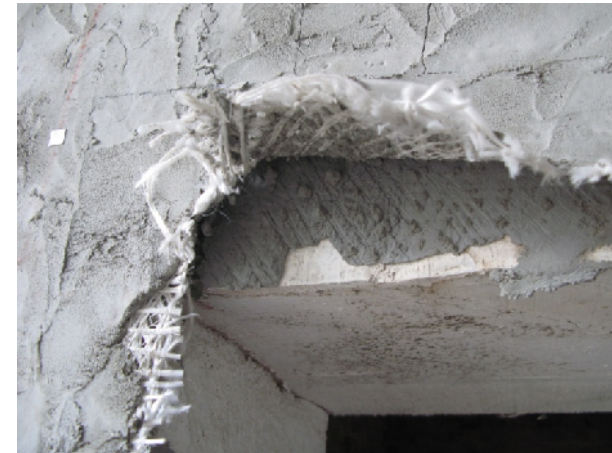
More than 0.6 g

Increase of 50 %
