The Professional Journal of the
Earthquake Engineering Research Institute

Surface Fault Rupture

Extensive surface rupture accompanied the August 17, 1999, Kocaeli earthquake. Surface rupture consisted primarily of right-lateral strike-slip displacement of up to 5.5 meters, averaging 3 to 4 meters, with localized vertical displacements of up to 2.4 meters. The fault rupture produced classic examples of strike-slip offset, including well-formed mole tracks, left-stepping *en echelon* fault traces at a variety of scales, uplift of pressure ridges, and subsidence of extensional pull-apart basins. Four distinct segments of the North Anatolian fault (NAF) ruptured during the earthquake, providing the opportunity to investigate the dynamic process of fault rupture and the physical and behavioral features of a fault that may control the propagation of fault rupture. Surface fault rupture traversed both rural and urban areas, generating excellent examples of the effects of surface fault rupture on engineered structures and, locally, the influence of some engineered structures on the surface expression of fault rupture.

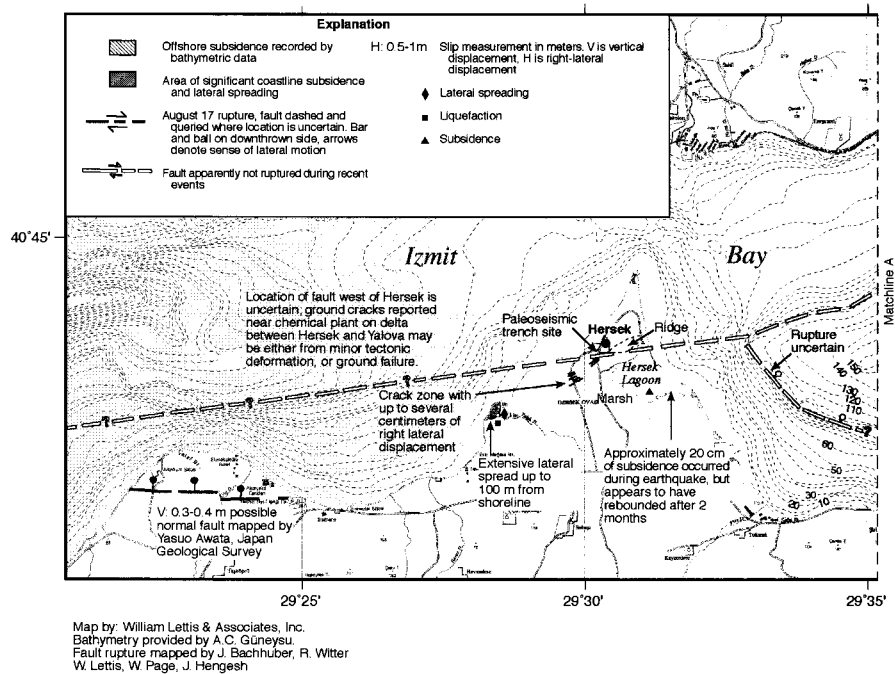
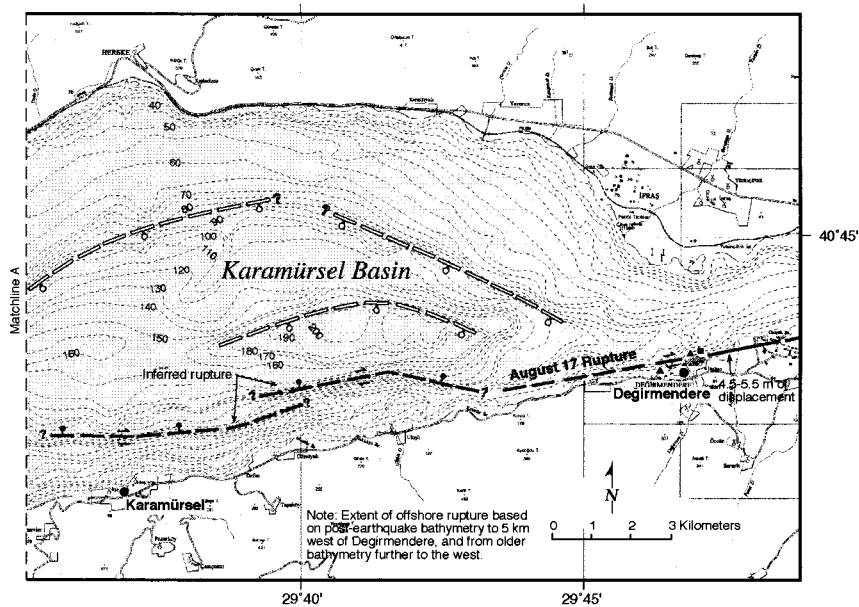
Figure 2.5a, b. Karamürsel stepover basin and western extent of rupture along the Gölçük fault segment.

The Karamürsel basin is about 5 km wide and 16 to 19 km long (table 2.2, figure 2.5a, b). Based on interpretation of bathymetric data, the basin is formed by a right-stepping overlap of the Yalova and Gölcük fault segments. The basin area is about 80 to 95 km². The basin appears to have arrested up to 5.5 meters of westward propagating right-lateral displacement on the Gölcük segment (observed on the Gölcük Naval Base). Displacement along the Gölcük segment extending offshore along the southern margin of the Karamürsel basin is inferred, based on the presence of extensive lateral spreading and offshore subsidence at various locations along the coastline, in particular near the towns of Degirmendere (chapter 4, figure 4.9) and Halidere.

Field reconnaissance on the Hersek Peninsula clearly shows that significant fault rupture did not extend onshore along the trend of the Gölcük segment or along the Yalova segment bordering the northern margin of the Karamürsel basin (figures 2.5a, b). There was no evidence of significant rupture along mapped older fault traces at the mountain front south of the Hersek Peninsula on trend with a westward projection of the Gölcük fault segment. On the Hersek Peninsula, the Yalova fault segment is geomorphically well expressed by linear depressions, a sag pond, a linear ridge, tonal lineaments, and truncated or offset late Pleistocene beach ridges. The geometry and location of the Hersek Lagoon is consistent with westward growth of the Karamürsel pull-apart basin and encroachment onto the Hersek Peninsula. Paleoseismic trenches excavated during our reconnaissance mapping across the north margin of the Hersek Lagoon documents the presence of the Yalova fault and the absence of rupture during the August 17 earthquake. No ground rupture was observed in the area following the earthquake, although Hersek Lagoon reportedly subsided by about 20 to 30 cm.

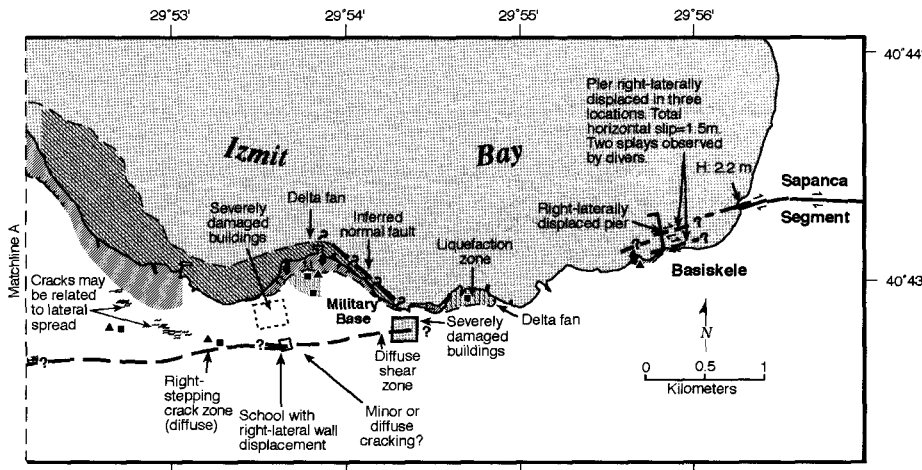
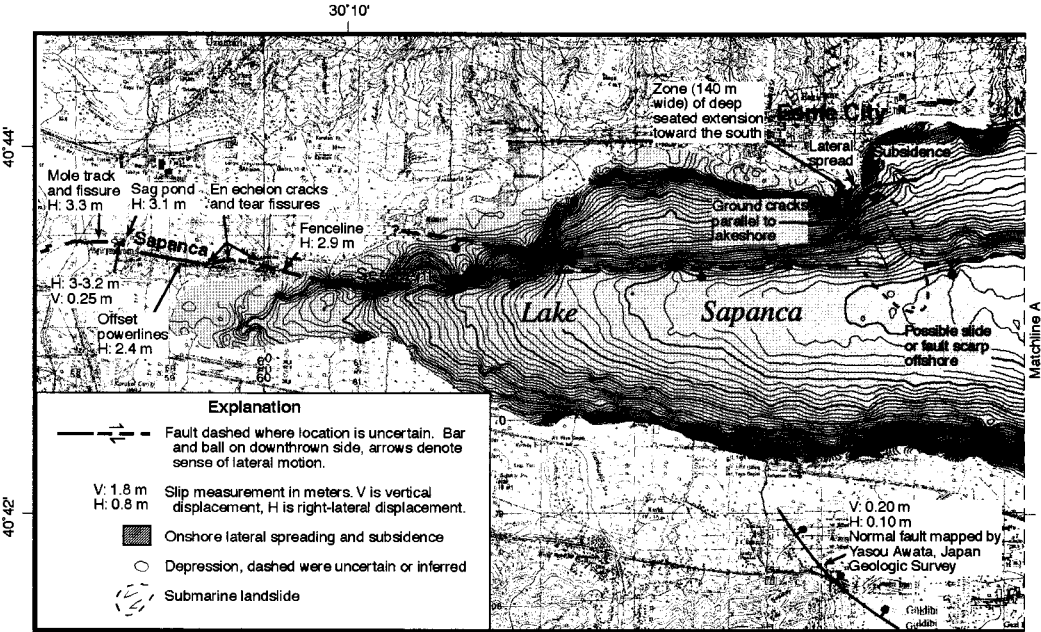
Figure 2.6a, b. Gölçük stepover basin and central and eastern part of Gölçük fault segments.

The August 17 earthquake appears to have nucleated within the Gölcük pull-apart basin. The earthquake epicenter generally plots within or directly north of the basin (plate 1). Rupture propagated bilaterally to the west along the Gölcük fault segment and to the east along the Sapanca, Sakarya, and Karadere fault segments (Pinar et al. 1999). Right slip of 4.5 to 5.5 meters occurred on the Gölcük segment at the western end of the basin, and 3 meters occurred on the Sapanca segment at the eastern end of the basin. Slip on the Sapanca segment progressively decreased into and along the southern margin of the Gölcük pull-apart basin, producing minor ground cracking directly east of Gölcük (figures 2.6a and 2.6b).

The earthquake also produced significant tectonic subsidence within the basin. Vertical displacement of up to 2.4 meters occurred on a continuous normal fault along the southwestern margin of the basin (figures 2.6a, b). Additional down-to-the-east normal faulting appears to have occurred along the coast directly east of Gölcük. The normal faulting produced global subsidence of the basin and locally caused submergence of the coastline and widespread inundation of the

The Gölcük basin is about 1 to 2 km wide and up to 6 km long (table 2.2, figure 2.6a, b). The basin is formed by a right stepover or right separation between the Gölcük and Sapanca segments. Based on interpretation of bathymetric data, the Gölcük segment may or may not extend along the northern margin of the basin; thus, we cannot determine the amount of overlap, if any, between the two fault segments. The basin area is about 6 to 12 km².

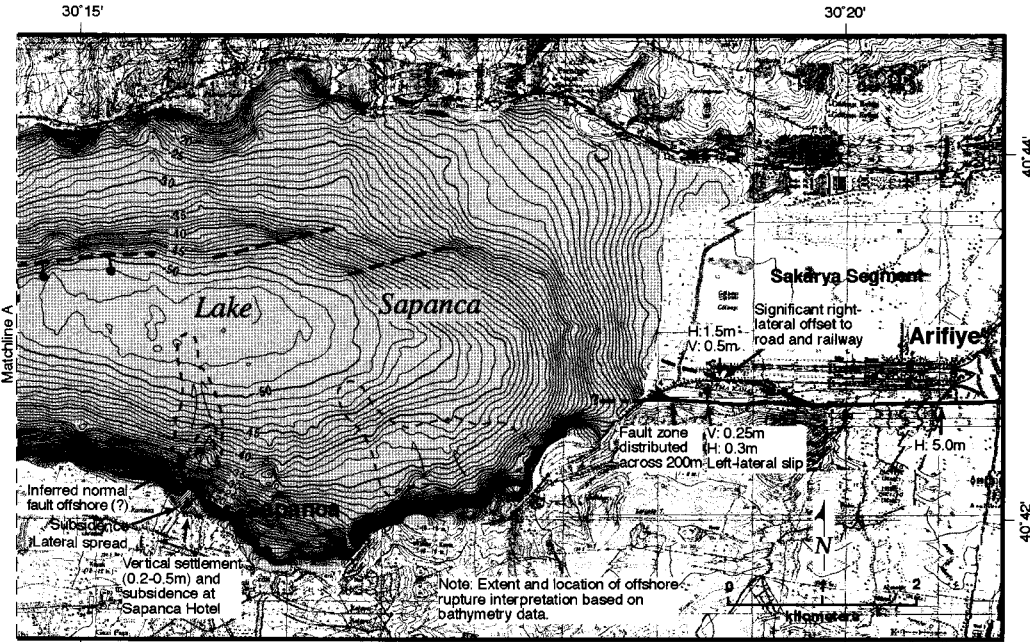
Figure 2.7a, b. Lake Sapanca stepover basin and portions of the Sapanca and Sakarya fault segments.

The Sapanca basin is about 1 to 2 km wide and up to 7 km long (table 2.2, figure 2.7a, b). Based on interpretation of bathymetric data, the basin is formed by a right stepover or separation between the Sapanca and Sakarya fault segments. The Sapanca fault segment defines the northern margin of the basin and extends almost entirely across Lake Sapanca to the eastern margin of the lake. The fault is expressed by a prominent scarp on the floor of Lake Sapanca. The Sakarya segment appears to die out at the eastern margin of the basin and is not expressed by bathymetry in Lake Sapanca. Rather, the southern margin of the Sapanca basin appears to be defined by a series of northwest-trending normal faults. In addition, the Mudurnu Valley segment of the southern branch of the NAF intersects the Sapanca segment at Lake Sapanca (plate 1). This intersection forms a larger 5-km-wide stepover and right-releasing bend in the southern branch of the NAF. Rupture during the M_w7.0 Mudurnu Valley earthquake of July 22, 1967, was arrested by this larger stepover at Lake Sapanca. Reported ground fissures observed near Sapanca and Esme following the 1967 Mudurnu Valley earthquake (Berg 1967) are considered to be related to large-scale lateral spread or liquefaction rather than primary tectonic rupture. Similar continuous cracks developed in these areas from lateral spread failure during the August 17 earthquake. Hence, surface fault rupture from the 1967 Mudurnu Valley earthquake is shown to terminate southeast of Sapanca on plate 1.

Rupture during the earthquake broke through the Sapanca stepover between the Sapanca and Sakarya fault segments. About 3 meters of right slip was observed on both the Sapanca and Sakarya segments near the lake. Right slip began to die out within 1 km of the shoreline as each fault entered the basin. In particular, right slip decreased from 3.5 meters to about 1 meter on the Sakarya segment near the eastern margin of Lake Sapanca (figures 2.7a, b). The pull-apart basin area is about 7 to 14 km². The earthquake also produced normal offset of about 30 cm on one normal fault south of the pull-apart basin, southwest of the town of Sapanca (Y. Awata, personal communication, 1999). Extensive subsidence also occurred along the southern coast of Lake Sapanca near the town of Sapanca. A notable occurrence of liquefaction and lateral spreading occurred near Hotel Sapanca, as described in chapter 6. An offshore scarp 2 to 3 meters high near the hotel may be the margin of a lateral spread or, equally likely, may be displacement on a normal fault along the lake margin.

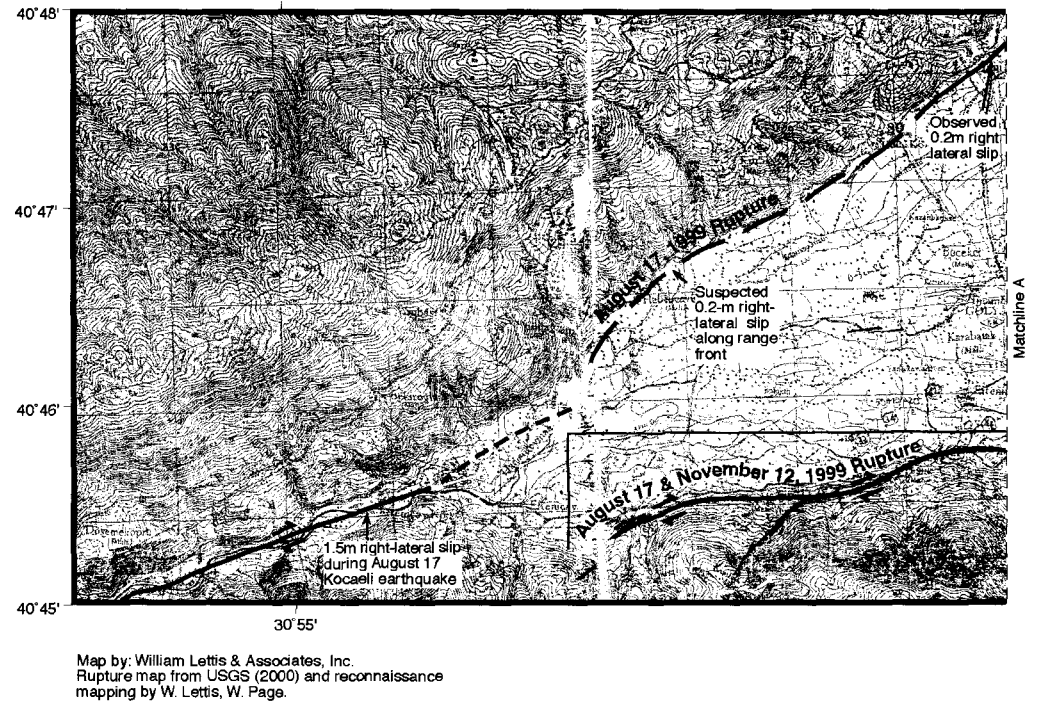
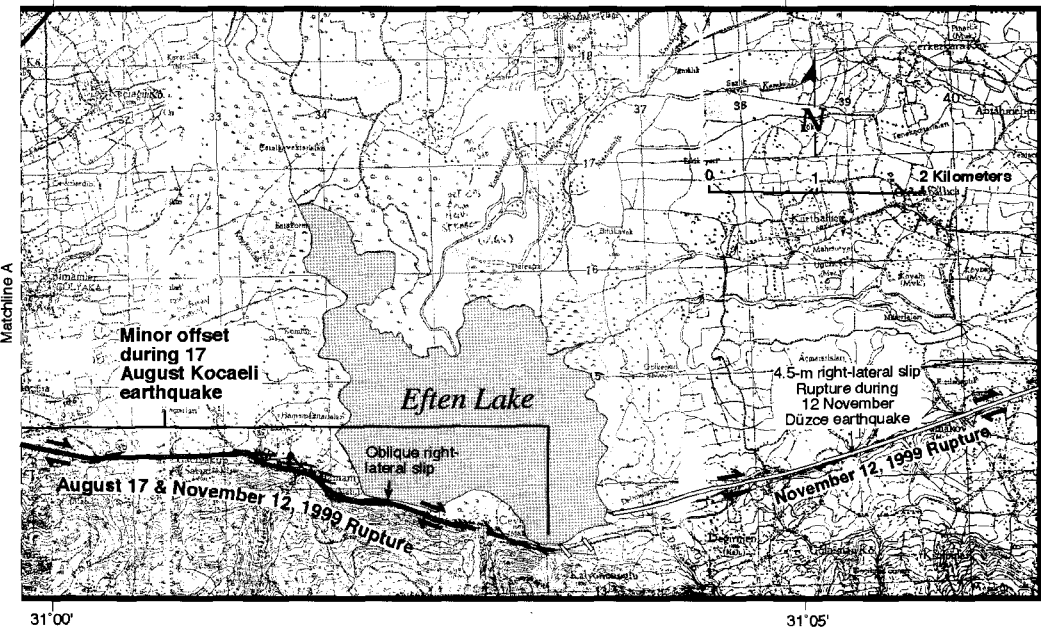
Figure 2.8a, b. Eften Lake right-stepping double pull-apart at eastern termination of the August 17, 1999, Kocaeli earthquake rupture. A small fault at the southern margin of the basin experienced slight displacement during the Kocaeli and November 12, 1999, Düzce earthquakes. The Düzce earthquake initiated in or near the Eften Lake pull-apart, and ruptured eastward along the Düzce fault.

The Karadere segment trends about 19° more northerly than the Sakarya segment and lies at or near the base of a steep range front. It is defined by linear drainages, fault scarps, and tonal lineaments. To the east, the segment forms a 4- to 6-km-wide double right-releasing stepover to the Düzce segment across the Eften Lake pull-apart basin (figure 2.8a, b).

The Eften Lake stepover appears to be a double-releasing stepover between the Karadere fault segment and the Düzce fault segment, with a short (6 to 8 km long) intervening fault segment (figure 2.8a, b). Each stepover is about 2 km wide, for a total stepover width of about 4 km. The total stepover length is about 9 km, indicating a stepover area of about 18 to 36 km².

The Eften Lake stepover arrested rupture during both the August 17 and November 12 earthquakes. Rupture of 1 to 1.5 meters occurred on the Karadere segment during the August 17 earthquake. This rupture progressively died out into the stepover basin, producing minor (up to 20 cm) right slip both on the intervening 6- to 8-km-long fault segment (USGS 2000) and along the southeast-facing rangefront bordering the northwestern margin of the basin (figure 2.8a, b).

The November 12 earthquake nucleated within or near the eastern margin of the stepover and produced unilateral east-propagating right-slip rupture of 4 to 4.5 meters on the Düzce segment. The earthquake also produced significant vertical slip of up to 4 meters along the southern margin of the basin. Slip occurred on an apparent normal fault connecting the Düzce fault with the intervening 6- to 8-km-long fault segment. Minor right-lateral slip of 20 to 30 cm also occurred on the intervening fault segment; thus, the intervening fault segment experienced minor rupture during both the August 17 and November 12 earthquakes.

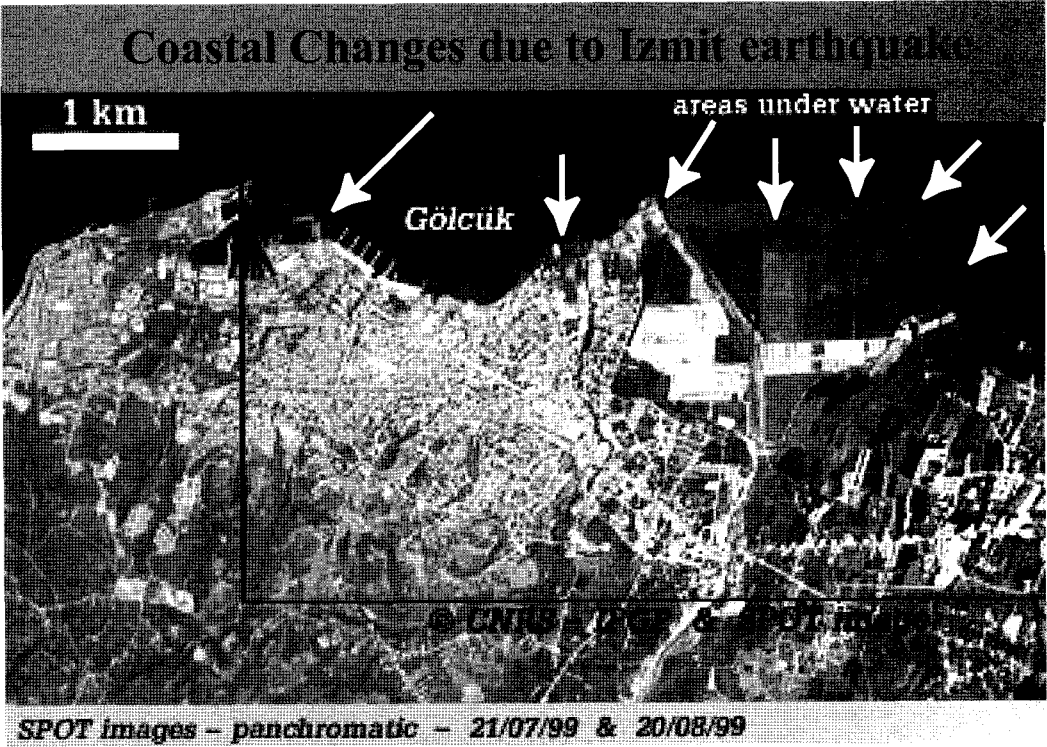
Figure 2.9. SPOT satellite image with enhanced blue shading delineating areas of flooding and subsidence within a tectonically down-dropped block along the south margin of Izmit Bay at Gölcük.

northeastern part of Gölcük city (figures 2.9, 2.10). Evaluation of pre- and post-earthquake bathymetry shows that several near-shore areas also subsided from 2 to 6 meters (plate 1, figure 2.6).

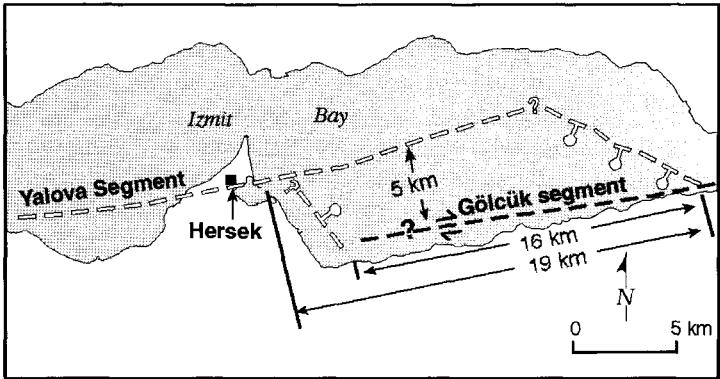
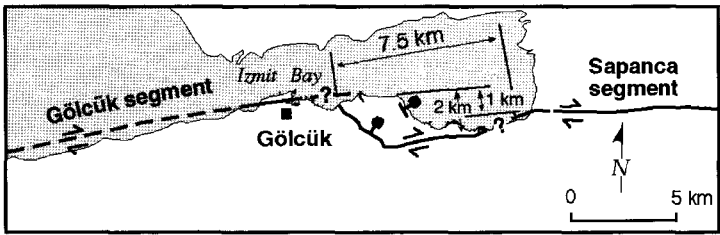
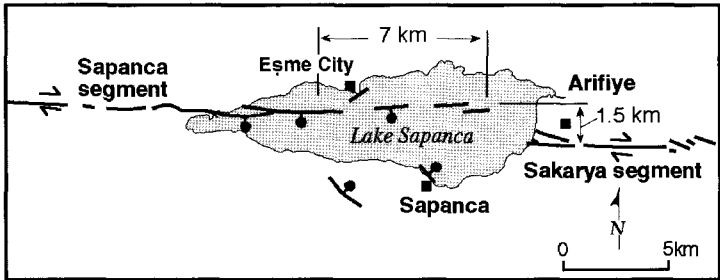
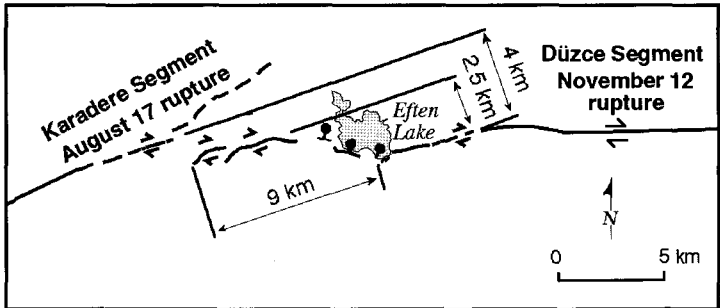
Four pull-apart basins were involved in the August 17 earthquake. These basins are shown at the same scale in figure 2.11 for comparison. The basins significantly influenced the distribution and length of fault rupture and, thus, provided broad controls on the size of earthquake magnitude. The Karamürsel stepover, a right-stepping overlap with a basin area of about 95 km², arrested up to 5.5 meters of rupture. The earthquake appears to have nucleated within the Gölcük pull-apart basin, producing bilateral rupture to the east and west. The stepover is a right-releasing separation between fault traces with a basin area of about 6 to 12 km². The Sapanca stepover is a right stepover with little or no fault overlap or separation. Fault rupture of about 3 meters broke through the basin. The basin area is about 7 to 14 km². The Eften Lake stepover is a double releasing right stepover with little or no fault overlap. The basin area is about 18 to 20 km². The basin arrested 1 to 1.5 meters of right slip during the earthquake. The November 12 earthquake appears to have nucleated within or near the basin, producing unilateral east-propagating rupture away from the basin.

Figure 2.11. Comparison of pull-apart basins along the August 17, 1999, Kocaeli earthquake rupture.

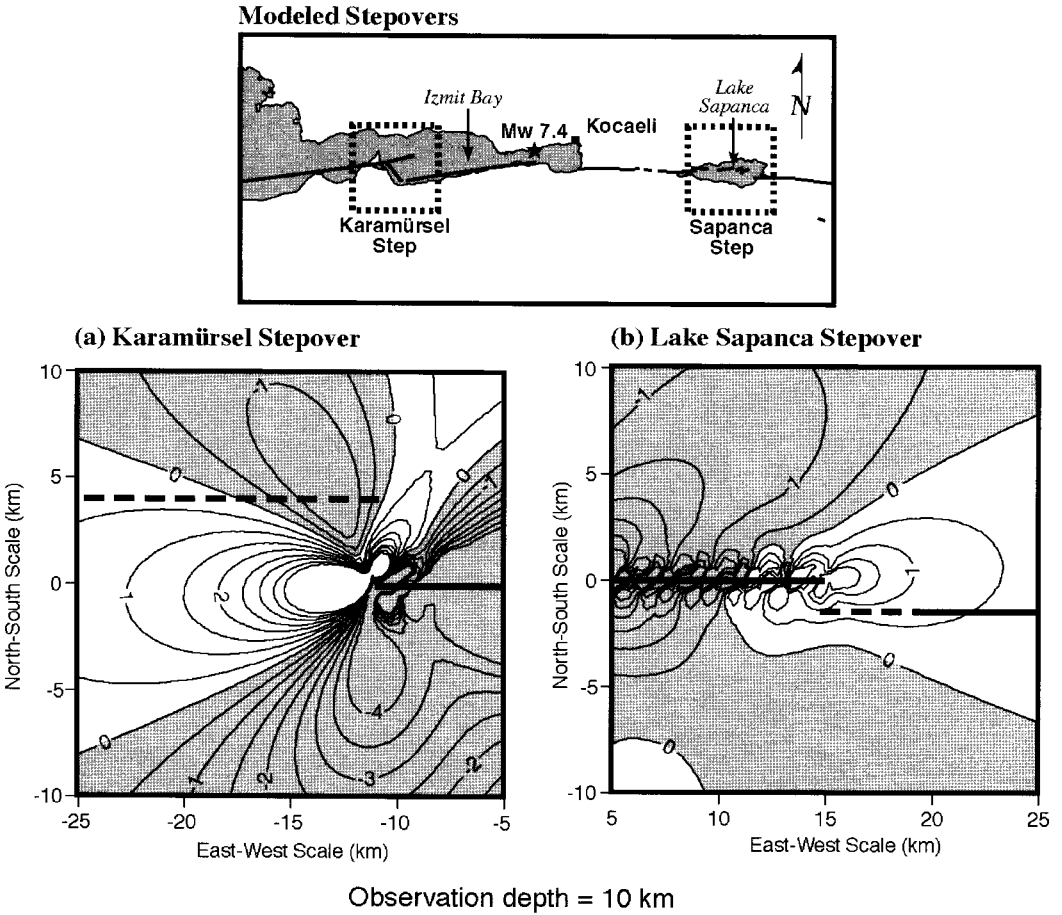
Preliminary modeling illustrates the fault stepover geometries that are most favorable for continued fault rupture and which others tend to inhibit fault rupture. Analysis focused on two pull-apart basins in the region of the August 17 rupture: the Sapanca stepover basin and the Karamürsel stepover basin. These basins were chosen as endmember cases; the Sapanca pull-apart did not arrest fault rupture, while the Karamürsel stepover did appear to halt the rupture. Preliminary results suggest that the stress perturbation associated with up to 3 meters of slip along the Sapanca segment was sufficient to increase stress on the adjacent Sakarya segment and allow rupture to propagate eastward across the intervening pull-apart basin (figure 2.12). In addition, the model of the Karamürsel stepover indicates that the observed 4 to 5 meters of slip on the Gölcük segment did not appear to stress the Yalova segment enough to cause rupture. The preliminary results of the model suggest that fault stepovers with widths greater than 4 to 5 km can arrest up to 5 meters of fault rupture propagation, but that 3 meters of rupture can propagate across a 1- to 2-km-wide stepover. This model agrees with the field observations that the 5-km-wide Karamürsel stepover terminated further westward rupture of the Kocaeli earthquake.

Figure 2.12. Model outputs for (a) Karamürsel and (b) Lake Sapanca fault steepers. (a) Contours of change in Coulomb stress (MPa) on east-west trending strike-slip faults caused by slip on the Gölcük fault segment. Approximate trace of the Yalova segment shown by dashed line. Fault rupture on the Gölcük segment was arrested at this steper and did not activate the Yalova segment. (b) Contours of change in Coulomb stress (MPa) on east-west trending strike-slip faults caused by slip on the Sapanca fault segment. Trace of the Sakarya segment shown by solid line, dashed where fault rupture is uncertain. Slip on Sapanca segment ruptured across this steper and continued onto Sakarya segment.
