## Failures of masonry and concrete buildings during the March 8, 2010 Kovancılar and Palu (Elazığ) Earthquakes in Turkey

Zekai Celep<sup>a</sup>, Ayfer Erken<sup>b</sup>, Beyza Taskin<sup>a</sup>, Alper Ilki<sup>c,\*</sup>

<sup>a</sup> Istanbul Technical University, Civil Engineering Faculty, Structural Engineering Department, 34469 Istanbul, Turkey

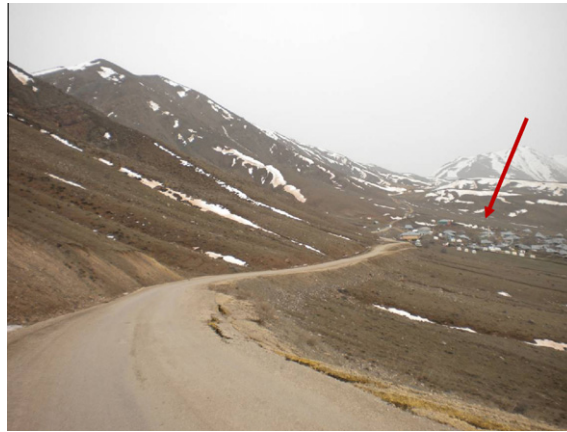
**Fig. 10.** Location of Yukarı Demirci Village.

the Murat River and on the natural slopes along the southern parts of the Murat Mountain, where Okçular, Yukarı Demirci and Kayalık villages are located (Figs. 10 and 11). The villages, where heavy damages occurred, are located on soil layers consisting of clay–sand–gravel mixture. Rubbles also cover the slope of the hills [18]. Okçular, Yukarı Demirci and Kayalık Villages are settled on such slopes. Fig. 10 shows the Yukarı Demirci Village located on the slopes of the neighboring mountain.

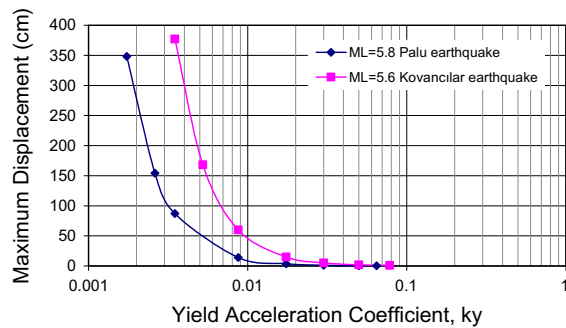
Fig. 14 illustrates the relationship between the coefficient of the yield acceleration  $k_y$  and the maximum displacement  $d_{max}$ , whereas Fig. 15 shows the variation of  $d_{max}$  with respect to  $a_{max}/a_y$  ratio. As it is seen, the maximum displacement decreases as the yield acceleration increases. As the inclinations of slopes increase, development of large displacements is observed. This kind of failures are observed in the Murat River valley on the high slopes of the Murat Mountain and on the high

**Fig. 14.** The relationship between the yield acceleration coefficient and the expected maximum displacement.

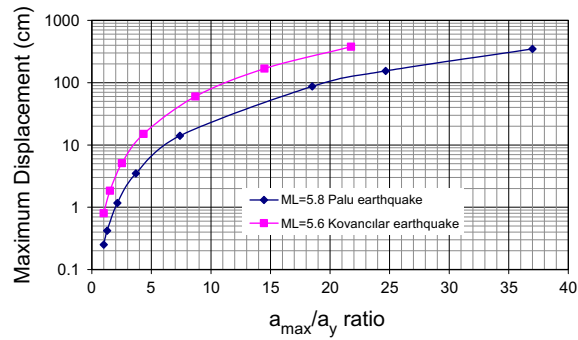
Fig. 15. The relationship between the maximum displacement and the  $a_{max}/a_y$  ratio.

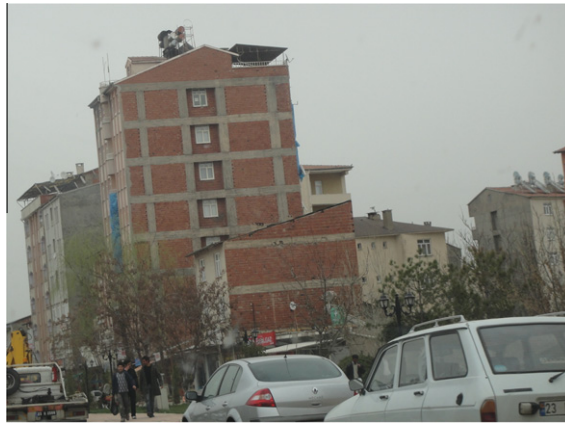
While Palu is a remarkably older district and has been one of the main city centers in the region for centuries, Kovancilar district has recently been developed much more rapidly due to its geographical location, which is on a main road connection between Elazığ and Bingöl cities. In Kovancilar district center, the structural systems of most of the buildings consist of reinforced concrete frames. These buildings generally do not include a basement and are 3–6 storeys high. Exceptionally, there are 7 and 8 storey reinforced concrete frame buildings as well (Fig. 16). As seen in this figure, generally infill walls are built

Fig. 16. Typical reinforced concrete frame buildings in Kovancılar.

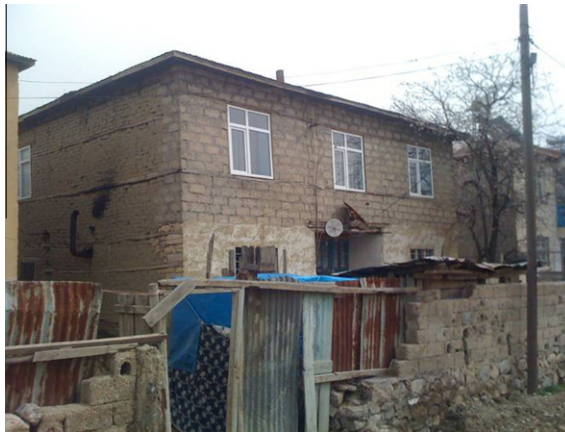
Fig. 17. Typical mixed-type stone-adobe buildings in Palu.

In Palu district, which is the closest settlement to the epicenter of the major aftershock, most of the buildings are two storey stone or adobe masonry houses. Many buildings are constructed using stone and adobe blocks together (Fig. 17). Foundations of all masonry buildings are constructed using stone only. Some of these buildings were severely damaged. Relatively newer masonry buildings in Palu district are constructed with brick masonry walls having concrete tie beams and slabs. Some of the one-storey brick masonry buildings have experienced only slight damage depending on the level of construction quality (Fig. 18). It should be noted that while there were many damaged buildings in the center of Palu and nearby villages, the damages were often limited and were not to the extent of total collapse. No casualties were reported from Palu district and its villages.

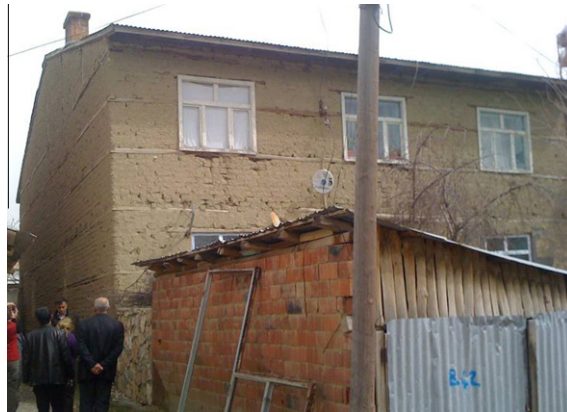
Fig. 30. An example of adobe buildings in Palu.

buildings in Palu district (Fig. 30). There are also some two storey buildings, with a combination of structural walls built with adobe blocks and stones (Fig. 17). The foundations of the adobe buildings in villages and Palu district are always built with stones. While the adobe and the adobe-stone buildings also suffered damages of various extents, the performances of these buildings were not as poor as improperly constructed stone masonry buildings.

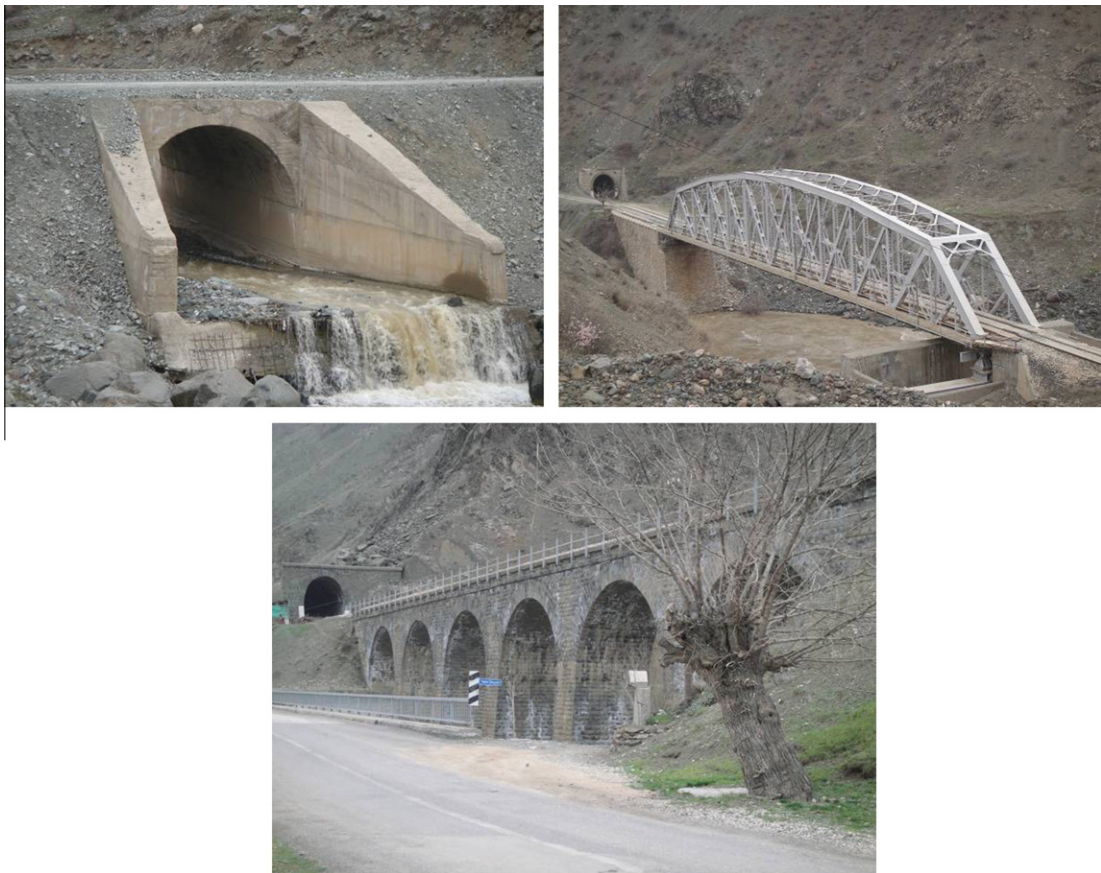
In the region, there was no widespread damage in the main transportation system. Other than some slope failure or rock fall problems in the mountainous areas, which were solved quickly in the aftermath of the earthquake, all roads in the area remained operational. No considerable damage was observed in the other lifelines, including power transmission lines. Some examples of these lifelines remained operational in the earthquake affected area are shown in Fig. 32. Actually, since the most affected areas are generally remote mountain villages, in these areas there are not widespread established lifelines, such as water piping and sewage systems, gas pipes, and telecommunication services.

**Fig. 32.** Examples of good performance of lifelines.
