# October 23<sup>rd</sup>, 2011 Van Earthquake: Preliminary Reconnaissance Report: Structural and Geotechnical Aspects of the Damage

U. Yazgan, B. Taşkın, P. Özdemir Çağlayan, A. Erken, Z. Celep,  
E. Ergüven, A. Sezen, R. Oyguç, Ü. Mert Tuğsal  
*Istanbul Technical University, Turkey*

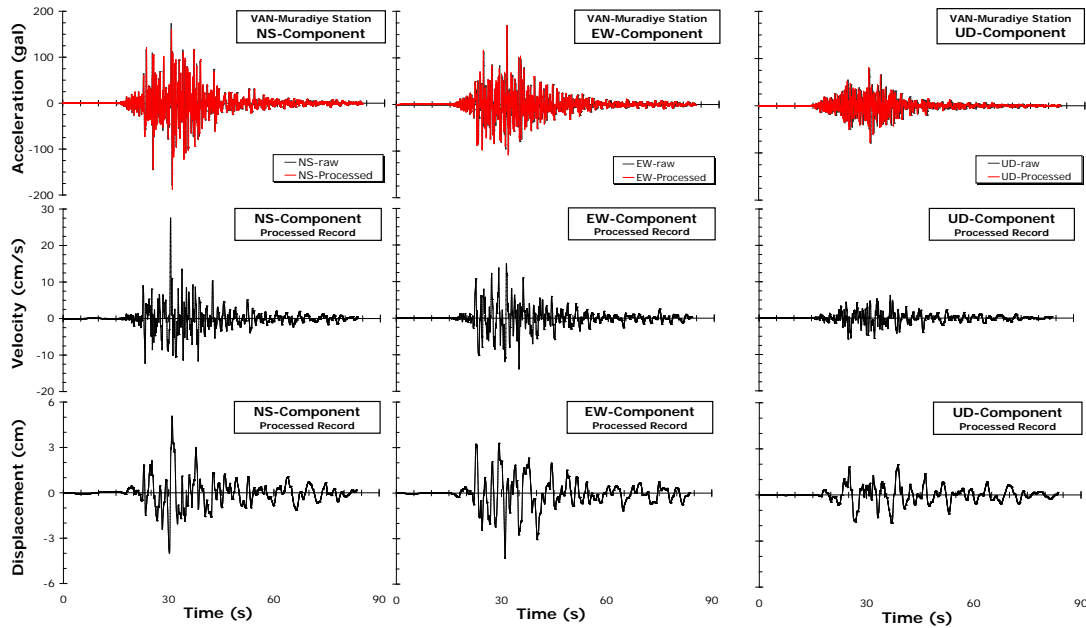
**Figure 2.1.** Acceleration, velocity and displacement histories of Muradiye NS (left column); EW (middle column) and UD (right column) components.

The highest PGA of the  $M_w$ 7.2 earthquake was recorded as the NS component from Muradiye station with a processed value of  $181.17 \text{ cm/s}^2$ . Fig 2.2 shows the acceleration, velocity and displacement spectra for the horizontal components of the processed motions recorded at Muradiye station employing different damping ratios. November 9, 2011 earthquake of  $M_L$ 5.6 occurred on a strike-slip fault located in Van Lake close to the shores of Edremit district of Van province. This second event was recorded by Van station with PGAs of 148.1 gal in the NS direction; 245.9 gal in the EW direction and 150.5 gal in the UD direction. Similar procedures are carried out to process the raw motions. It is concluded that the peak ground velocity and the displacement are recorded in the EW direction with maximum values of 31.6 cm/s and 7.5 cm, respectively.

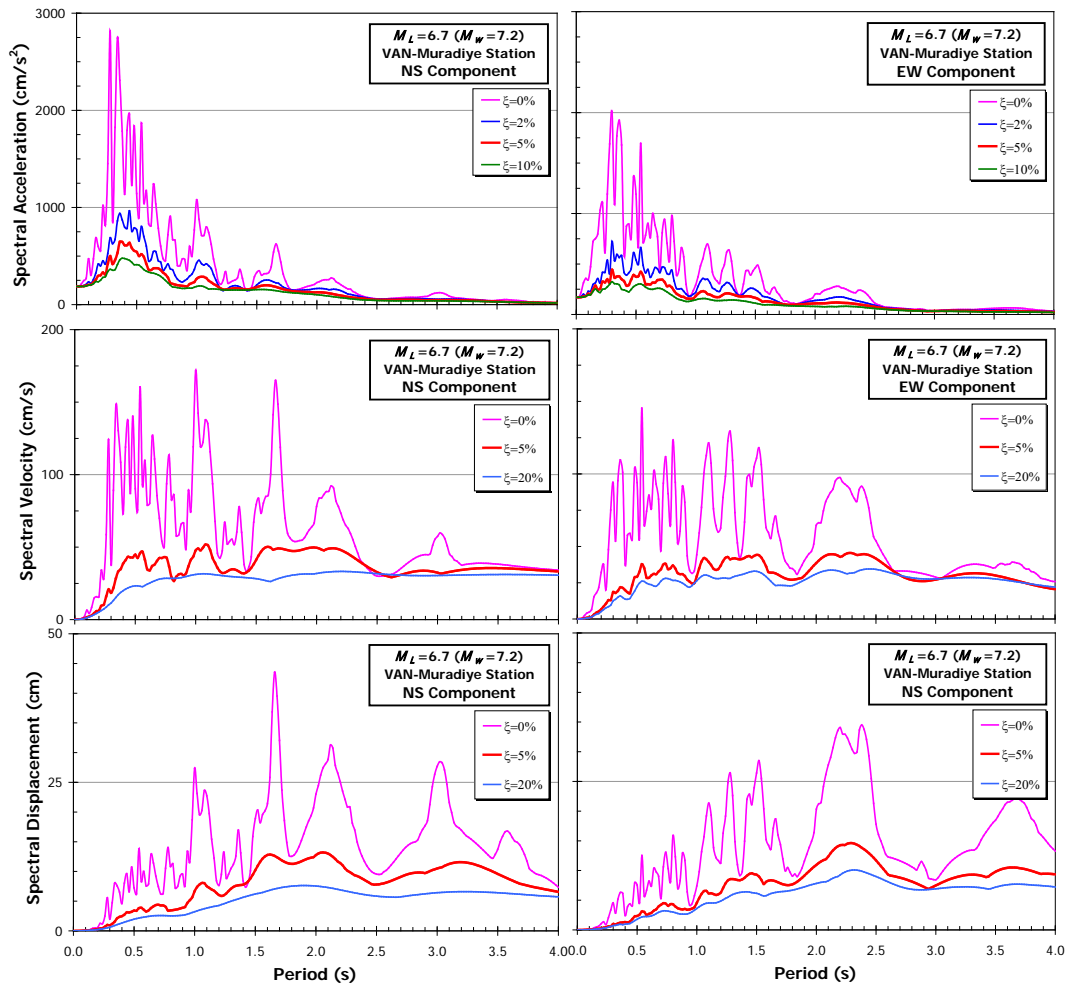
Figure 2.2. Acceleration (top row), velocity (middle row) and displacement (bottom row) spectra of Muradiye NS and EW components

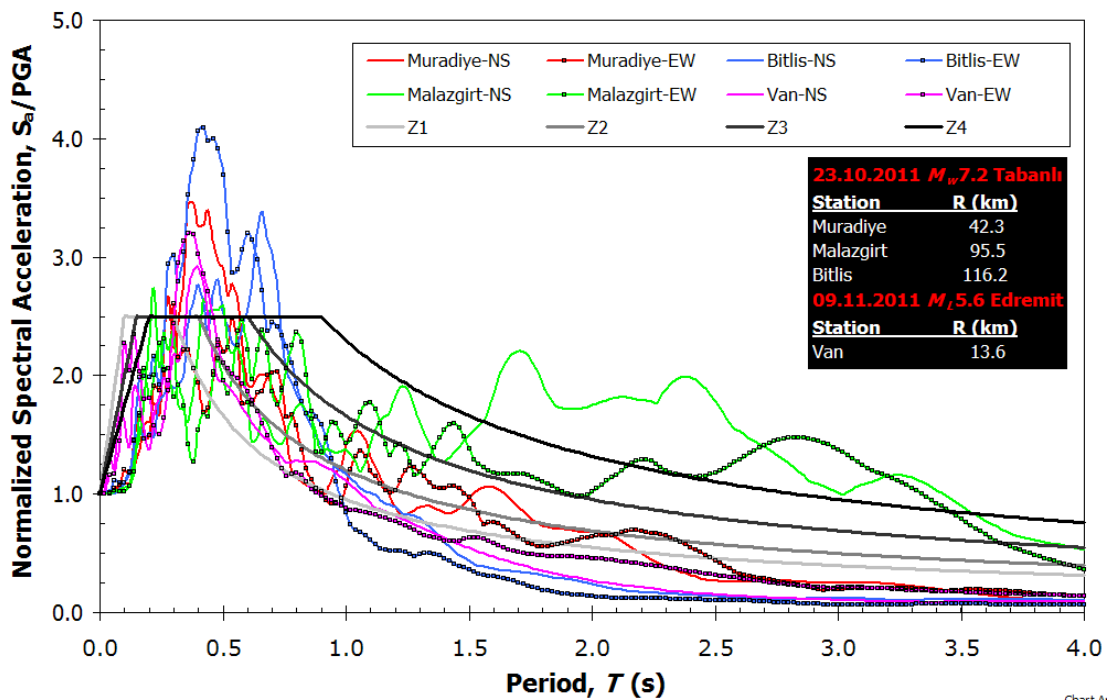
The 5% damped normalized acceleration response spectra of the nearest three stations' NS and EW components of  $M_w$ 7.2 earthquake and Van station records for the  $M_L$ 5.6 earthquake are computed and compared to the design spectra defined in the Turkish Earthquake Resistant Design Code (TERDC, 2007) for soil classes Z1, Z2, Z3 and Z4, where Z1 represents the firmest and Z4 represents the softest soil. It can be observed from Fig 2.3 that, the site amplification for moderate periods of  $T=0.25\sim 0.75$  s exceeds the design code limit of 2.5 up to 60% for Bitlis records and 40% for Muradiye records. For periods longer than 1.5 s, Malazgirt records indicate soft soil conditions with significantly higher amplification values compared to the code. When the second earthquake is considered high amplification values are only encountered for a period range between 0.30~0.45 seconds with a maximum value of 3.5.

Figure 2.3. Comparison of the normalized spectra with the design spectra for Z1, Z2, Z3 and Z4

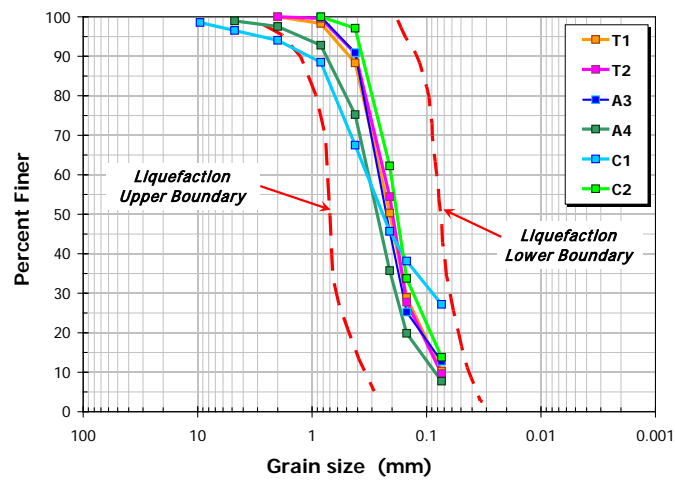
Sieve analyses were conducted on samples taken from the sand boils at Alaköy, Topraktaş and Çelebibağı. The samples tested were determined to be as sand with 8% to 27% fines ratio. On The grain size distribution curve depicted in Fig. 3.3, Port and Harbour Research Institute of Japan (1997) recommendation for upper and lower boundaries for liquefaction potential is given as a reference to capture the liquefaction potential of the soil samples.

**Figure. 3.3.** Grain size distribution of soil samples taken from sand boils at Alaköy, Topraktaş and Çelebibağı
