SeRFIn Seismic Retrofitting of RC Frames with RC Infilling

RC Infilling of Existing RC Structures for Seismic Retrofitting

C. Z. Chrysostomou, N. Kyriakides, P. Kotronis, P. Roussis, M. Poljansek, F. Taucer

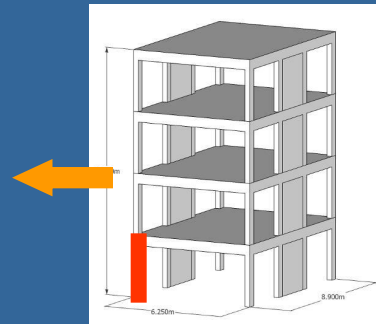
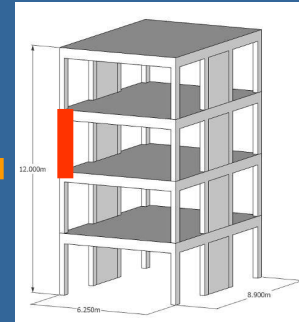
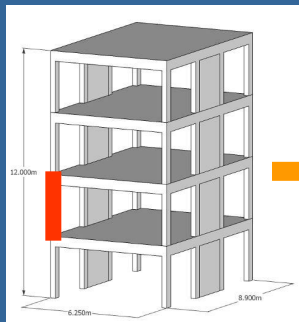
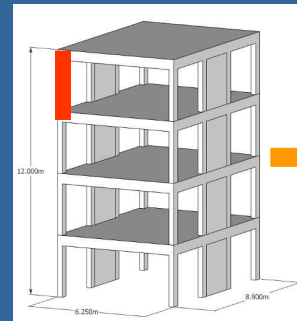
SeRFIn *Lap-splice failure – West column of North frame*

- The structure managed to sustain an earthquake of 0.25g without significant damage
- Some column lap-splices failed with concrete spalling, but the structure continued to carry load
- The 3-sided FRPs protected the wall bounding columns at the 1st floor and prevented lap-splice failure

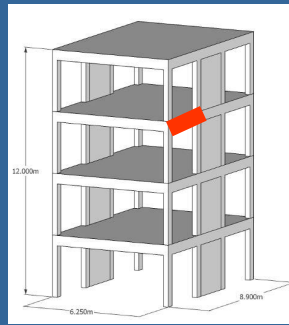
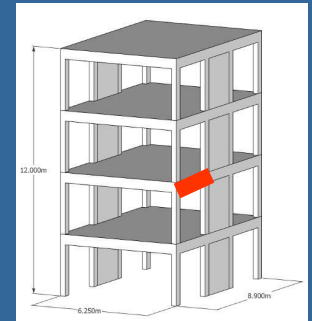
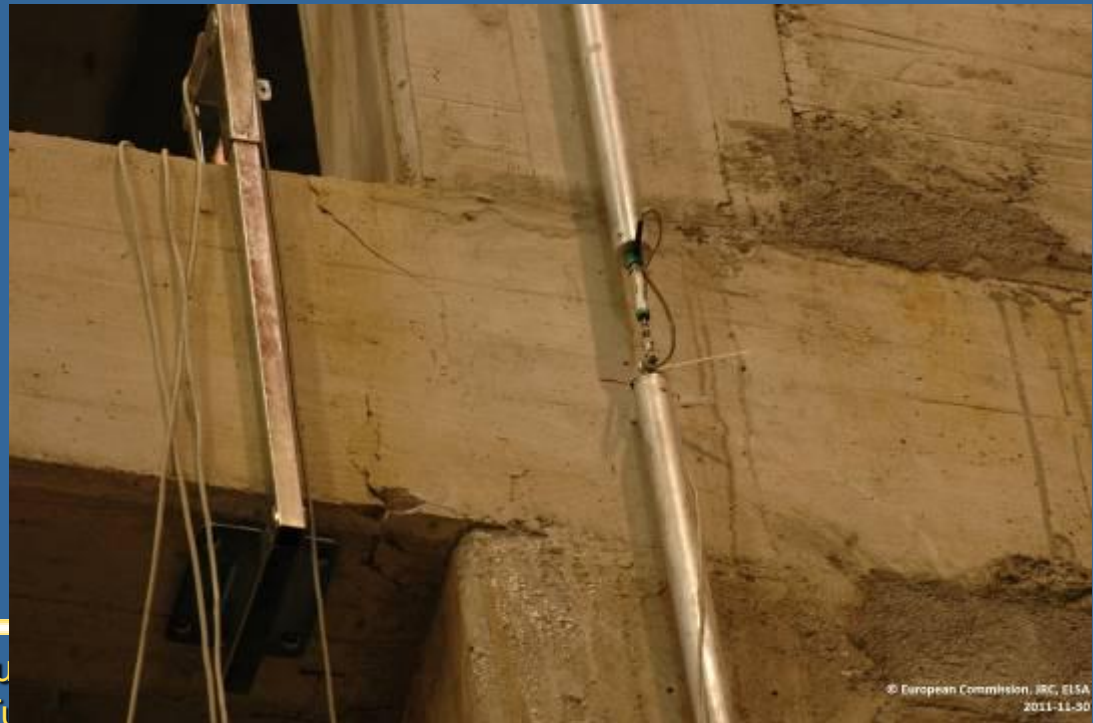
Beam cracking

- Some vertical cracks appeared at the connection of the beams to both the exterior column and the wall columns
- A horizontal crack appeared at the ground beam of the walls, and it was the main reason for loss of strength of the south frame
- The proposed system seems to behave in a satisfactory manner

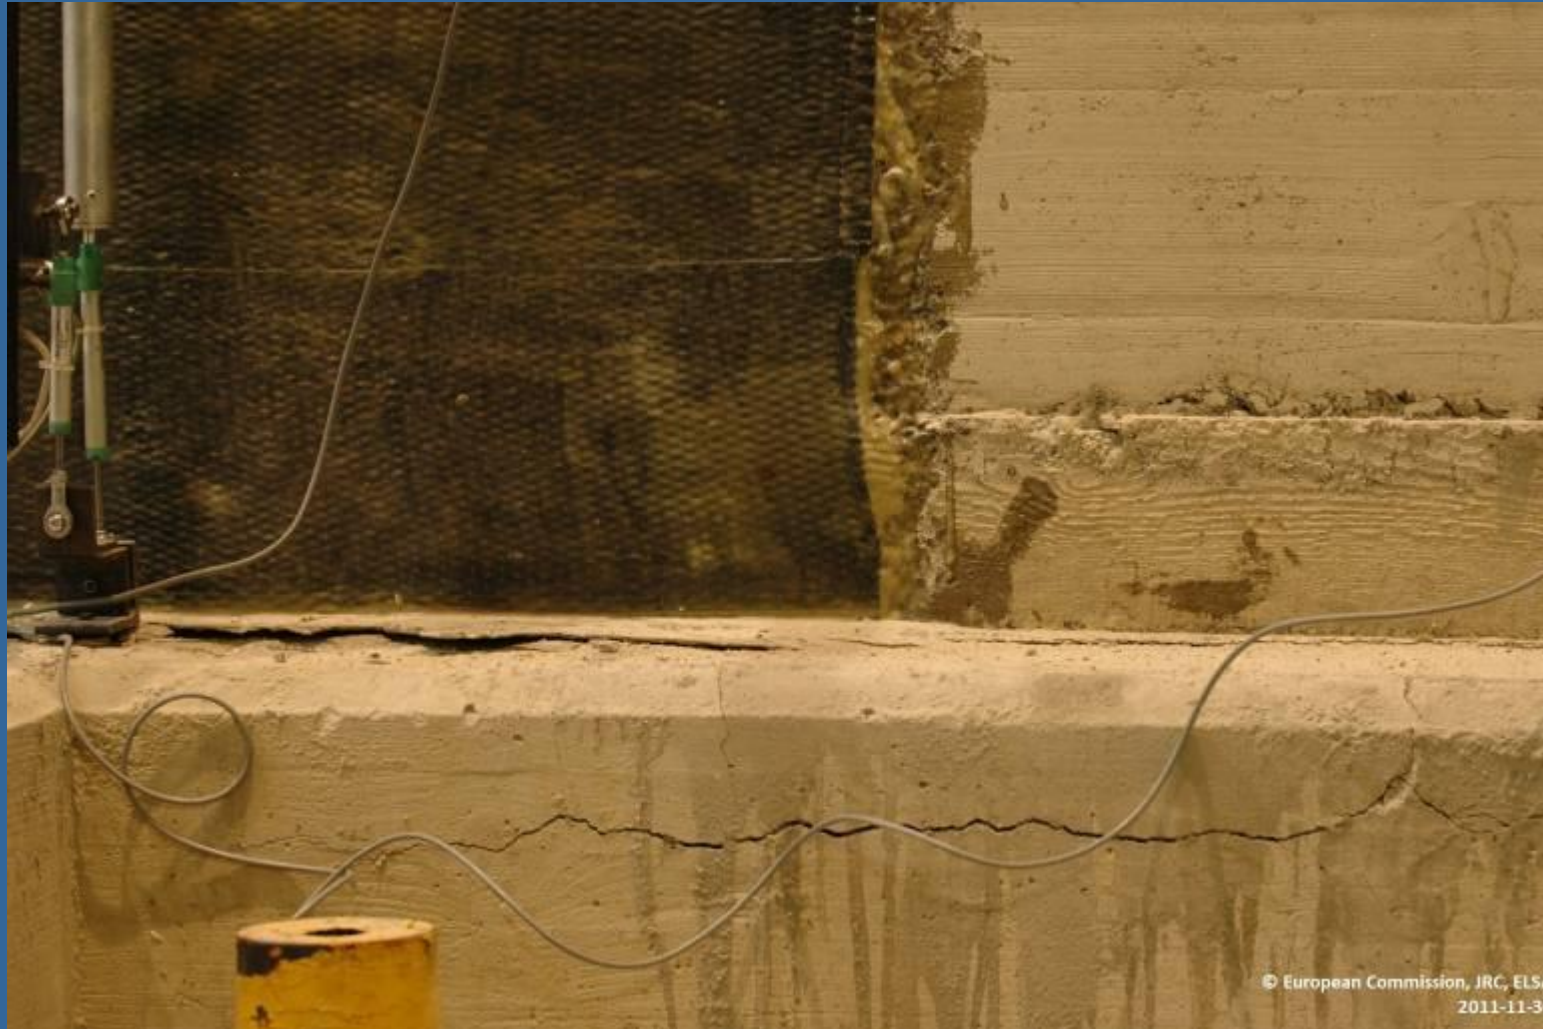
Ground beam cracking – North wall

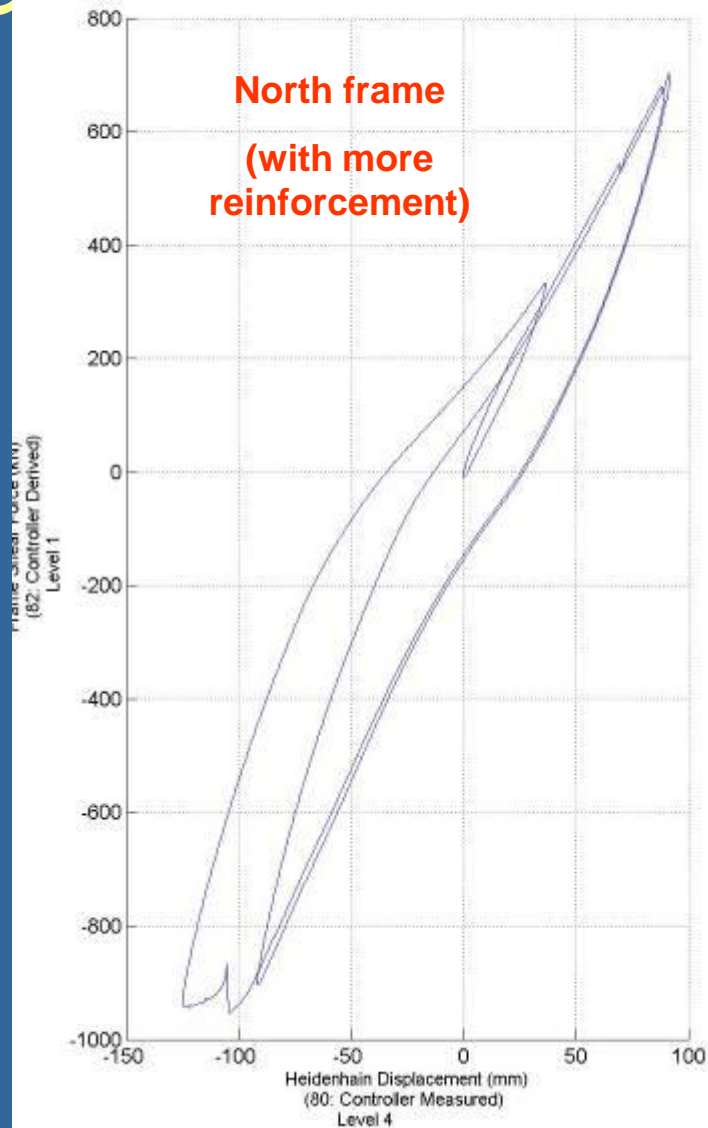
SERFIN ELSA [RC Building]
f21: Final cyclic test 07/12/2011
NORTH

**North frame
(with more
reinforcement)**

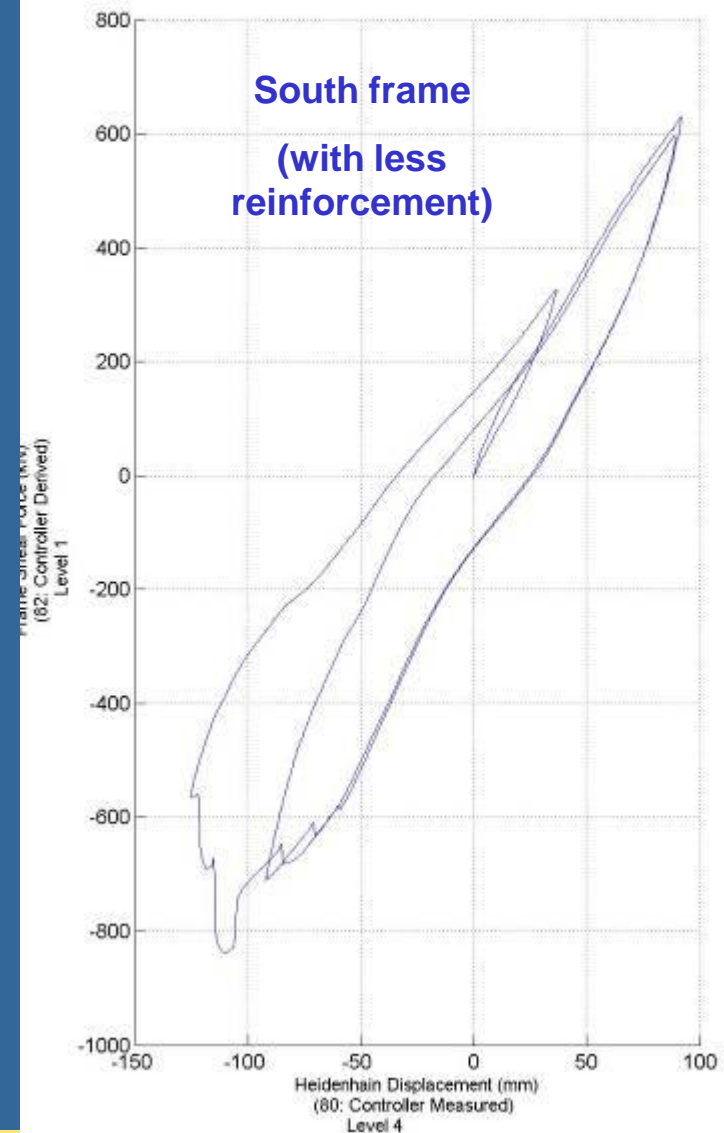
SERFIN ELSA [RC Building]
f21: Final cyclic test 07/12/2011
SOUTH

**South frame
(with less
reinforcement)**

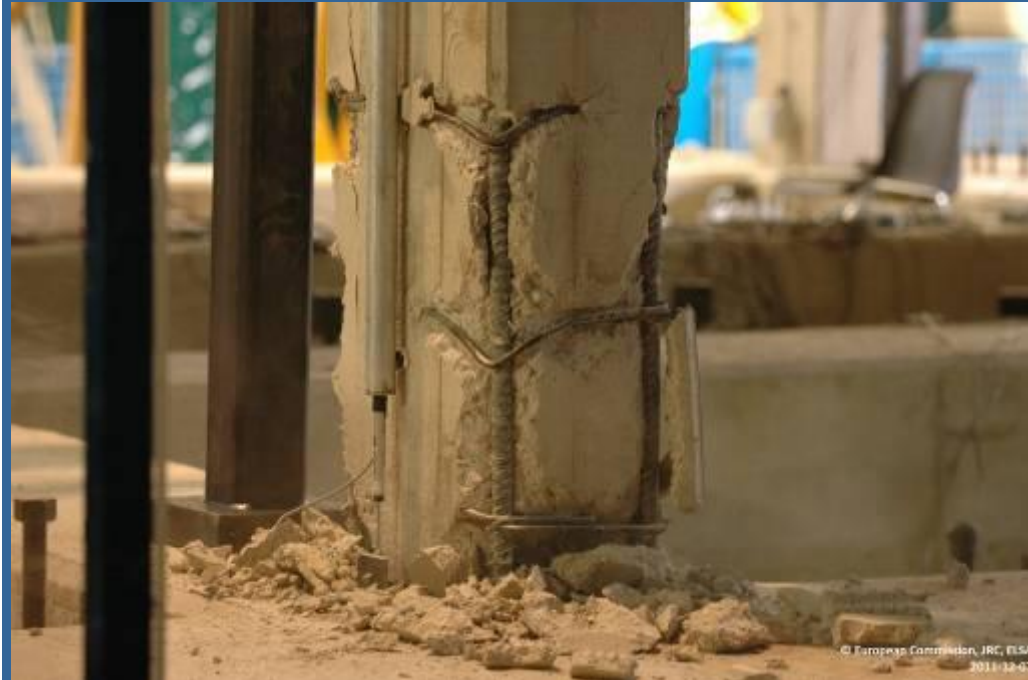
Cyclic testing

- The “weak” frame behaved equally well as the “strong” frame
- There has not been visible movement at the interface between the wall and the bounding frame
- The behaviour of the wall was mainly flexural, although on the south-frame wall some diagonal cracks appeared
